THE SUCCESSFUL USE OF INTERNALLY PLASTIC COATED TUBING IN ARTIFICIAL LIFT APPLICATIONS

Ryan Christopher
NOV Tuboscope

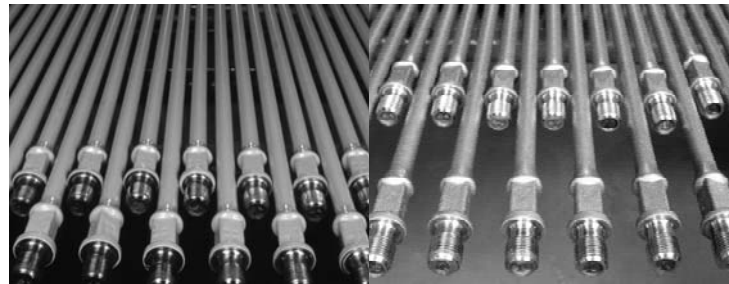
Figure 1 – Plastic Coated and Spray Metal Sucker Rods

In addition to the tubing losses due to corrosion, erosion-corrosion, and mechanical wear in rod pumping applications, the sucker rod string is susceptible to the same losses as it is exposed to the identical elements. Spray Metal Plastic Coated (SPMPC) sucker rods (Figure 1) have proven to provide life extension in sucker rods for

severe service applications including highly deviated, high side-load, heavy solid and even sour service wells in certain applications. The spray metal material utilized is a 316 stainless steel that is applied 1 ½ - 2 mils (0.0015-0.002 in.) thick. Like other thermal spray materials, this type of application is known to produce a porous structure that can potentially provide pathways for corrosive fluids. The use of a 10 – 20 mil thick (0.001-0.002 in.) thermoset epoxy topcoat, applied over the spray metal, provides the most robust system by eliminating any potential corrosion pathways.

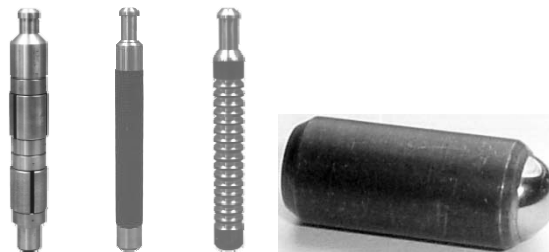
Figure 2 – Examples of the padded, brush and solid and two part plunger configurations

There are many configurations of plungers which will provide a variety of wear interactions with potential IPC tubing use. Typically parameters of the well dictate which configuration of plunger is best suited for each individual application. When IPC tubing is considered proper plunger selection should also be considered in regards to compatibility with the IPC. Non-metallic brush style plungers are the preferred configuration eliminating any metal to coating contact during plunger cycles. A variety of padded, brush, solid and two-part (ball and cylinder) are currently being utilized in trial wells with no reported issues to date (Figure 2). The use of plungers with paraffin/scale scraper sections should be avoided (Figure 3).
