# **CASE STUDIES IN IMPROVED PUMP CAGE PERFORMANCE USING AN IMPACT RESISTANT MATERIAL**

Joe Garcia, Bob Nguyen, and Walter Phillips  
Blackgold Pump & Supply

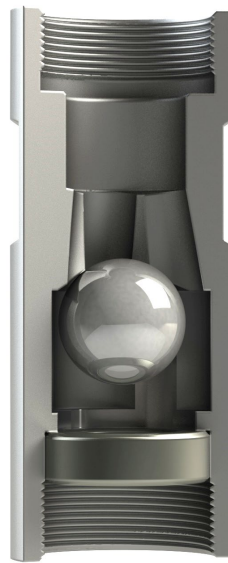
*Figure 1 – A full open, metal cage is shown above. The IR cage utilizes a similar geometry to improve flow, compared to a standard API style cage.*

The API-style cage is "closed" meaning the region directly above the ball is solid, with passages drilled for fluid flow. The IR Cage is an open design which improves flow above the ball. An open design can be seen in Figure 1 below.

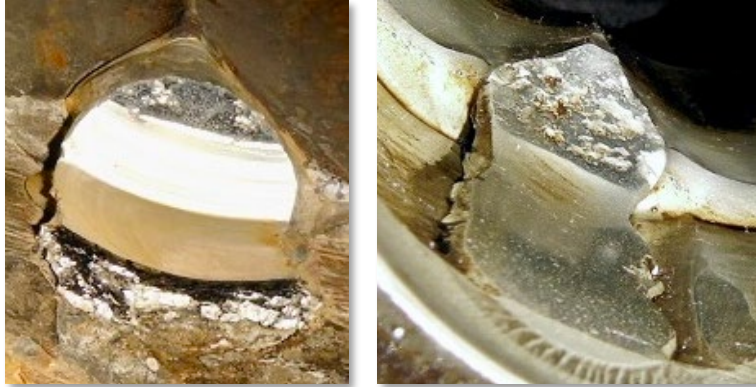
*Figure 2* – The cages show above are severely beat-out. The chipping of the lining and undermining of the softer base material can be clearly seen around the edges of the lining face.

Stellite-lined cages have shown mixed field performance. The hardness of Stellite makes it brittle and prone to fracture from repeated impacts, causing shards of extremely hard material to break off and lodge between the plunger and barrel, leading to failures. Additionally, bare-metal bypasses are vulnerable to fluid erosion/corrosion, requiring cage replacements. Design variations by manufacturers also affect ball clearance and travel, with key parameters like layer thickness, weld quality, and machining impacting cage performance. Poor quality in these areas can cause weld adhesion issues, rough finishes, and jagged transitions on Stellite layers.

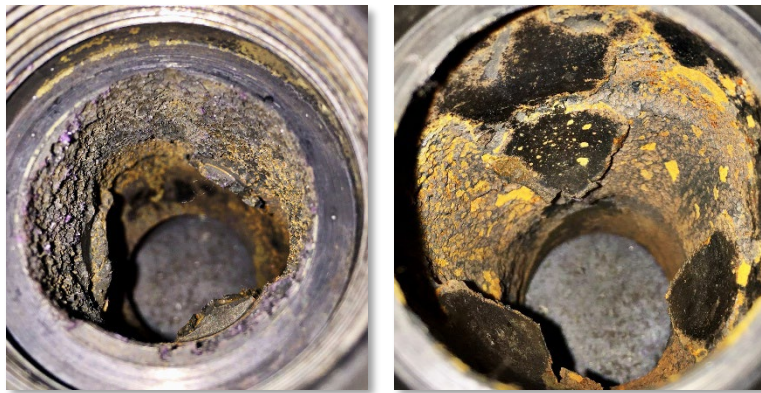
*Figure 3* – Corrosion is another factor in metal cages, particularly hardlined cages. In the photo on the left, the base material corroded to the point where the lining completely separated from the body. These pieces of hardened material likely caused damage elsewhere in the pumping system. The photo on the right shows severe corrosion, but the hardened tabs are still present. The area around the ball has also corroded allowing the ball excessive lateral movement, which can indirectly result in ball and seat damage.

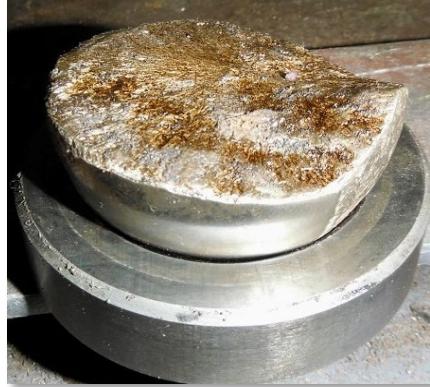
*Figure 4* – Ball and seat issues are not always attributed to cages. The ball impacts both the seat and the cage and so it sees twice as many impacts (if not more due to ball rattling around in the cage and chattering, or reseating multiple times through the stroke). The significant stress a ball sees can result in catastrophic failure, as seen above. The IR Cage lessens the impact and can extend the service life of a ball.

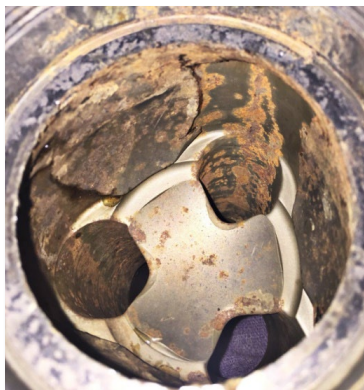
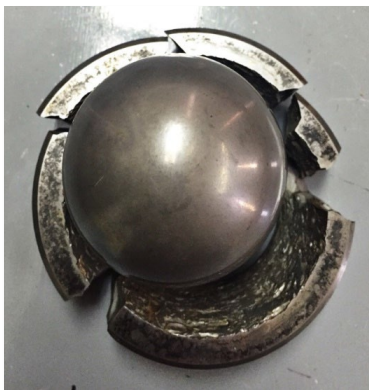
128 days Pulled for Valve failures. Destroyed Seat. Severely beat-out cage.

Discussion: The standard API cage shown on the left indicates the ball spent most of the open phase rattling (or floating) within the cage, not pinned in the full open position. Excessive wear on the lateral ball guides and seat indicates the ball was not adequately constrained. The IR Cage provides uniform ball guides through the travel of the ball to better position the ball for closing cycles and to reduce rattling.

Discussion: Runtime represents a substantial improvement over the previous failure of a combined cage beat-out and seat failure. The improvement is due to reduced ball travel in the lateral direction, resulting in less of an impact between the ball and seat. Lateral movement is a problem when the flow through the valve is insufficient to fully lift the ball to the open position. The weight of the ball opposes the flow meaning the ball can “hover” or rattle in a partially open position. The IR Cage addresses this by constraining lateral ball movement. The improved flow area around the ball (between the ball guides) also lessened the force in which the ball was pushed down onto the seat.

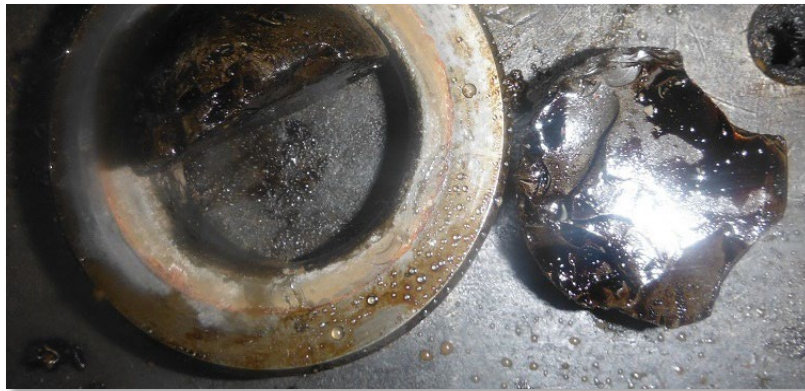
42 days      Pulled for valve failures. Split Ball. Damaged Seat

Discussion: A split ball and damage seat might not appear to be related to the cage, but recall the ball impacts both and so it sees twice as many impacts, if not more.

Discussion: In addition to the IR Cage, the ball material was also changed. This may have contributed to resolving the previous failure (cracked ball). It is important to note that the valve was re-run showing a remarkable improvement with just changing 2 components (ball and cage).

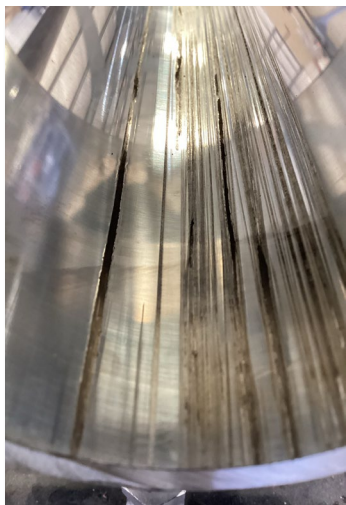
a) Scored barrel  
Failure #1

Discussion: The previous 2 failures were attributable to cage issues. Specifically chipped Stellite. In the picture of the first failure, this material entered the pump barrel and scored the barrel and plunger. The second failure is likely a repeat of the first. This well is a high producer and the operator elected to replace the pump immediately without waiting for the teardown report.

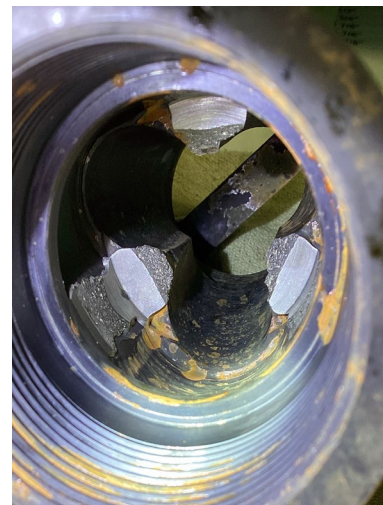
- 232 days Pulled for poor pump efficiency (worn barrel/plunger).
- 184 days Beat-out cages.

b) Beat-out Cages  
Failure #2

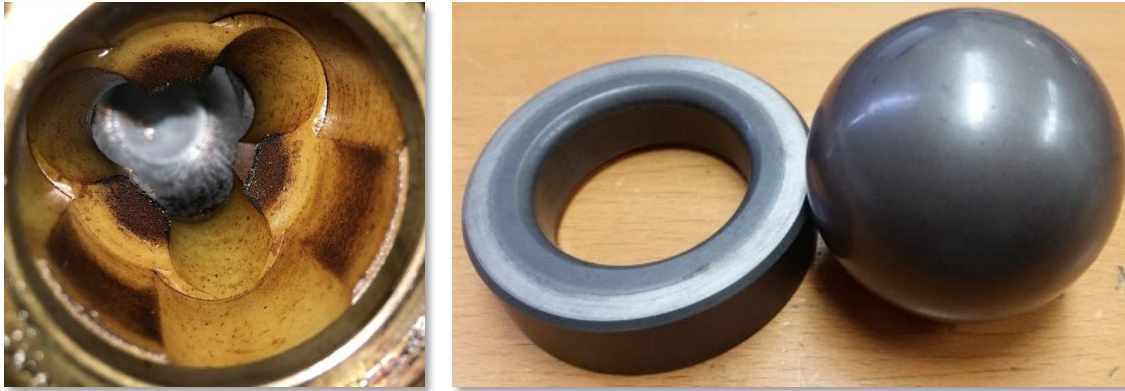
*Figure 6 – Typical IR Cage inspection. The cage material has some minor surface discoloration, but this does not affect its performance. The material is inspected, specifically around the tabs and ball guides and determined to be fully functional. Balls and seats are assessed through the usual vacuum test process. In all of the above Case Studies, the cage and ball/seat were assessed to be in good condition and re-deployed as-is.*
