# **FULL-SCALE TRIBOCORROSION AND ABRASIVE TESTING TO MITIGATE ROD AND TUBING WEAR**

Guillermo Emiliano Ghione, Matias Gustavo Pereyra, Pablo Zupanc,  
Esteban Oliva, and Francisco More  
Tenaris

## **ABSTRACT**

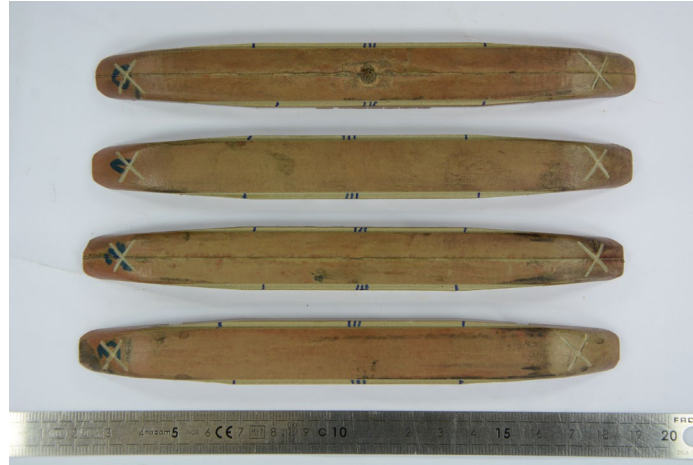
Figure 6. Guides segments before the experiment.

As for the guides, prior to the experiment, they undergo autoclave aging for 15 days at 120°C in a saline solution with CO<sub>2</sub> at 1300 psi. After aging, the fins of the guide are cut, cleaned with water, soap, and ethanol. After cleaning, a reference mark is made on the area that does not contact the tubing. The injection fin is used as the reference, and the other three fins are the ones tested (Figure 6). Data is recorded during entire experiment (Figure 7).
