# **CORROSION AND WEAR PROTECTION IN ENDLESS ROD DESIGNS IN UNCONVENTIONAL WELLS FEATURING KEBOND TECHNOLOGY – POLYKETONE-BASED EXTRUDED COATING**

Courtney Richardson  
Occidental

Taylor Krenek  
Lifting Solutions

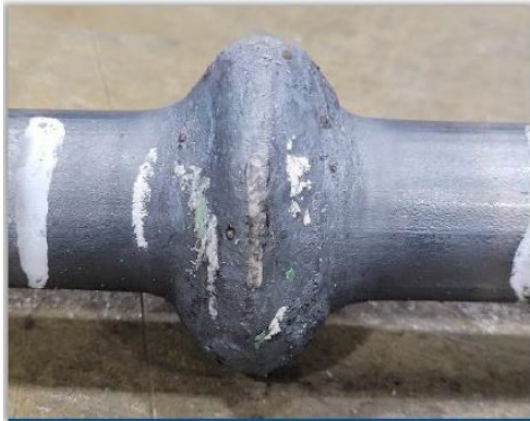
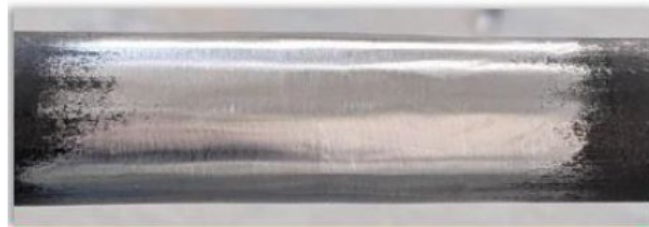
Figure 1a

Figure 1: Example of oxy-acetylene forged butt weld in process (1a) and final product (1b).

Over the last several decades, continuous rod has faced three main challenges: welding, service quality and availability, and corrosion. Welding challenges stemmed from now-outdated electrical resistance flash-butt methods that applied high current to melt the rod ends which were then forged together. This method was inconsistent in nature and could trap oxides and cast metal in the forged ends, leading to premature failure. In 2004, the oxy-acetylene forged butt weld process was introduced to the market and is now the most common method, enabling consistent and reliable welds that can withstand operational loads (Figure 1).

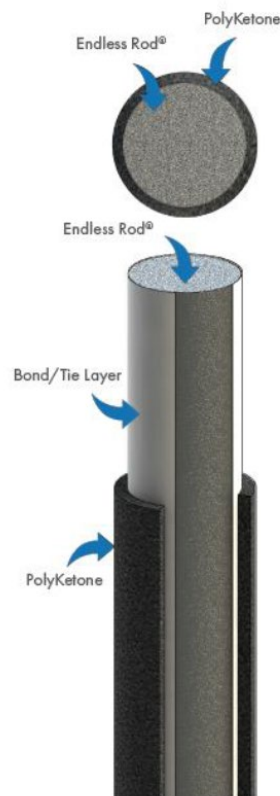
Figure 2. Cutaway diagram of coated continuous rod

The second generation of coated continuous rod by this vendor is comprised of an engineered, blended thermoplastic polyketone outer coating fused to a tie layer bonded to the rod body. Its primary objective is to serve as a barrier, protecting the parent steel material from wellbore fluids and from mechanical damage.

After the rod surface is conditioned, a bonding agent is applied to the rod body before passing it through two extrusion heads. The patented process extrudes the tie layer and then the final outer polyketone layer, bonding the thermoplastic polyketone to the steel.

A key feature of this product is the relatively thick coating, as shown in Figure 2, which extends runtimes by reducing rod-on-tubing wear, especially when compared to thinner coatings also explored during product development. Additionally, the outer coating reduces the coefficient of friction throughout the rod string, improves the downhole stroke, decreases the peak polished rod load, and increases the minimum polished rod load.

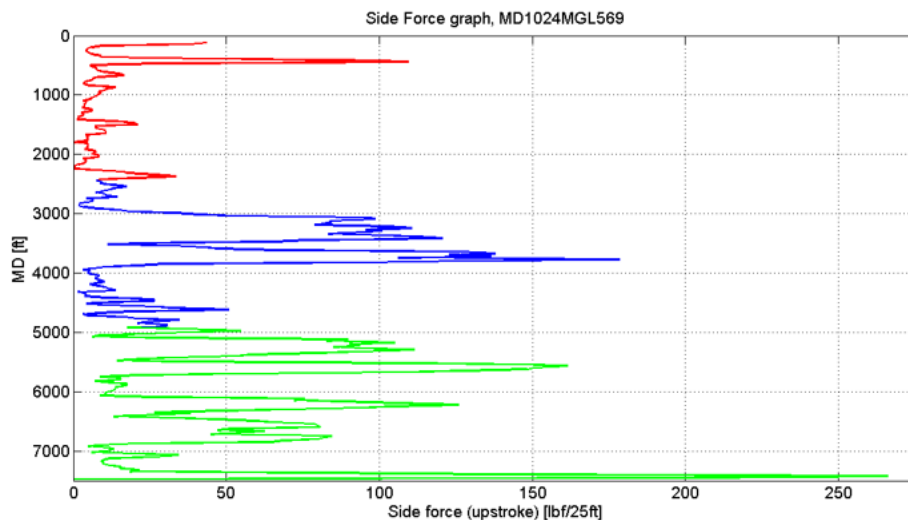
Figure 6: Well No. 6 side loads.

Well No. 6 has a history of short runtimes between failures, attributed to side loading throughout the wellbore. As illustrated in Figure 6, Well No. 6 experiences significant side loading within the initial 400 ft and continues to encounter side loads exceeding 150 lb in two other intervals in the wellbore. Furthermore, this well exhibits high corrosivity and has a corrosion-related failure history, requiring continuous treatment. The runtime improvement observed with polyketone was considered a success, given the historical frequency of failures and considering the wellbore trajectory, corrosive fluid properties, and the throughput of 300 barrels of total fluid per day.

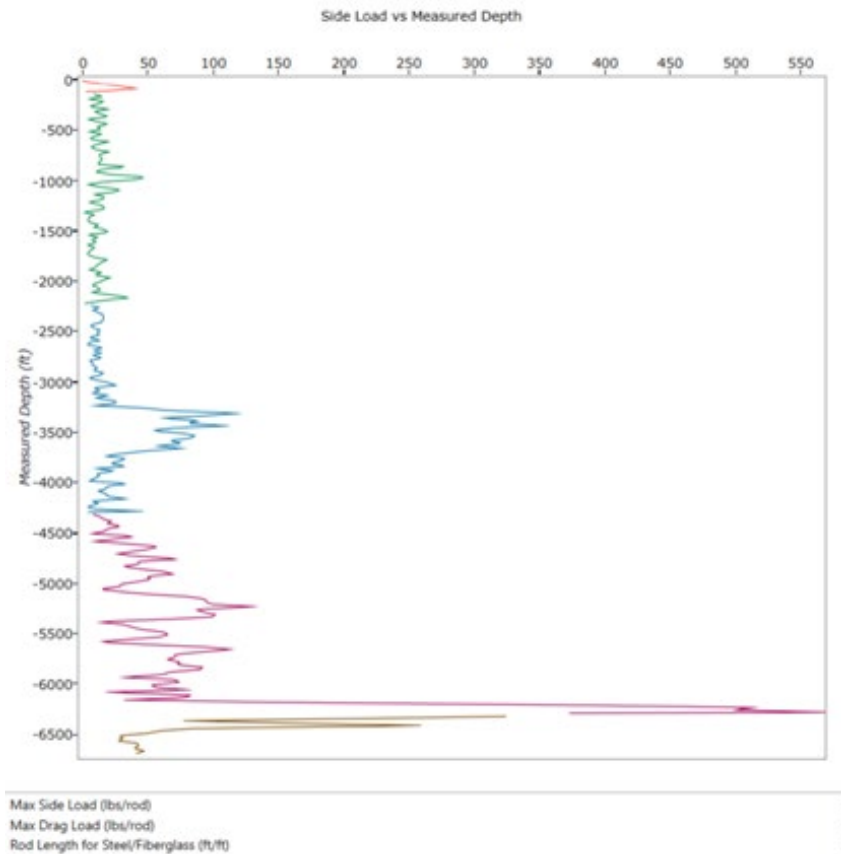
Figure 7: Well No. 4 side loads.

Well No. 4 was converted to an RRP after being on an electric submersible pump (ESP) in late 2023. Shortly after conversion, the well experienced two brief runs on the RRP, with failures primarily driven by corrosive fluids causing corrosion fatigue failure due to corrosion fatigue by inhibitor wipe. These run intervals were 69 and 63 days, respectively. From an operational standpoint, the well was running with a 2-in. pump, 186 in. SL, and 3-5 SPM on a variable speed drive (VSD). The pump was set at 6,850 ft, approximately 150 ft above KOP. The well has several areas experiencing up to 150 lb of side loading; however, starting at around 6,250 ft, side loads in this well increase to over 500 lb (Figure 7). Given the side loading and the corrosive fluid properties, the operator determined that the best chance for success was with polyketone-coated continuous rod.

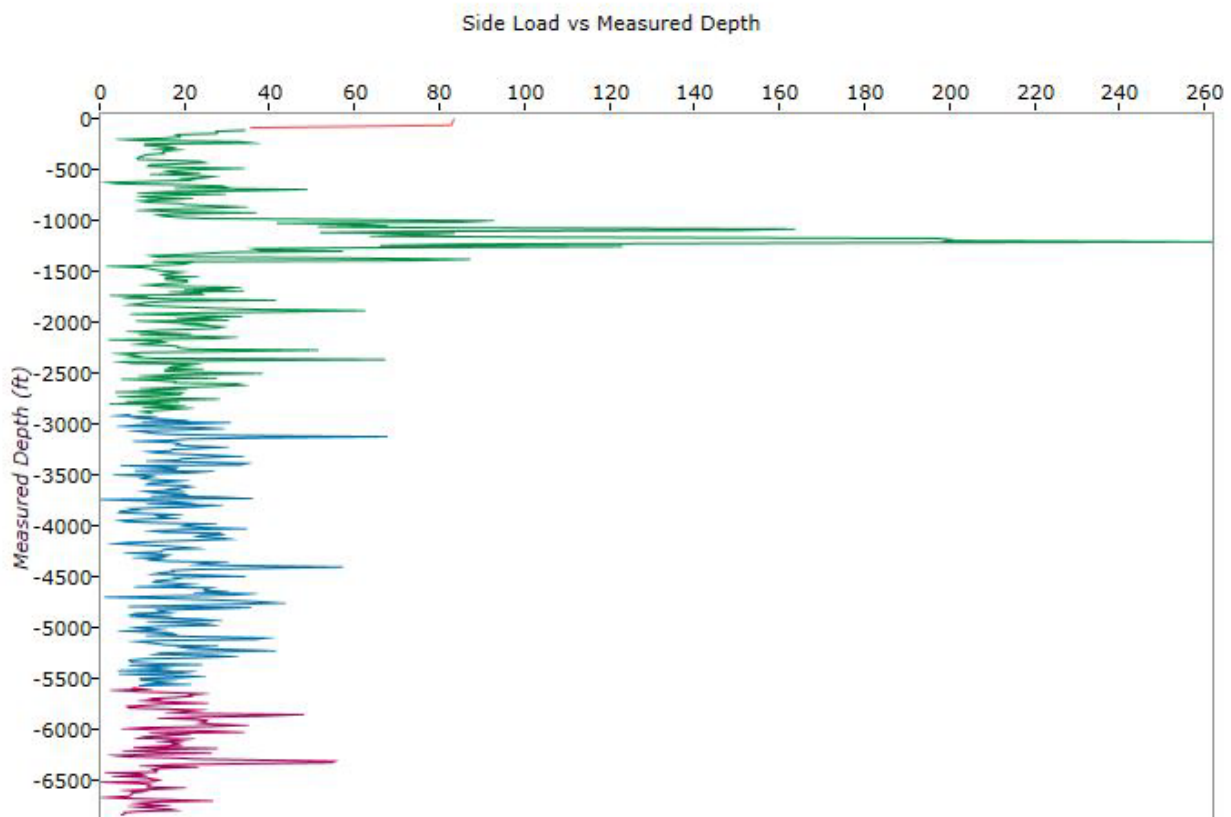
Figure 9: Well No. 9 side loads.

This well continues to operate with polyketone-coated continuous rod without any subsequent failures. This well sees up to 260 lb of side load in the first 1,200 ft of the wellbore, which creates a unique challenge with rod pumping (Figure 9). High shallow side load in the wellbore paired with a rod rotator has not proven to evenly distribute wear. From the operator's experience, the higher and shallower the side load, the less reliable the rotator is for wear distribution. The run days for the life of the well are outlined in the chart below (Figure 10). Currently, polyketone run days are at 424 days and still accruing, approaching similar runtime to historical ESP run days between failure.
