DISTRIBUTED FIBER-OPTIC TEMPERATURE PROFILING ALONG FULL ESP SYSTEMS IN GASSY UNCONVENTIONAL WELLS

Araceli Rivera Mandujano and Michael Rumbaugh
SLB

ABSTRACT

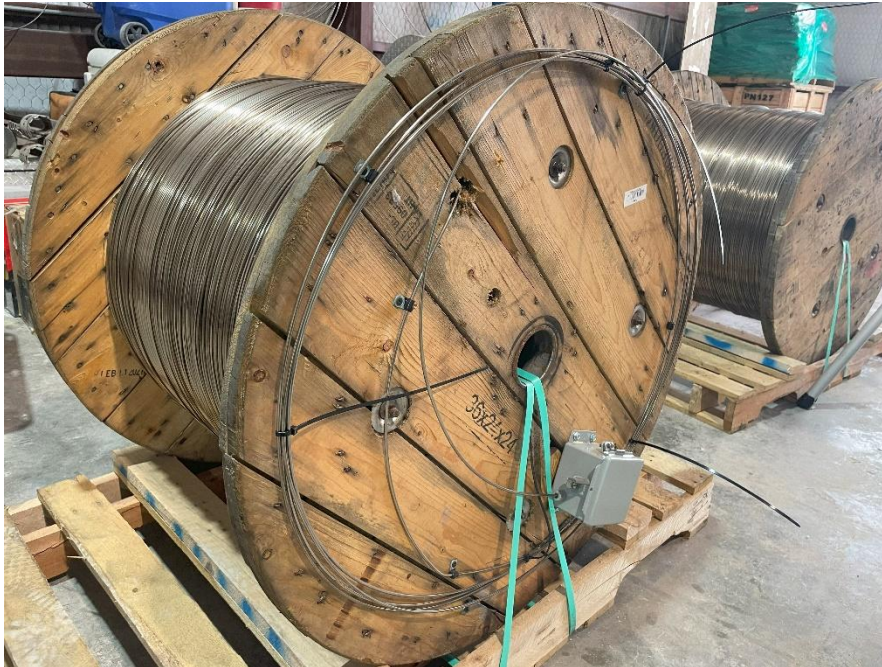
- Cable Type: Tube Encased Fiber (TEF) (Figure 1)
- Temperature rating: 200 °C (392 °F)
- Outer tube: 4mm OD; 0.028" wall; 316L

Figure 1. Fiber Optic Profile/Downhole Steel Tube Cable. Source: Silixa

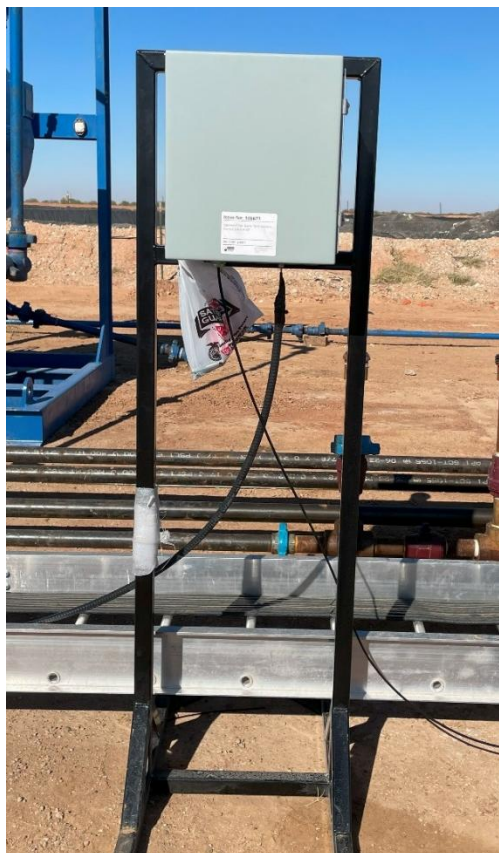
A NEMA 3R junction box was installed (Figure 5), where the surface cable and the downhole fiber get spliced and protected from the environment.

Figure 5. Junction Box. Source: SLB

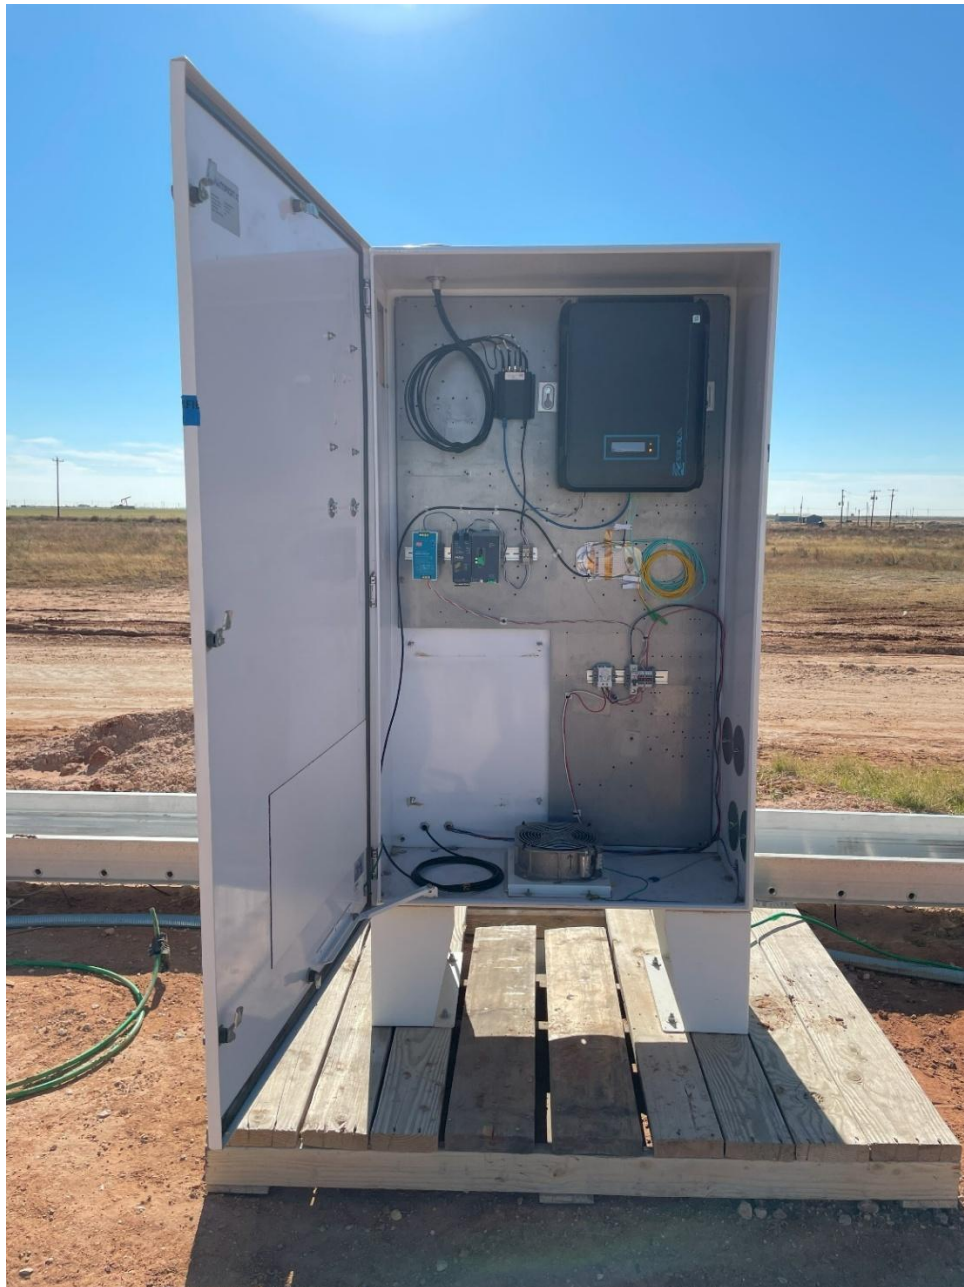
The interrogator is installed inside a NEMA3 enclosure, custom built by SLB (Figure 6)
The enclosure contains:

- DTS box
- 100-200VAC to 24 VDC power supply
- 120/240VAC power switch
- UPS battery backup
- Fan
- Cellular modem

Figure 6. DTS Interrogator Enclosure. Source: SLB

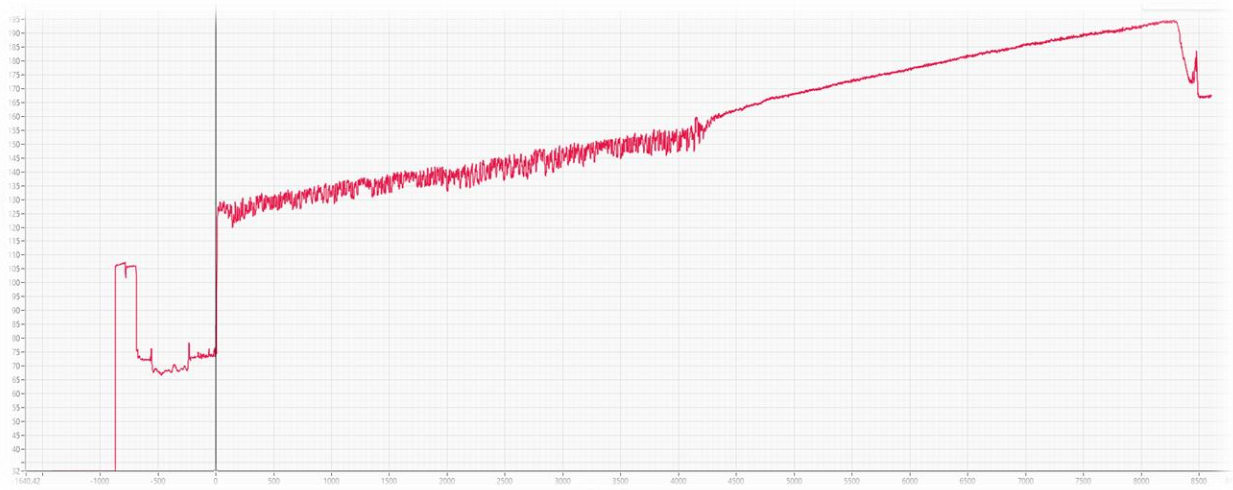
The interrogator provided a full well profile every four minutes, as shown in Figure 7.

Figure 7. DTS Profile (Well 2). Source: SLB

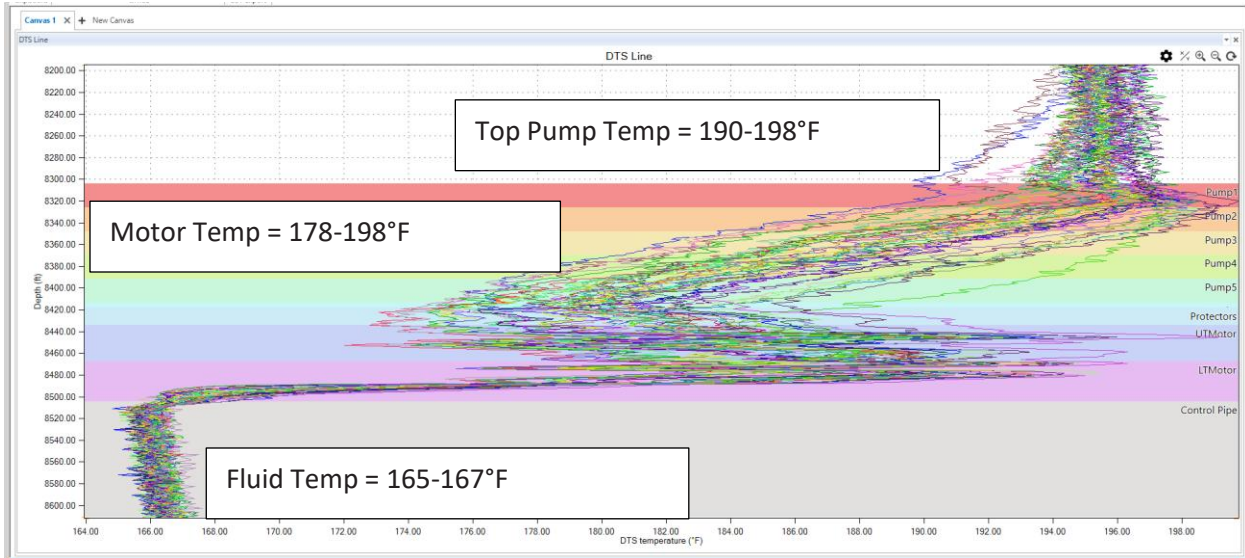
When the well operates below the bubble point, performance becomes unstable due to the presence of free gas in the produced fluid (Figure 10). Under these conditions, and when there are no specific low- or no-flow events, the temperature differential between the wellbore fluid and both the motor and the pumps increases to approximately 31°F (Table 3).

Figure 10. Temperature profile below Pb. Source: SLB

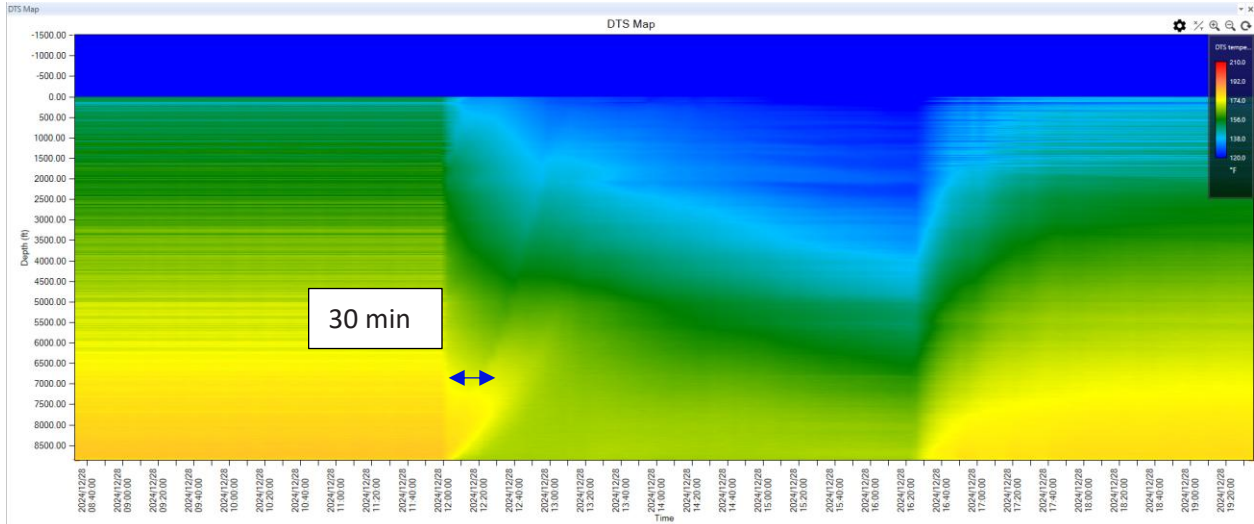
Figure 11 presents a screenshot captured during a power trip. At the bottom, the heat dissipation profile from the ESP to surface is observed. Approximately 30 minutes are required for the temperature at the top of the pump to equalize, during which heated fluid migrates upward until thermal equilibrium with the surrounding environment is achieved. During this 4-hour period before restarting the ESP, we can observe how much tubing space is equalized with the wellhead temperature of about 120°F.

Figure 11. FOC Tubing Temp Profile. ESP heat dissipation. Source: SLB

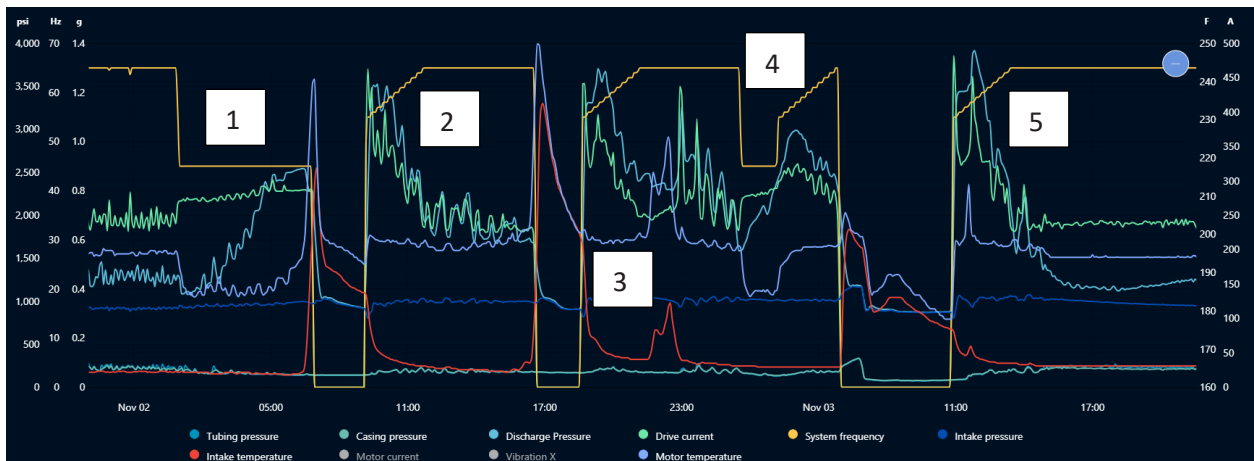
The events in Figure 12 represent a three-day period during which two winding-temperature shutdowns and one facility-related shutdown occurred. The VSD was operating in PID mode throughout these events.

Figure 12. Multiple Shutdowns (numbered by event). Source: SLB

During Event #1, the VSD automatically reduced speed from 65 to 45 Hz in response to increased current during operation while running in PID mode. This behavior is believed to have resulted from a partial restriction between the pump and the wellhead, given the steady increase in current, discharge pressure and decrease in tubing pressure. Figure 13 between slowdown to 45Hz and the motor temp shut down shows a clear decrease in tubing temperature, likely associated with insufficient lift capacity.

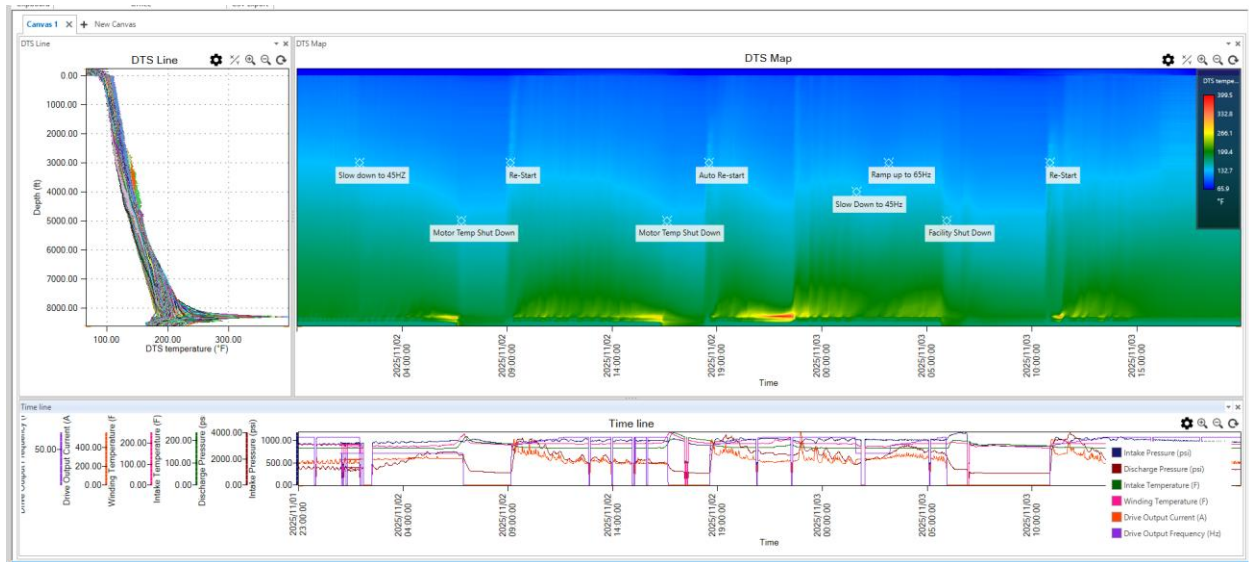
Figure 13. FOC Tubing Temp Profile after multiple shutdowns. Source: SLB

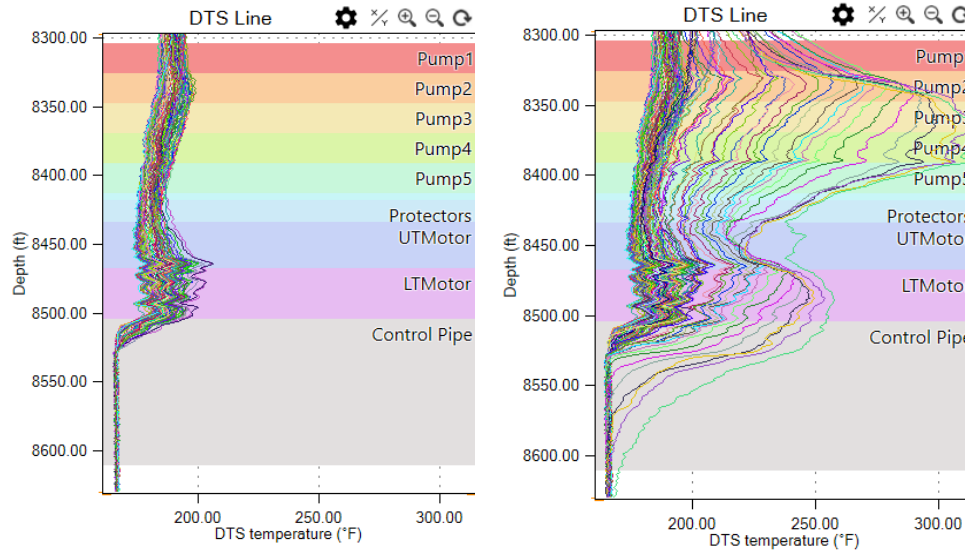
Immediately following the speed reduction, the motor temperature at the FOC increased slightly from 194°F to 206°F, temporarily exceeding the pump operating temperature of 197°F (Figure 14, left image). This thermal profile persisted for approximately two hours and fifteen minutes. Subsequently, pump temperature increased steadily for two hours and thirty-eight minutes until it reached 314°F, while motor temperature rose to 254°F (Figure 14, right image). The winding-temperature shutdown limit was set at 240°F at the sensor, resulting in a protective shutdown.

Figure 14. FOC ESP Temperature profile. Event #1. Left: Immediately after slowing down to 45Hz. Right: 2.5h after slowing down, before controller shutdown on winding temperature. Source: SLB

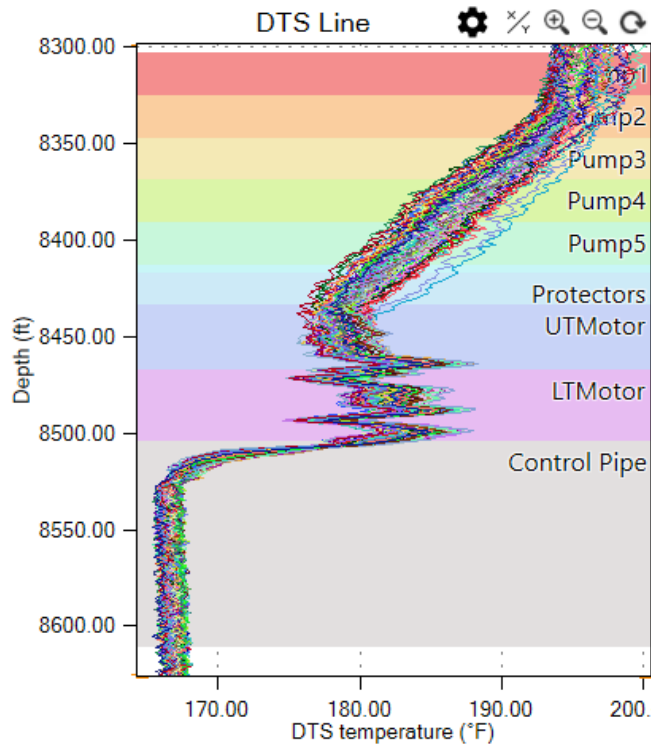
The profile during normal operation at 65hz is represented in Figure 16. The maximum pump temperature at 200°F, motor temperature at 188°F, and intake temperature at 167.5°F.

Figure 16. FOC ESP Temperature profile. Normal operation at 65 Hz. Source: SLB

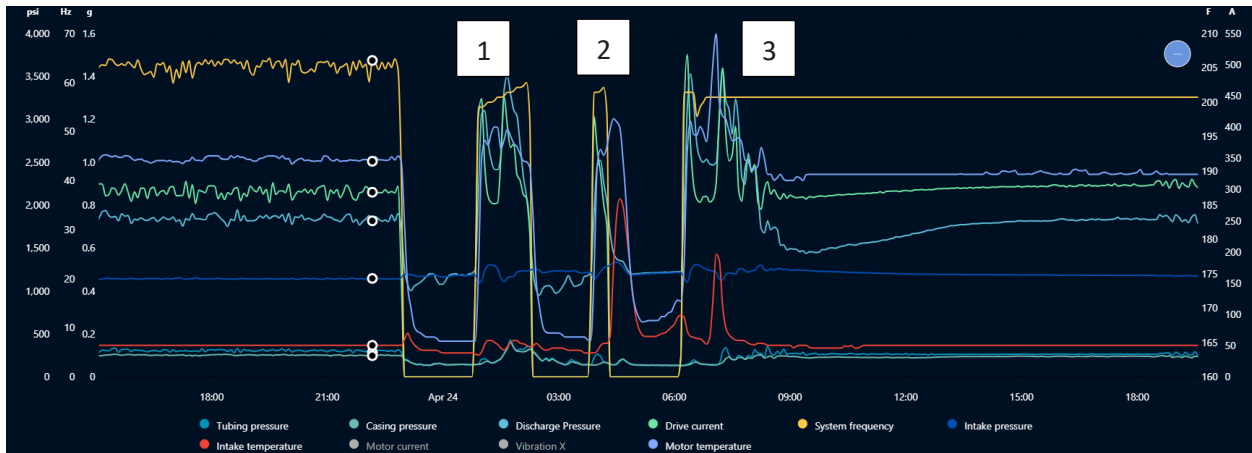
The screenshot in Figure 17 represents a two-day event, where the ESP attempts to recover from a facility (PLC) shutdown, and fails to recover load on subsequent two restarts.

Figure 17. Trends consecutive PLC and UL Trips. Source: SLB

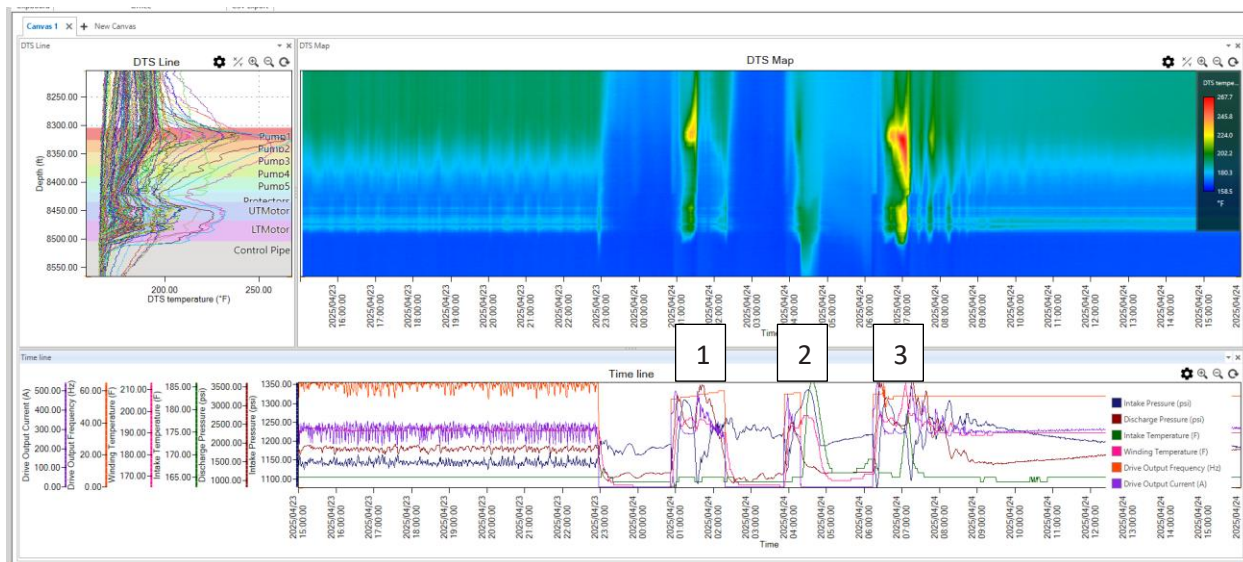
the previous example, the maximum temperature typically occurs several minutes after restart, when the produced fluid begins to lose energy (Figure 18 Event #3). Trend data indicate that tubing pressure continued to build until 1:07 AM, 14 minutes after restart. A loss of energy consistent with a low- or no-flow condition was subsequently observed, exhibiting the characteristic indicators of gas interference. The fiber optic cable recorded an increase in pump temperature beginning at 1:09 AM, peaking at 237°F at 1:21 AM, and returning to baseline by 1:33 AM. The total duration of the thermal event was approximately 24 minutes. Tubing pressure began increasing again near 1:21 AM. Following the restart, motor current steadily declined, and the controller ultimately shut down the ESP on underload 1 hour and 26 minutes after startup.

Figure 18. FOC ESP temperature profile after multiple shutdowns. Source: SLB

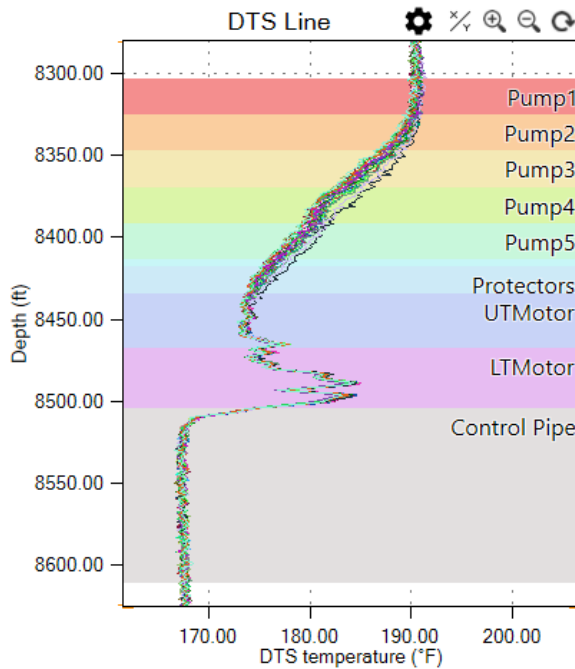
After these events, the ESP continued operation at the max speed of 65 Hz. Maximum pump temperature at 192°F, motor temperature at 185°F, and intake temperature at 167.5°F (Figure 21)

Figure 21. FOC Temperature profile normal operation for example 2. Source: SLB

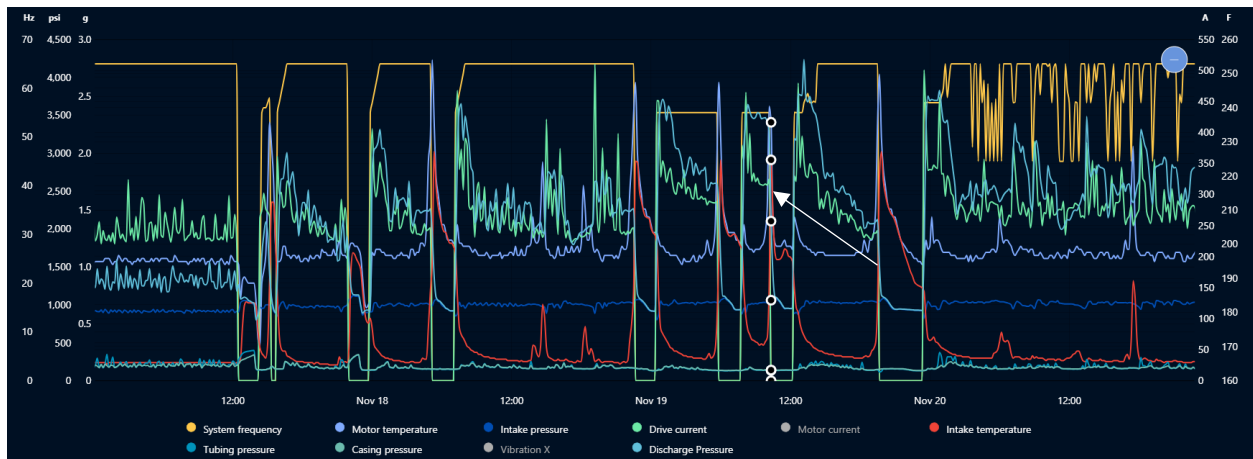
The fiber optic cable recorded a maximum temperature of 400.7°F during an event on November 19, 2025, between 09:30 and 09:49. This event corresponded to the sixth restart in an abnormal operational sequence that began with a facility shutdown, followed by seven additional temperature-related shutdowns, until gas lock mode was activated to maintain load (Figure 22).

Figure 22. Trends, events corresponding to the maximum temperature event registered by FOC. Source: SLB

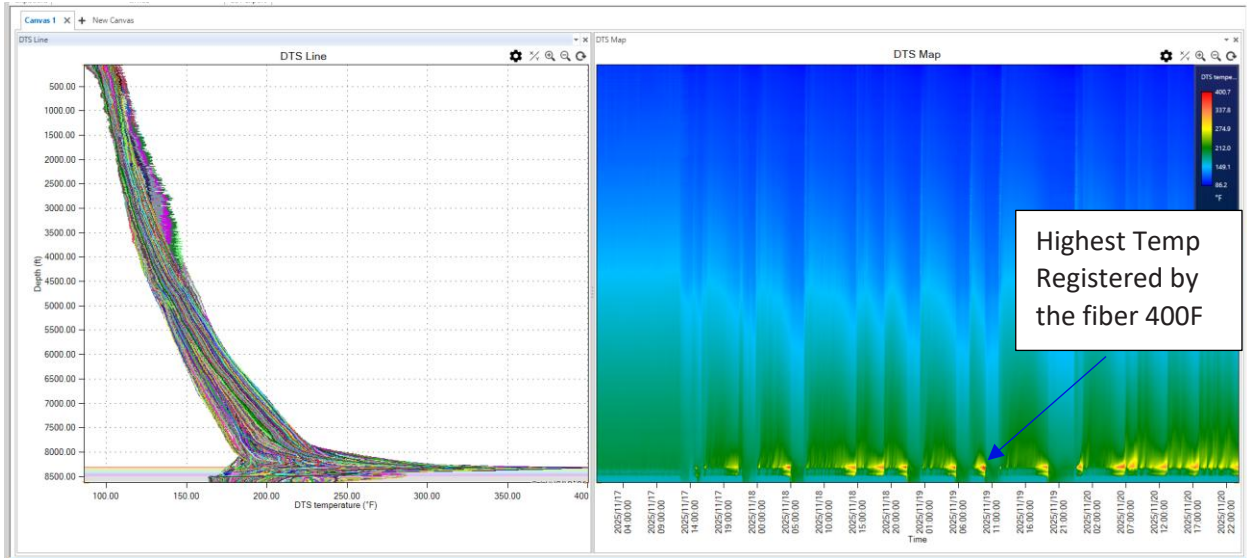
Unlike the cases presented above, these events represent confirmed motor temperature trips. During each event, tubing pressure increased only marginally above baseline, and the ESP tripped on motor temperature due to insufficient lift. The event associated with the highest pump temperature occurred within two hours of a prior motor temperature shutdown, during which the ESP had been restarted at a lower speed than normal operating conditions. This attempt lasted two hours and twenty minutes. During this period, tubing pressure dropped to baseline and remained at that level for approximately one hour prior to shut down, while discharge pressure remained higher than usual (Figures 23 and 24).

Figure 23. FOC Tubing temperature profile, power shutdown. Source: SLB

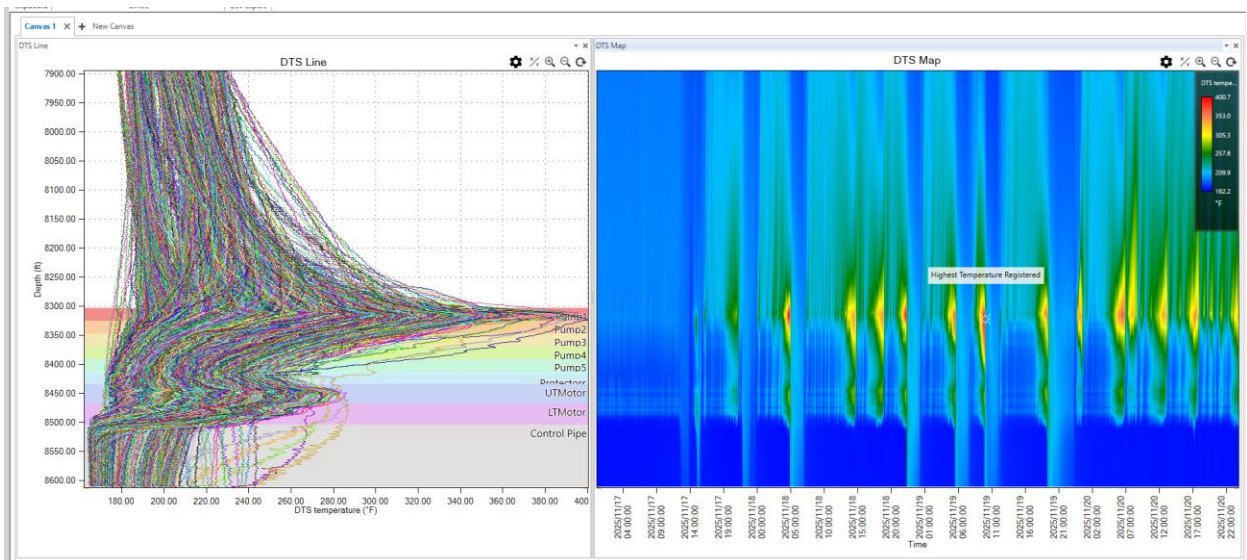
Figure 24. FOC ESP Temperature profile, power shutdown. Source: SLB

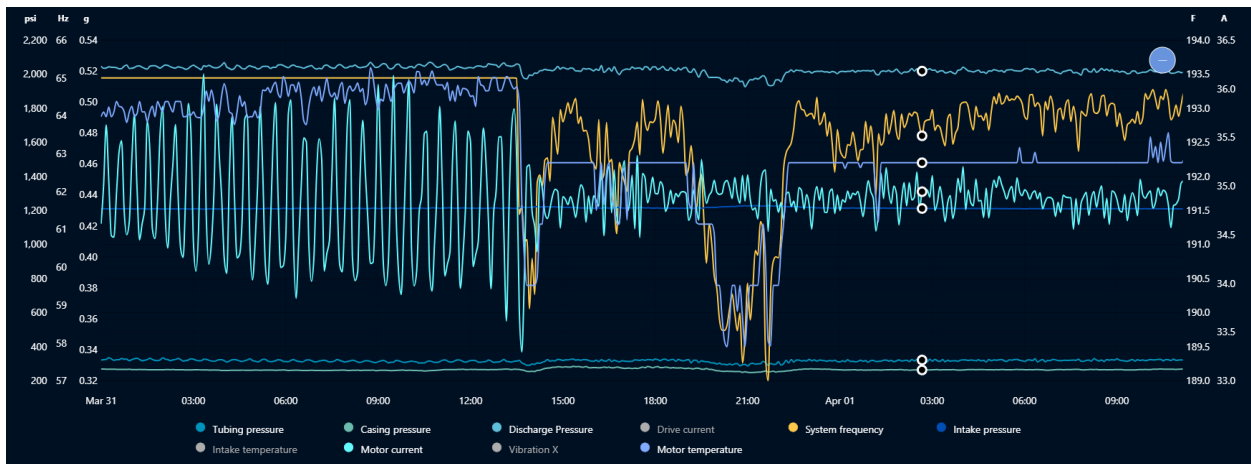
Early adjustments to ESP parameters facilitate the work of the optimization engineer, allowing more efficient identification of appropriate control parameters. During this test, motor current variation was minimal, ranging from 33 A to 36 A, but there was an attempt to revert this trend to baseline by changing from target speed to PID mode, as observed on Figure 25.

Figure 25. Trends. Target speed to PID. Source: SLB

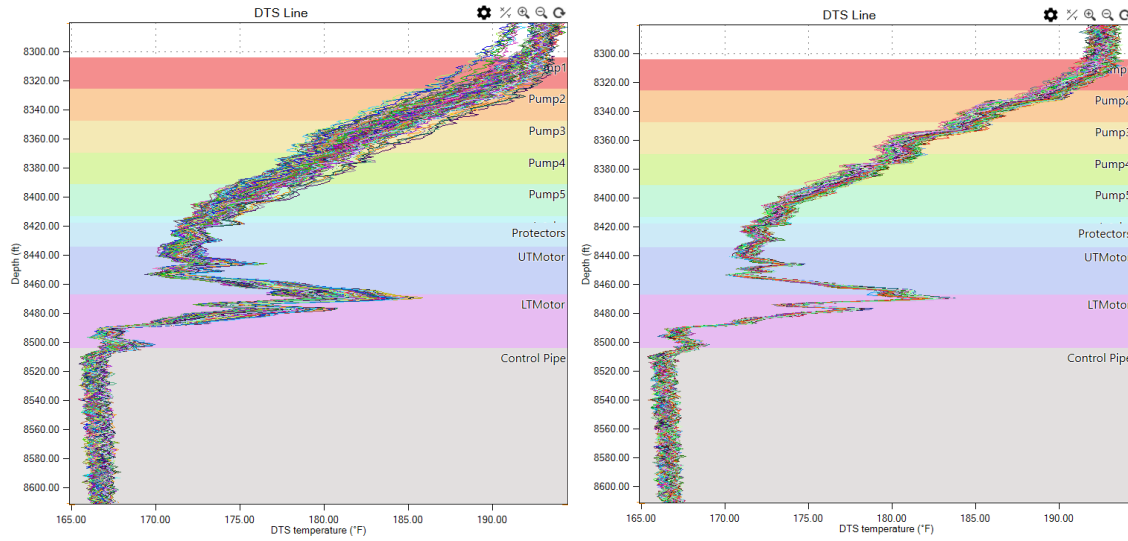
As shown in Figure 26 (left), a current variation of approximately 3 A corresponded to a pump temperature change of 5°F and a motor temperature change of 7°F. With timely adjustments, motor current stabilized at 34 A, reducing temperature fluctuations to approximately 2°F for both the pumps and the motors (Figure 26, right).

Figure 26. FOC ESP Temperature Profile. Comparison 3A swings (left), vs steady current (right). Source: SLB

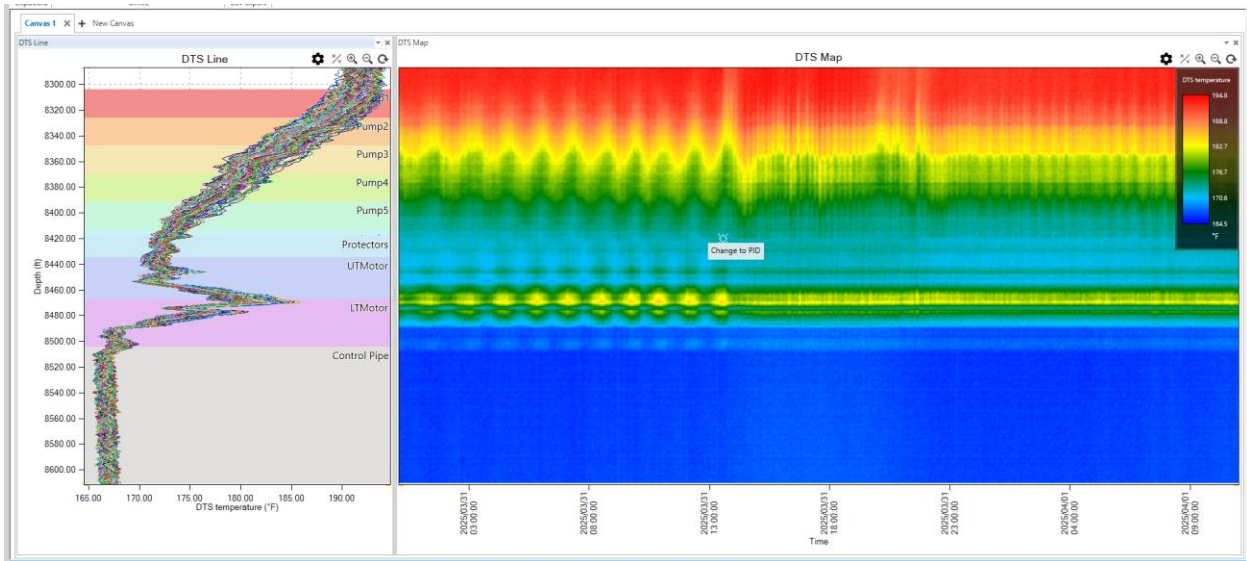
Operating wells in the Permian Basin frequently involve managing slug flow conditions. Erratic performance is often observed when operating below the bubble point, and the magnitude of temperature increases at both the pump and motor is closely linked to the amplitude of current fluctuations (Figure 27).

Figure 27. FOC ESP Temp Profile Target Speed to PID. Source: SLB

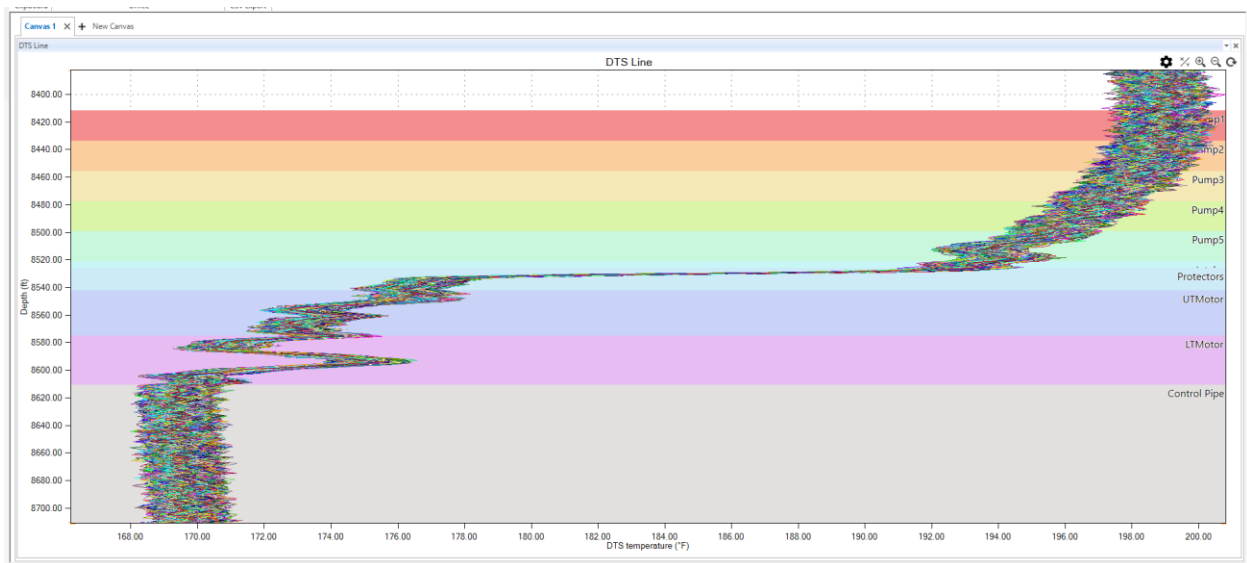
Figure 29. Well 2 Temperature Profile. Source: SLB

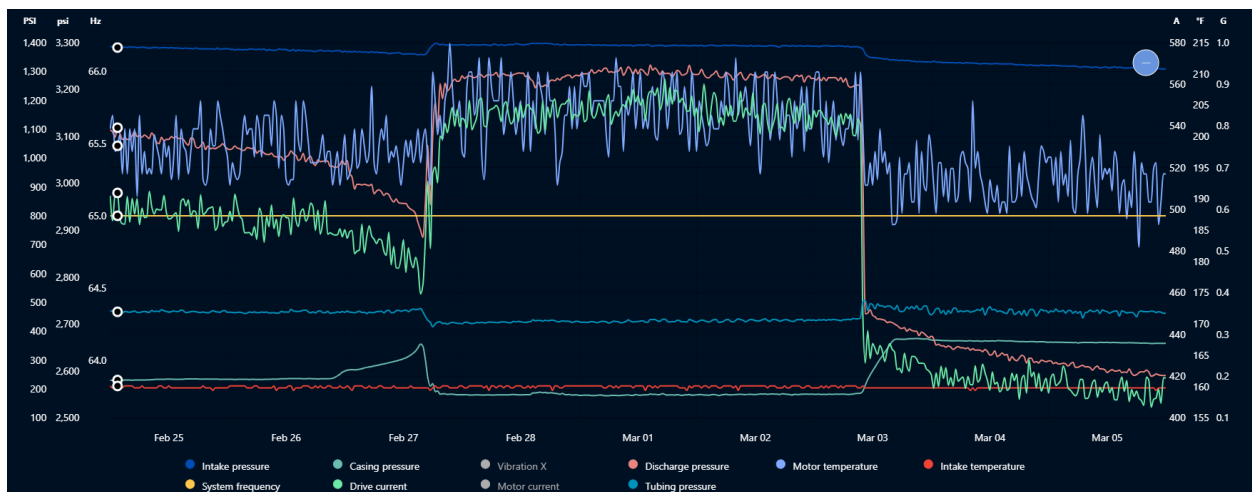
Early in the life of Well #2, an operational change was observed following an event in which surface casing pressure increased. During this event, discharge pressure rose by approximately 200 psi above normal operating conditions, and a slight rise in motor operating temperature was observed, as measured at the downhole sensor (Figure 30).

Figure 30. Trends, casing valve recirculation. Source: SLB

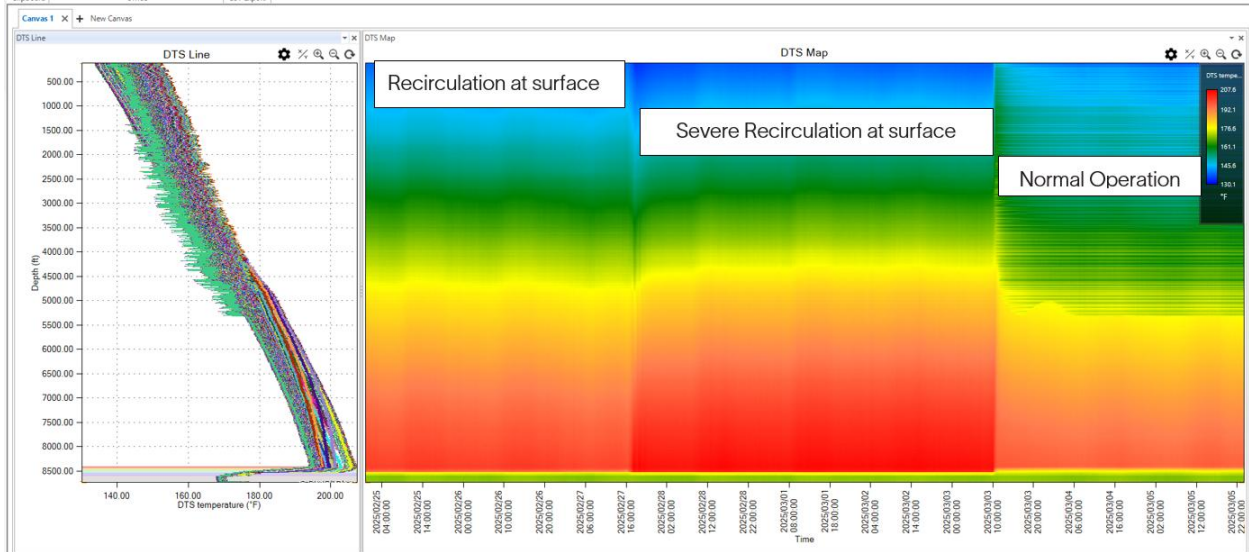
Analysis of the fiber optic data revealed a distinct temperature pattern. Tubing temperature (Figure 31) increased during the event, which was subsequently identified as severe recirculation through a casing valve. Once the valve was fixed, the temperature profile returned to normal.

Figure 31. FOC Tubing Temp profile, casing valve recirculation. Source: SLB

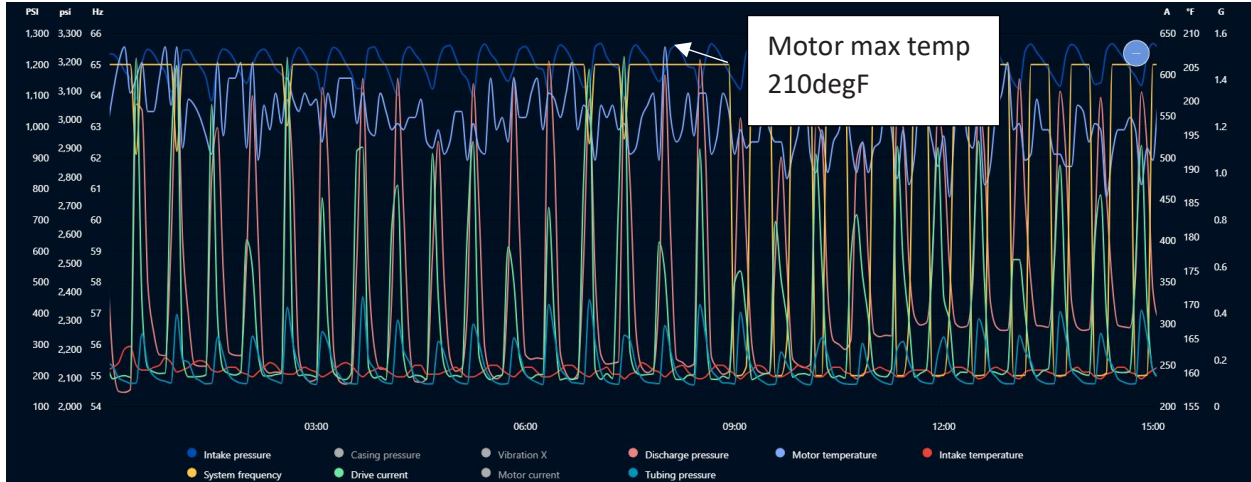
Figure 33 illustrates events lasting between 20 and 35 minutes, followed by approximately 10 minutes of fluid production to surface. These events exhibit a pattern consistent with slugging operation. These events show pump temperature swings of up

Figure 33. Trend Slug Operation. Source: SLB

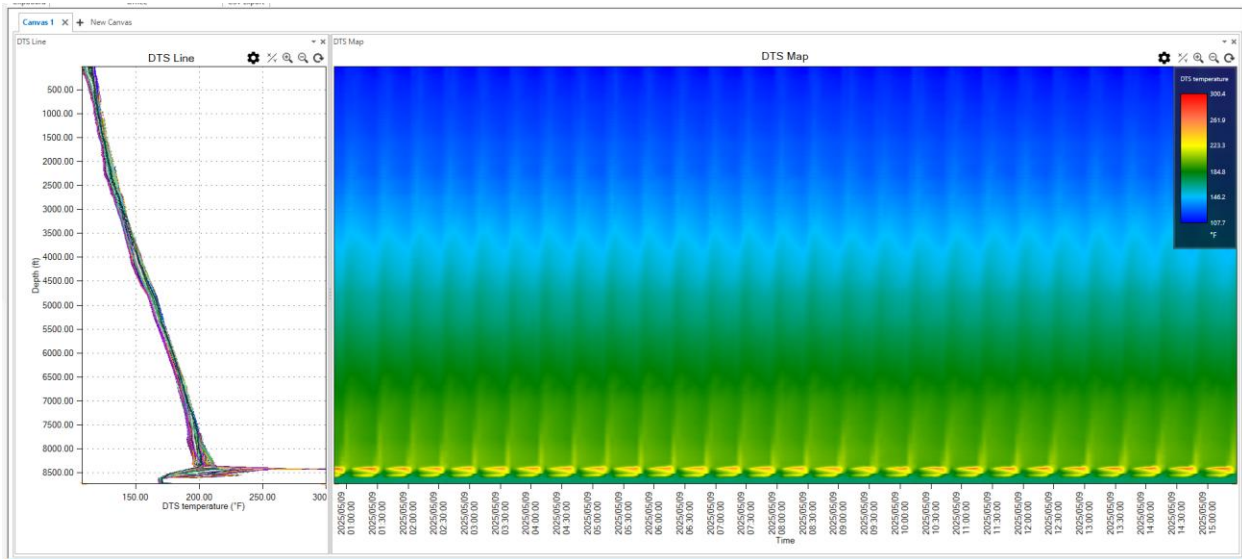
to 100°F (Figures 34 and 35), depending on the time the low/no flow condition persists and cools back down very fast when fluid is loading again.

Figure 34. FOC Tubing temp profile, slug operation. Source: SLB

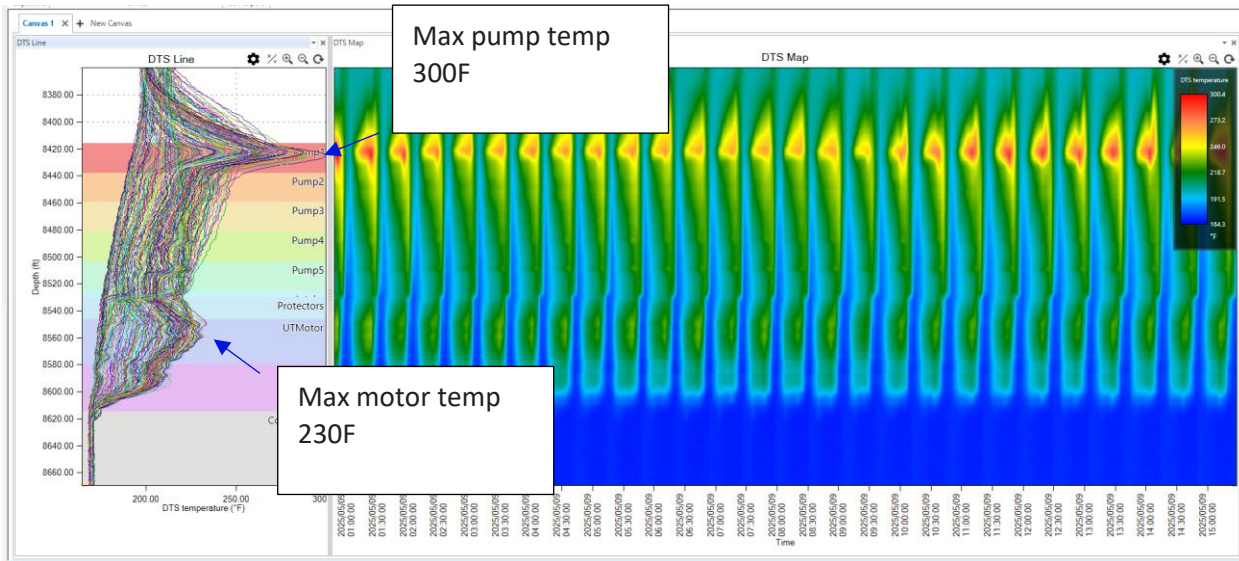
Figure 35. FOC ESP Temp profile, slug operation. Source: SLB

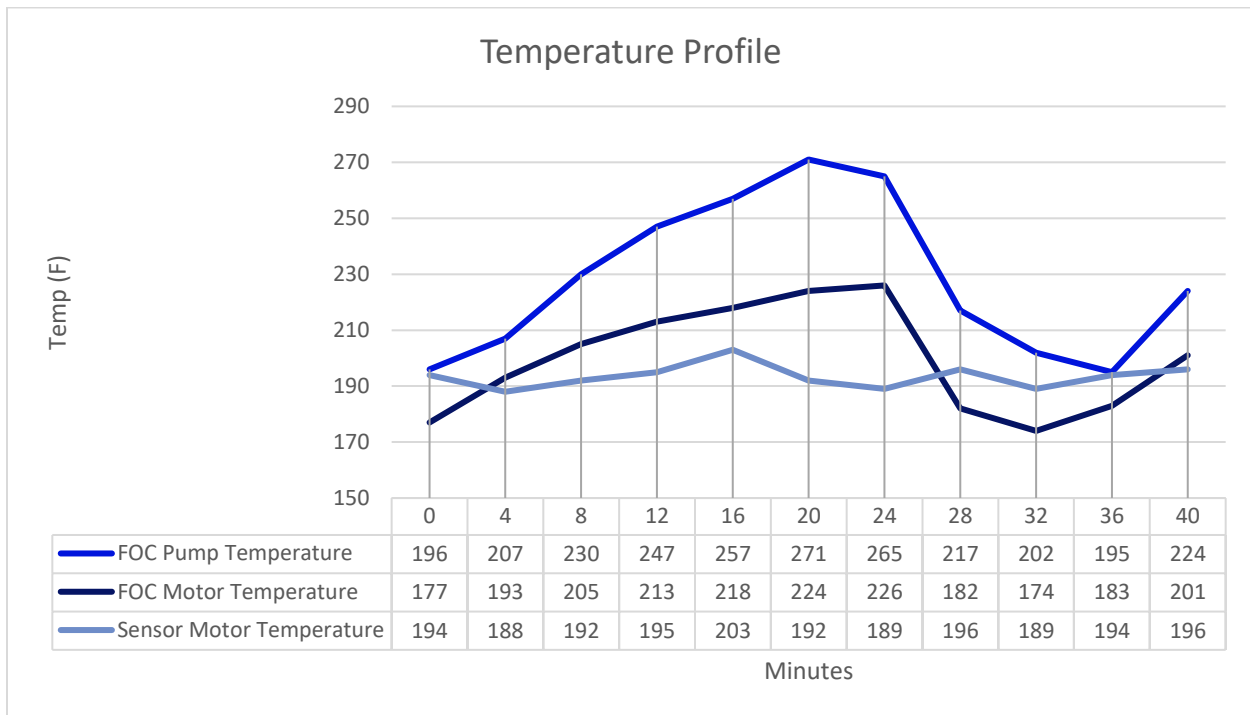
Figure 36 reconstructs the temperature profile at both the downhole sensor and the fiber optic cable in 4-minute increments. From the onset of the event to peak temperature, the temperature increases by 71°F over approximately 20 minutes, before declining to baseline conditions within 16 minutes.

Figure 36. Temperature Profile. 36 min event. Source: SLB

This test shows that the cooling rate is much faster than the temperature increase, but also the rate of the temperature increase at the pumps is significantly higher than winding temperature reported at the sensor, further signaling that motor temperature presents as a lagging indicator for temperature related events.
