FIELD EVALUATION OF ESP MOTOR COOLING TECHNOLOGIES DEPLOYED IN MULTIZONE PERMIAN WELLS: CASE STUDIES AND LESSONS LEARNED

Baker Hughes

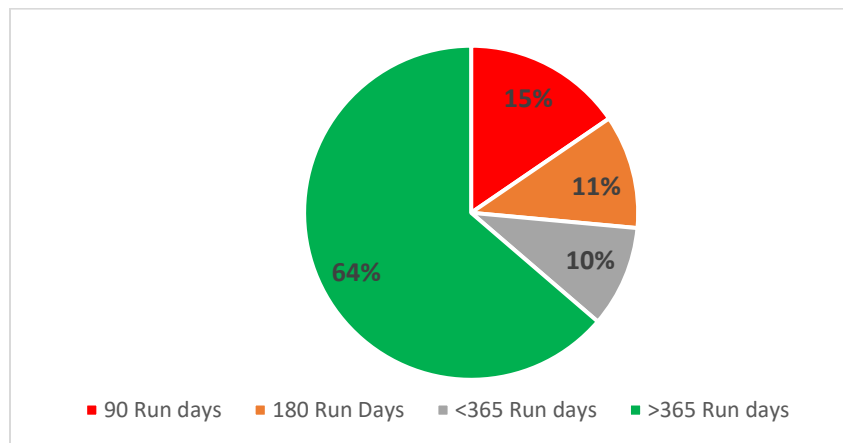
A breakdown of the run life of over 420 recirculation system installed in the Permian is depicted in Figure 4. 64% of the systems ran over a year. Looking at the infant short runs, Grounded Down Hole and Low/no production were the main reasons for pulling with 21% and 23% respectively.

Figure 4. Breakdown of the run life for the recirculation.

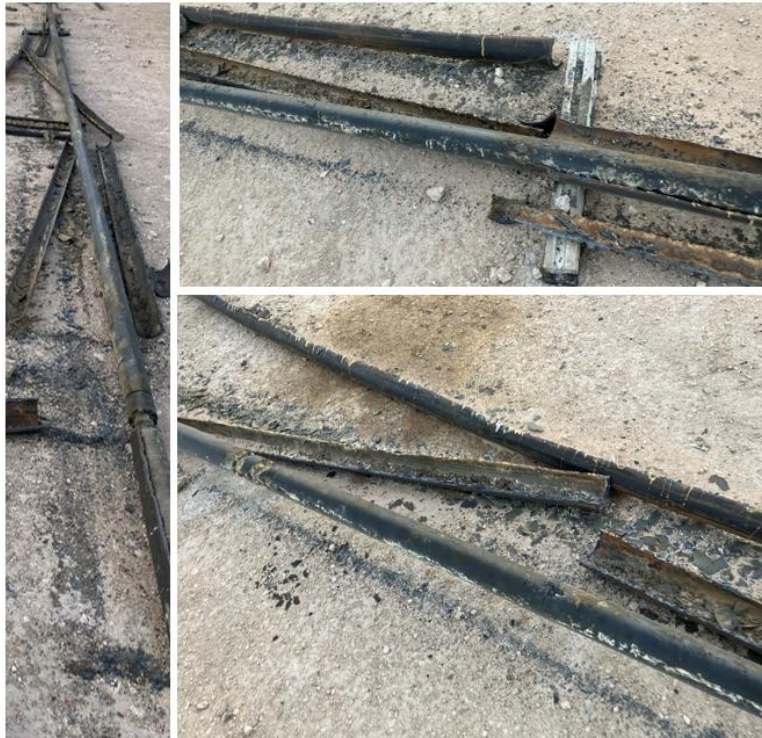
An ESP equipped with a shroud system was installed in May 2024, with the ESP sensor set at 4,620 ft. After 168 days of operation, the unit was pulled due to Low/No Production. During retrieval, the equipment was found stuck inside the shroud. Water and acid were pumped into the shroud and allowed to soak overnight, but this intervention was unsuccessful. A welder was required to cut the shroud, allowing the intake, seals, motor, and sensor to be retrieved. The Figure 5 below shows the equipment and the shroud after cutting. Chemical treatments are often less effective when a shroud is installed, and the reduced flow area inside the shroud can increase pressure losses and promote scale deposition.

Figure 5. Equipment and the shroud after cutting.

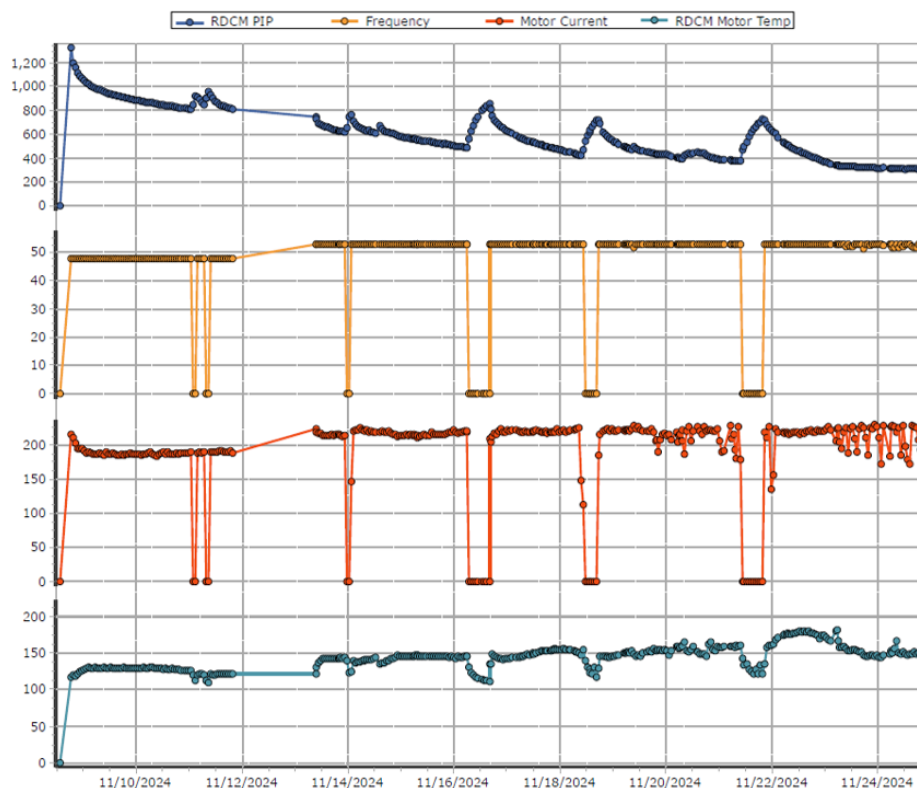
Based on the matched case analysis, the gas separation efficiency is estimated at approximately 96%, reducing the free gas entering the pump to about 25%. The resulting lower gas volume fraction (GVF) inside the pump ensures stable operating trends, minimal motor current fluctuations, and fewer shutdown events, as illustrated in the operating trends shown in the Figure 7.

Figure 7. Operating trends with recirculation.

The operating company subsequently decided to replace the system with a recirculation system. The new system has been operating for more than 400 days. The ESP sensor is currently set at 4,400 ft. The recirculation tube enables improved chemical distribution, helping prevent scale deposition around the motor and intake.

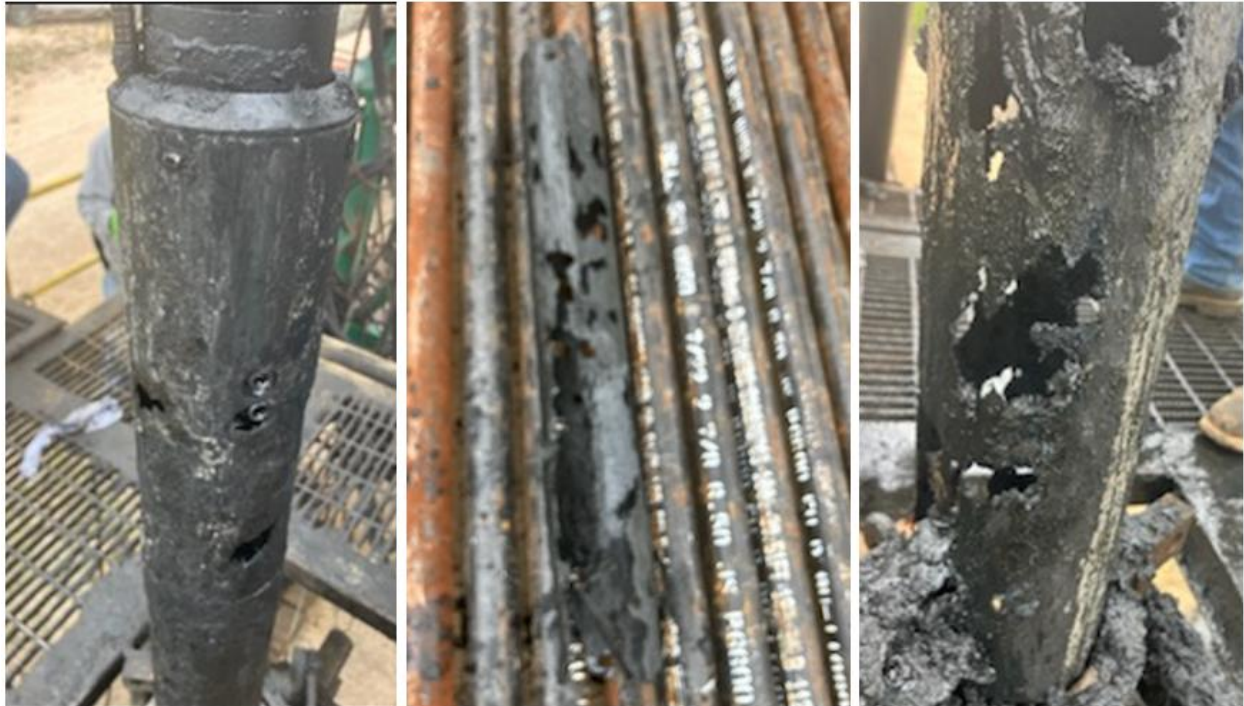
Figure 9 presents the condition of the equipment pulled after the forth install. As can be seen, the retrieved shroud has many holes.

Figure 9. Condition of the equipment after the pull, Well B.

shroud because they were stuck inside.
Shroud Install 4	476	Grounded Down Hole	The shroud was severely pitted. Precautions were taken while pulling the equipment. A significant amount of iron sulfide was observed on the body of the equipment. The shroud remains in the wellbore, and the operating company plans to attempt fishing operations to retrieve it.

After several installations using shroud systems, the fifth installation utilized a recirculation cooling system. The unit has been operating for more than 650 days, and the operating company reported production increases of up to 20% compared with the previous shroud installations. A key advantage of the recirculation system in corrosive environments is that the recirculation tubing is constructed from stainless steel, providing greater resistance to corrosion and improving system reliability. Alternatively, the shroud can be coated with an anti-corrosion protective layer, or its metallurgy can be upgraded to improve corrosion resistance.
