TEST OF THE GEOTHERMAL POTENTIAL OF THE EDNA DELCAMBRE NO. 1 VERMILION PARISH, LOUISIANA

JAMES R. HODGES
Hodges Properties

ABSTRACT

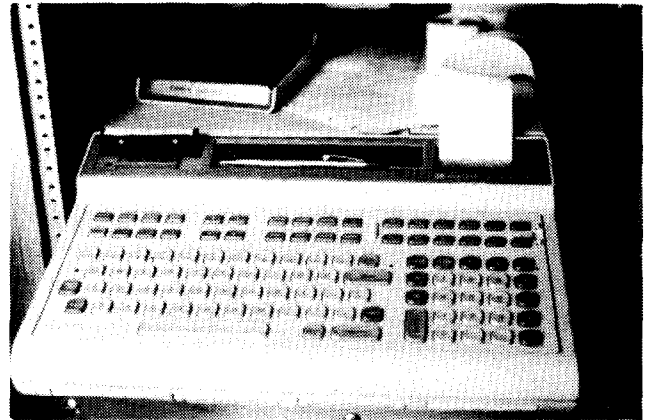
FIGURE 4—HEWLETT-PACKARD SIGNAL CONVERTING COMPUTER. THE COMPUTER ACCEPTED DATA TYPED IN ON THIS CONSOLE. INSTRUCTIONS FOR DATA PRESENTATION AND VARIATIONS OF TIME BETWEEN DATA PRINTINGS WERE GIVEN TO THE COMPUTER.

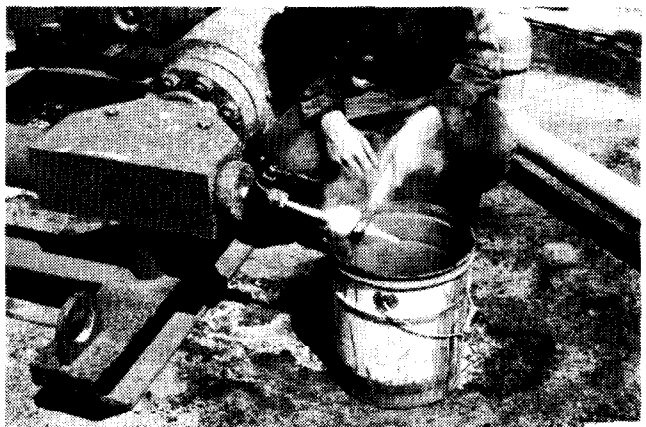
FIGURE 10—CATCHING WATER SAMPLE FROM CHOKE MANIFOLD. RECORDS WERE KEPT OF ACTUAL SAND SHAKE OUT. HERE A WATER SAMPLE IS BEING COLLECTED.
