UNDERSTANDING AND MITIGATING DOWNHOLE CORROSION AND WEAR FAILURES

Rob Davis, Michael Naguib, Bill Snider
Western Falcon Energy Services

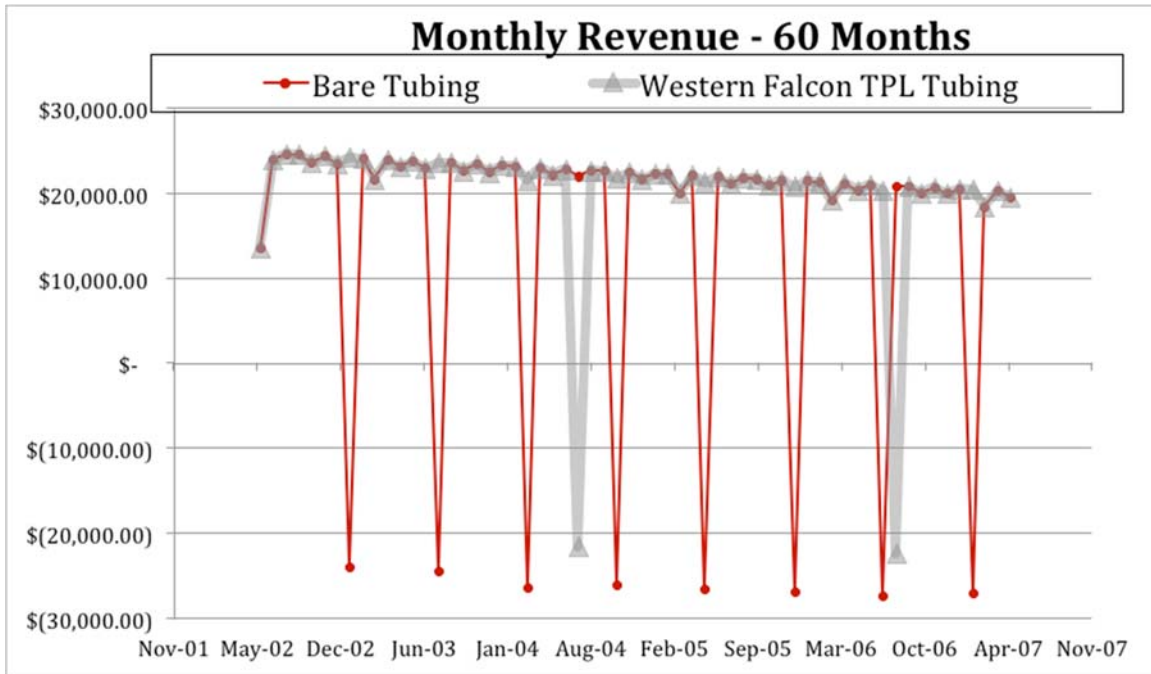
Figure 1 – Comparative Monthly Single Well Revenue Before and After Installation of TPL Tubing For Case Study One

The use of TPL tubing to solve the severe downhole tubular failure issues made this field much more economically efficient to operate. Figures 1, 2, and 3 show the economic return for one well over a five-year time frame. The input data used to generate these figures using a new proprietary downhole runtime economic model is listed in Table 1. Even at an average oil price of 30 USD per BBL of oil and allowing for a pump related workover every 25 months, each TPL lined well yielded an additional 295,000 USD of revenue every 5 years (or approximately 700,000 USD over the 12 year run life in this well) to the operator in increased uptime and reduced workover costs (NOT including energy savings or increased sucker rod fatigue life from reduced rod on tubing friction) at a base cost of under 9,000 USD for the thermoplastic tubing liner. Ironically, the TPL tubing was still in reusable condition after over 12 years of service. It is important to note that the key driver in the economic return figures is accurately finding the product, or combination of products, that maintain the integrity of the completion assets (rods, pumps, tubing, etc.) for the longest service life; because the cost of a single workover often more than offsets the cumulative cost of the solutions. Significant focus is often put on the initial capital expenditure in attempting to “save” perhaps 20, 50 or even 100 percent on the initial cost of the solution(s) instead of the actual return on investment made to maximize the MTBF and maintain the integrity of downhole assets. In this example, the solution was able to protect the used tubing for over 20 times the original service life (and still rendering it reusable) of new tubing instead of simply extending the run time by 3 or 4 times and requiring replacement. The same solution paid for itself five fold in just eight months of downhole service. The graphs in the attached figures make it clear that optimizing the MTBF and solving the true root causes of downhole failures the first time were economically the most profitable process for this operator.

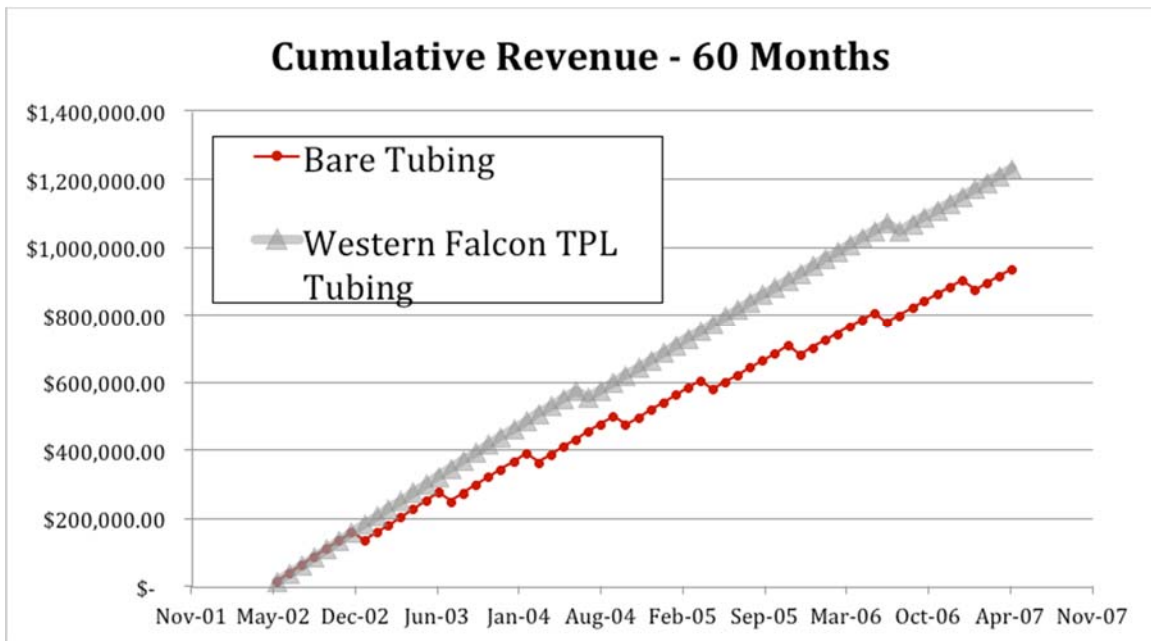
Figure 2 – Cumulative Single Well Revenue Averaging Just Under \$60,000 of Incremental Gain (Over 9X the Total TPL Cost) Per Year over 5 Years, Before vs. After TPL Tubing Installation For Case Study One

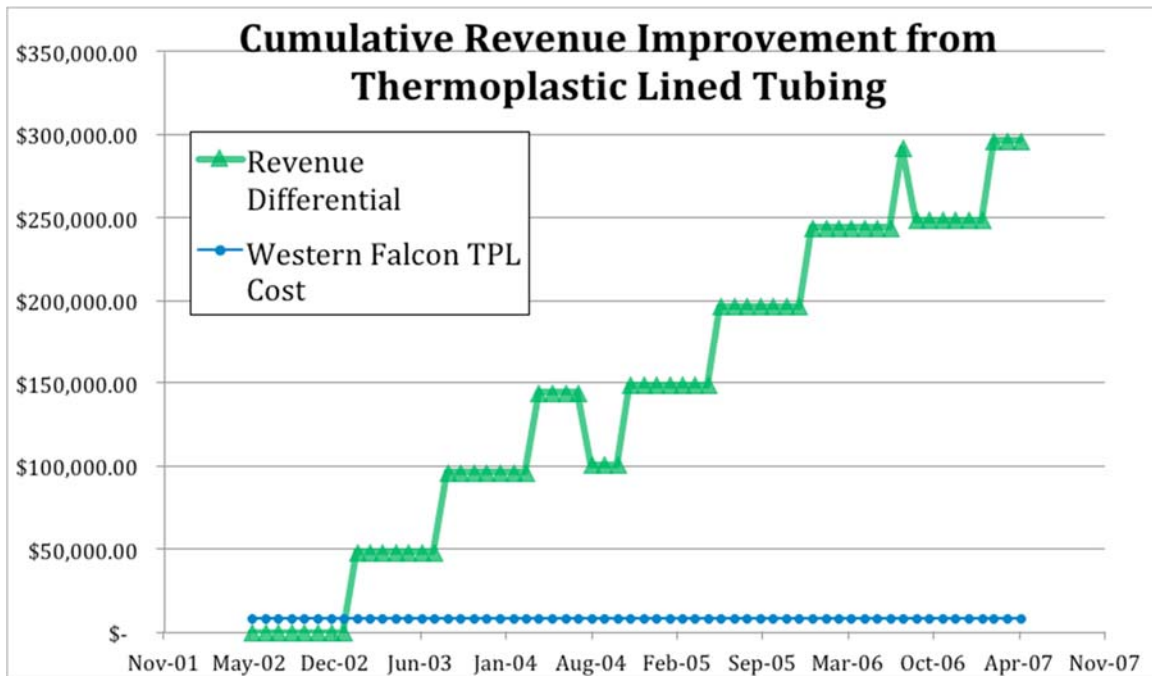
Figure 3 – Single Well Revenue Differential Over 5 Year Period After Installation of TPL Tubing Costing Less Than \$9,000 For Case Study One

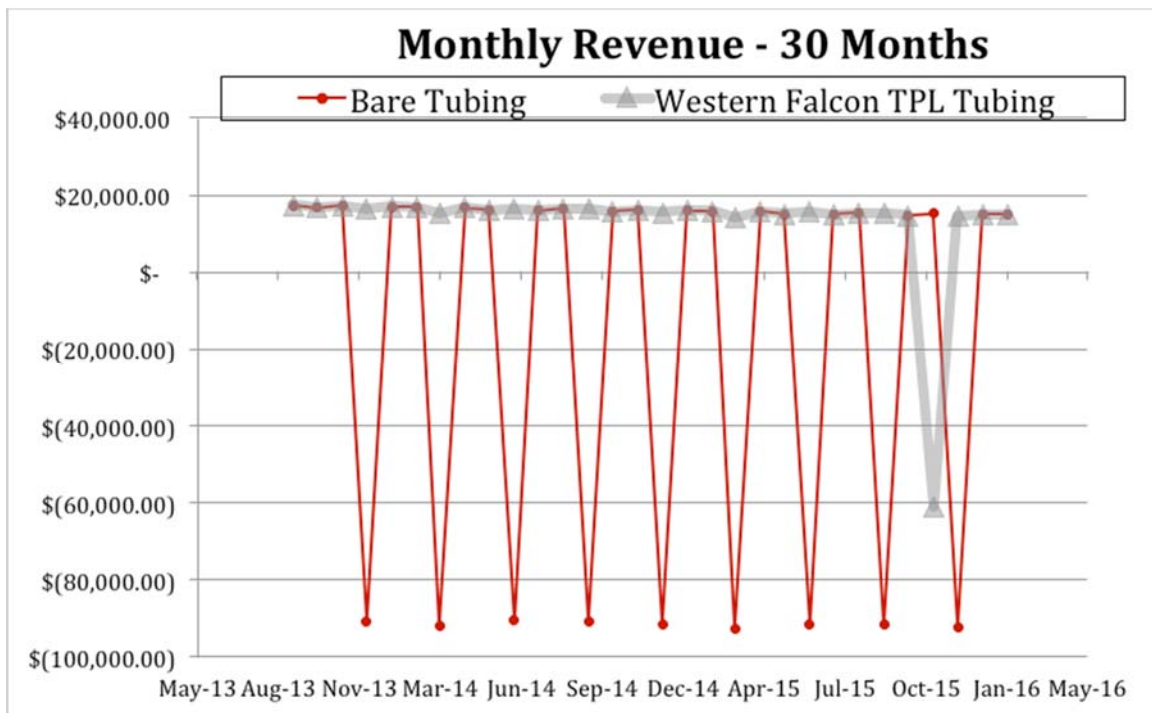
Figure 4 – Comparative Monthly Single Well Revenue Before and After Installation of TPL Tubing For Case Study Two

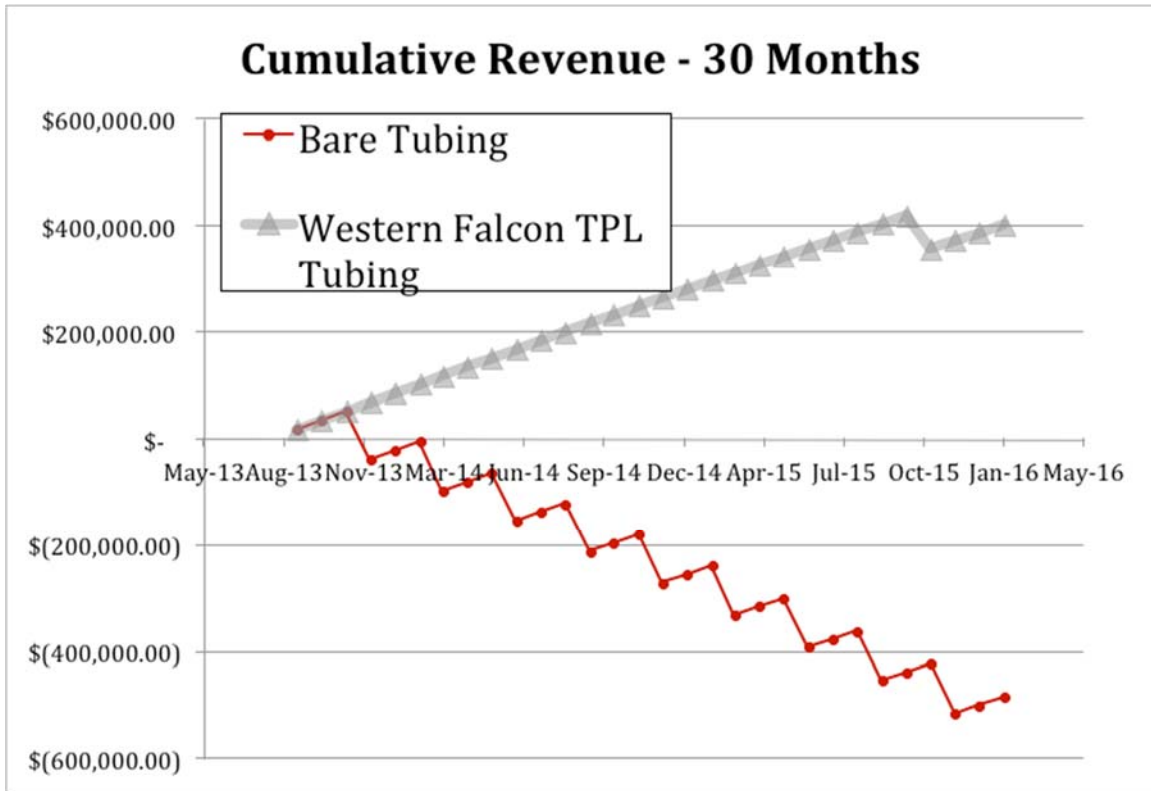
Figure 5 – Cumulative Single Well Revenue Averaging Just Over \$355,000 of Incremental Gain Per Year over 45 Months, Before vs. After TPL Tubing Installation For Case Study Two

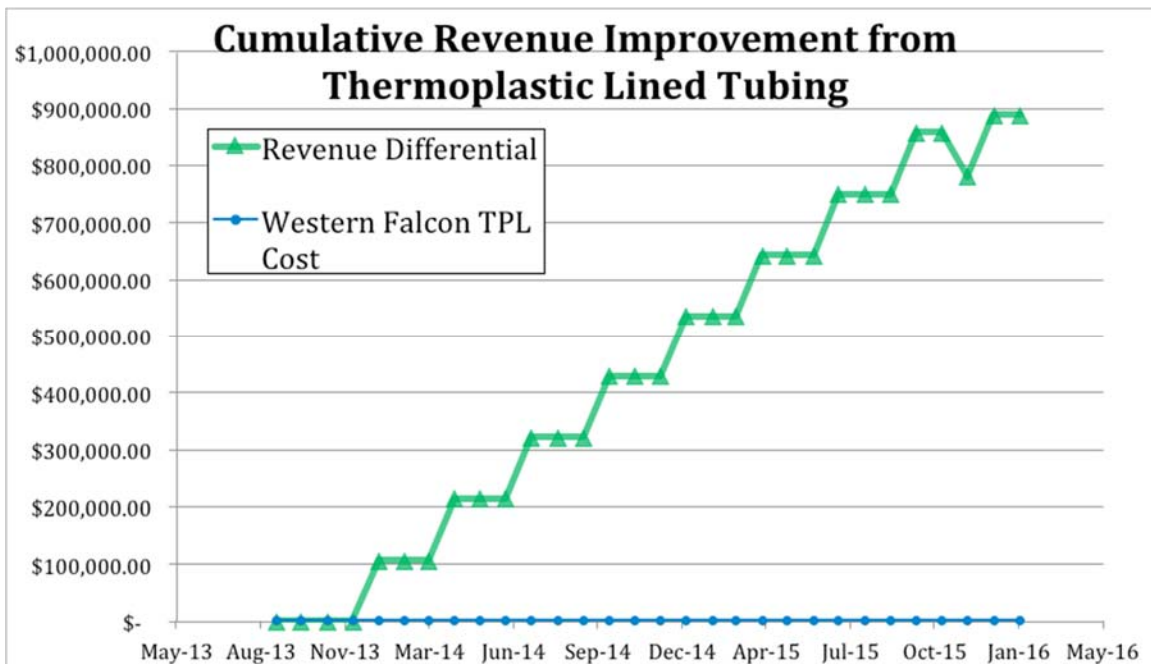
Figure 6 – Single Well Revenue Differential Over 45 Month Period After Installation of TPL Tubing Costing Less Than \$26,000 For Case Study Two

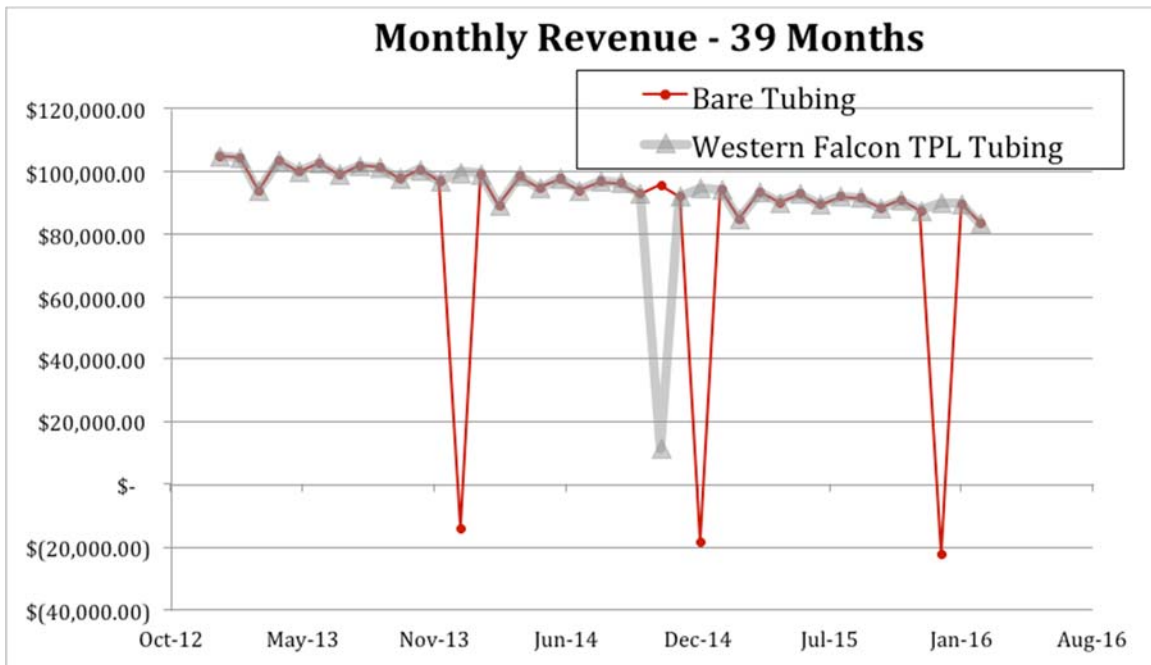
Figure 7 – Comparative Monthly Single Well Revenue Before and After Installation of TPL Tubing For Case Study Three

The data used to generate the economic comparisons for this well shown in Figures 7, 8 and 9 is listed in Table 3 at the end of this paper. After 39 months of operation this well has generated an additional \$250,000 benefit at a total cost of less than \$20,000 for the TPL. Because some rod on tubing wear was seen in the guided section above the lined tubing, it is speculated that running perhaps as much as 3,000 feet of lined tubing (at an additional cost of less than \$10,000) may be needed to avoid a potential premature tubing failure as the pump designs improve and provide a longer MTBF.

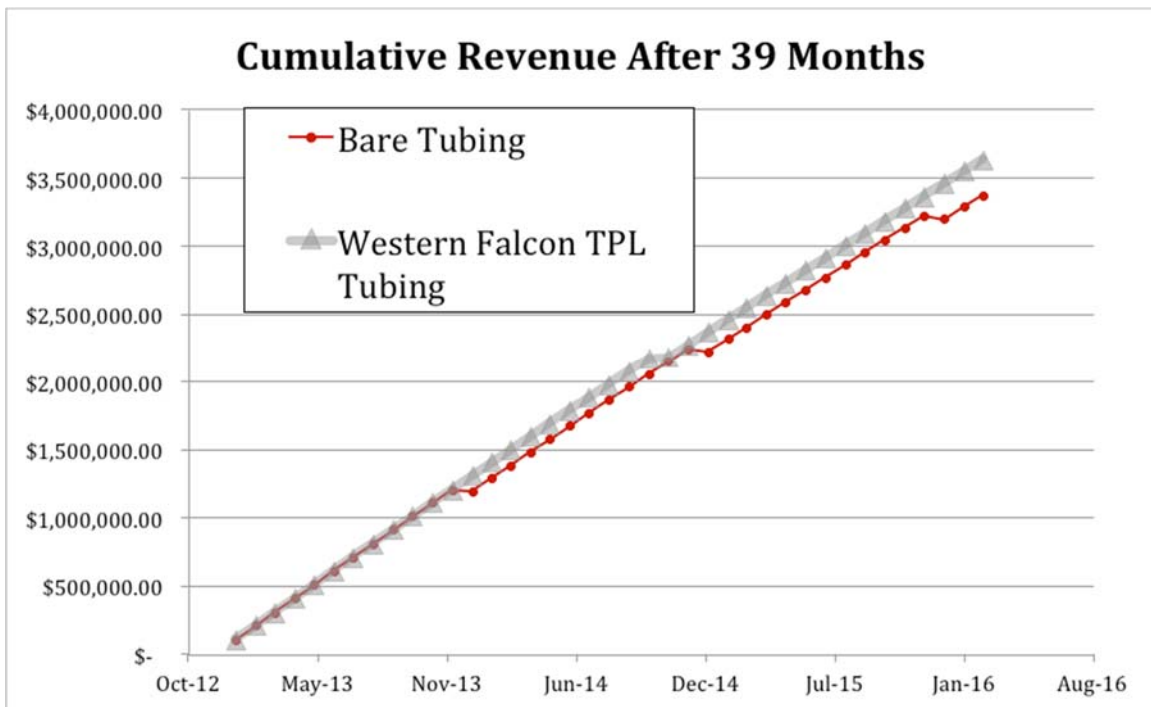
Figure 8 – Cumulative Single Well Revenue Averaging Approximately \$77,000 of Incremental Gain Per Year over 39 Months, Before vs. After TPL Tubing Installation For Case Study Three

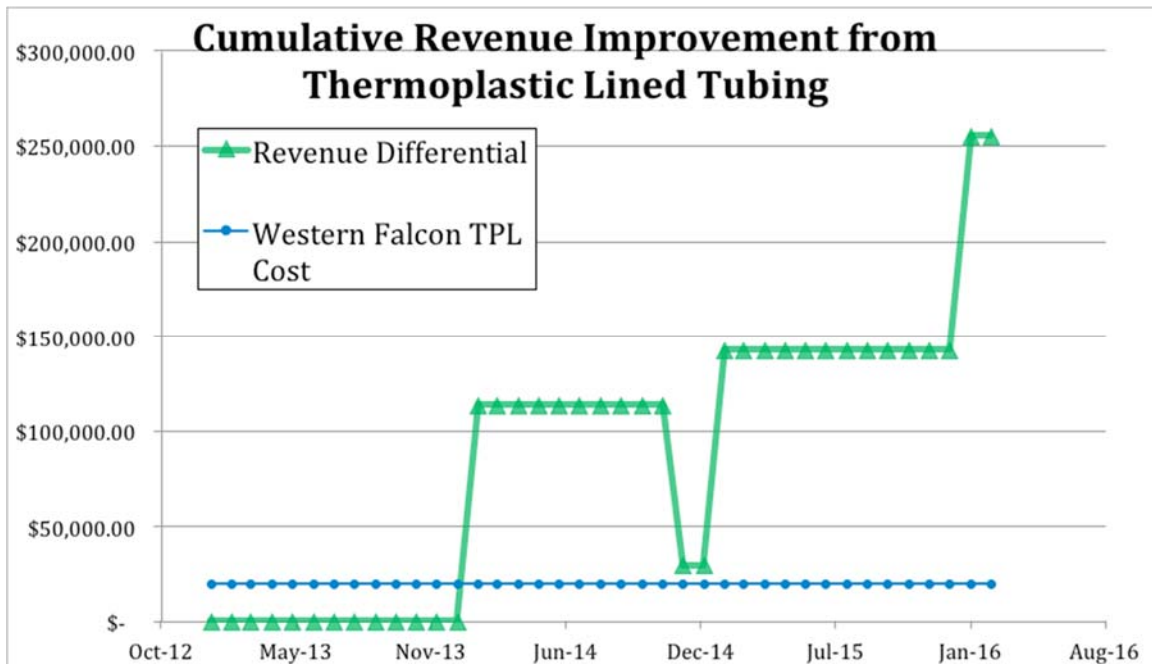
Figure 9 – Single Well Revenue Differential Over 39 Month Period After Installation of TPL Tubing Costing Less Than \$20,000 For Case Study Three

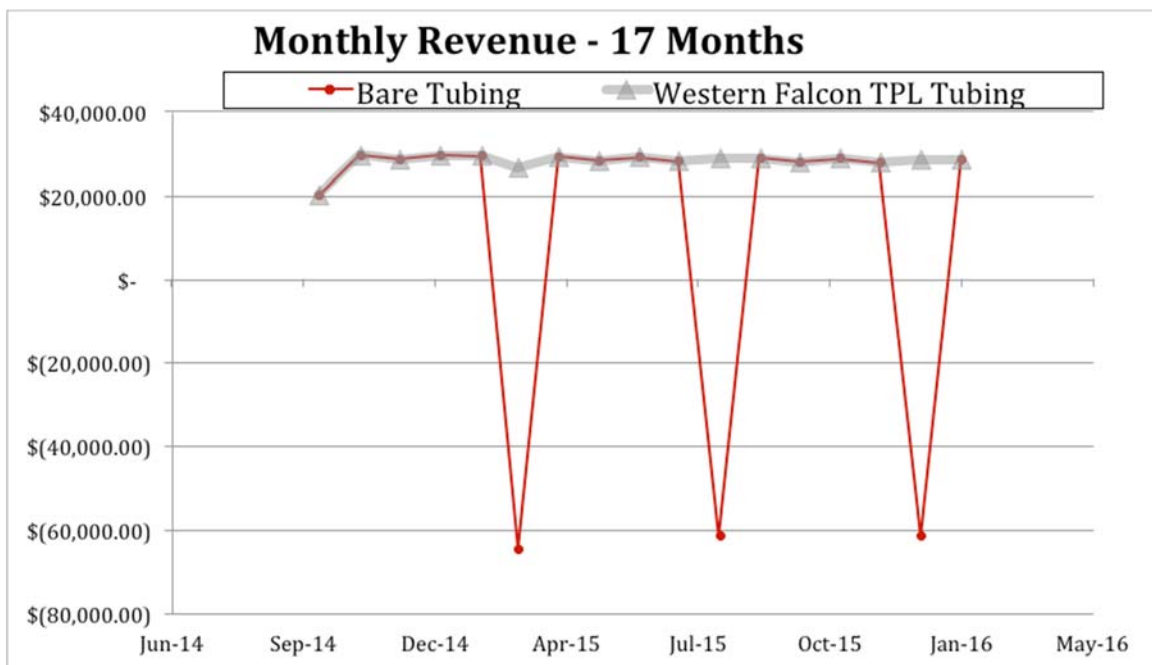
Figure 10 – Comparative Monthly Single Well Revenue Before and After Installation of TPL Tubing For Case Study Four

The data used for the 17 month economic comparisons illustrated in Figures 10, 11, and 12 is listed in Table 4. The incremental cost increase for the modified TPL in these wells is less than \$6,000 per well. In the 17 months of service for this one well, the improved completion design has yielded a benefit of approximately \$265,000. Currently, the average annual benefit of the TPL is approximately \$187,000 per well, which is over 30X the entire incremental cost increase of the TPL. It should be noted that this well has not yet failed (pump still operational after 17 months) and it is expected that the pump could fail at anytime thereby reducing the benefit by approximately \$35,000 (the estimated cost of a rod workover) at that time. The operator reports that due to the additional well uptime alone, the same field is producing over 10,000 BPD more (from the same number of production and injection wells) than when it first started using TPL tubing and currently averaging fewer than 8 failures per month (down from over 32). These results have been realized by deploying TPL tubing in approximately one-third of the field's producing wells to date.

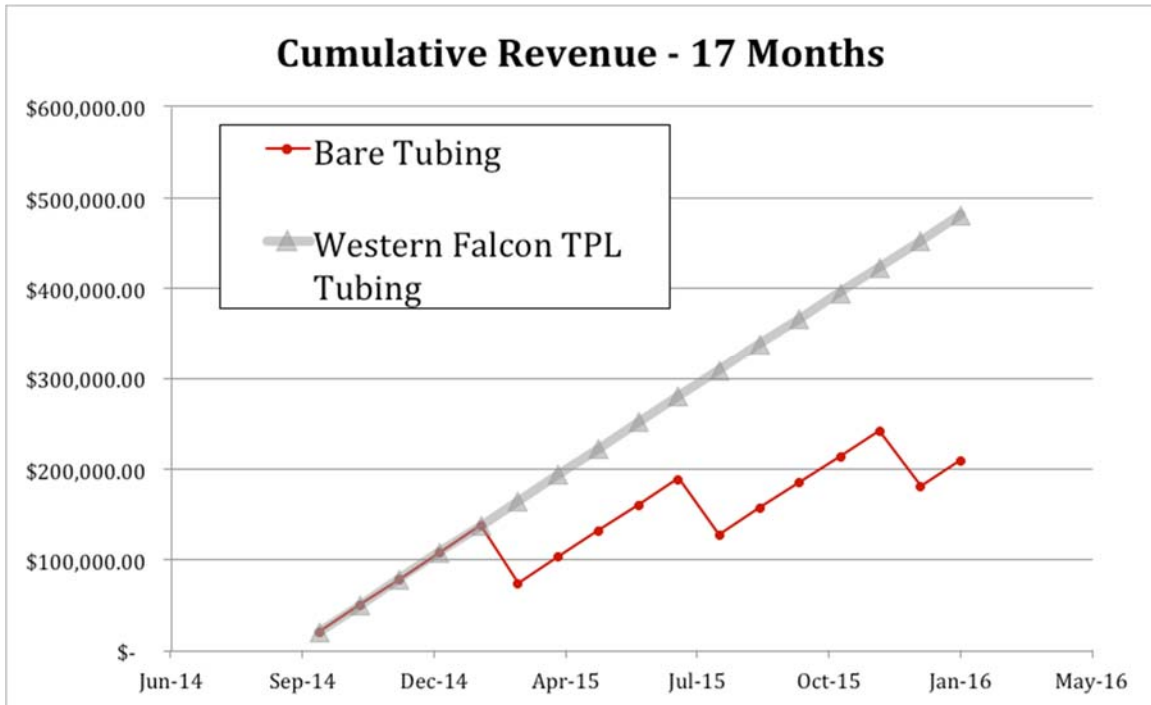
Figure 11 – Cumulative Single Well Revenue Averaging Approximately \$187,000 of Incremental Gain Per Year over 17 Months, Before vs. After TPL Tubing Installation For Case Study Four

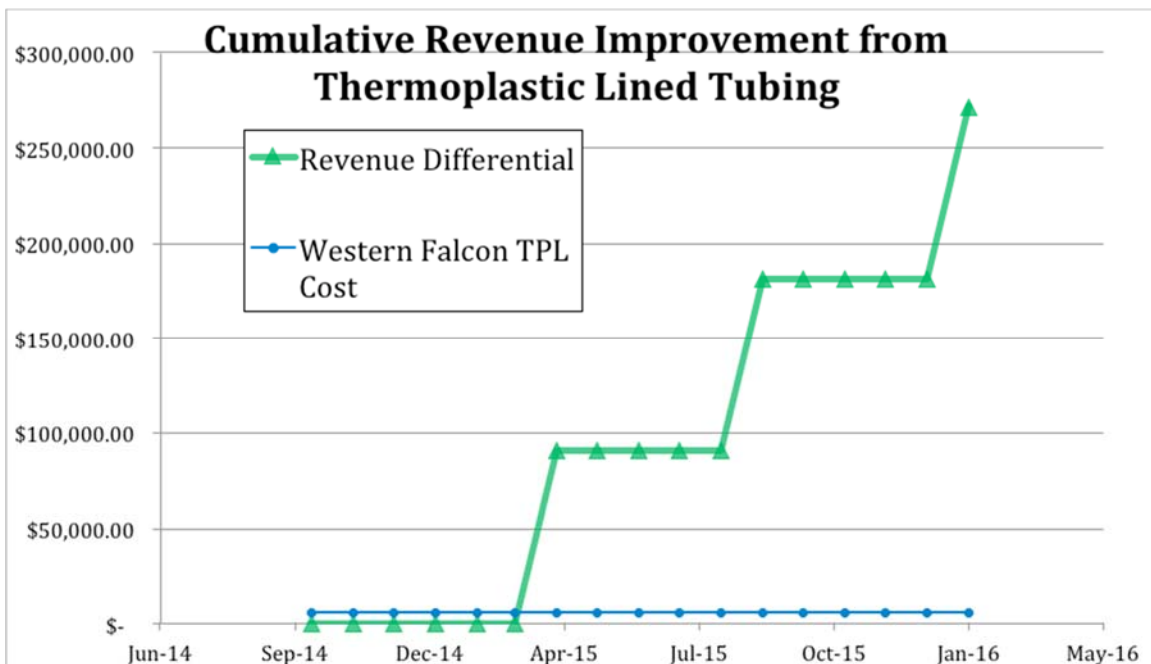
Figure 12 – Single Well Revenue Differential Over 17 Month Period After Installation of TPL Tubing Costing Less Than \$6,000 For Case Study Four
