# HOW YOUR TUBULAR STRING PROFILE COMPARES TO SURVEYS AND SOLUTIONS

Hilton Prejean  
Tuboscope NOV Wellbore Technologies

## ABSTRACT

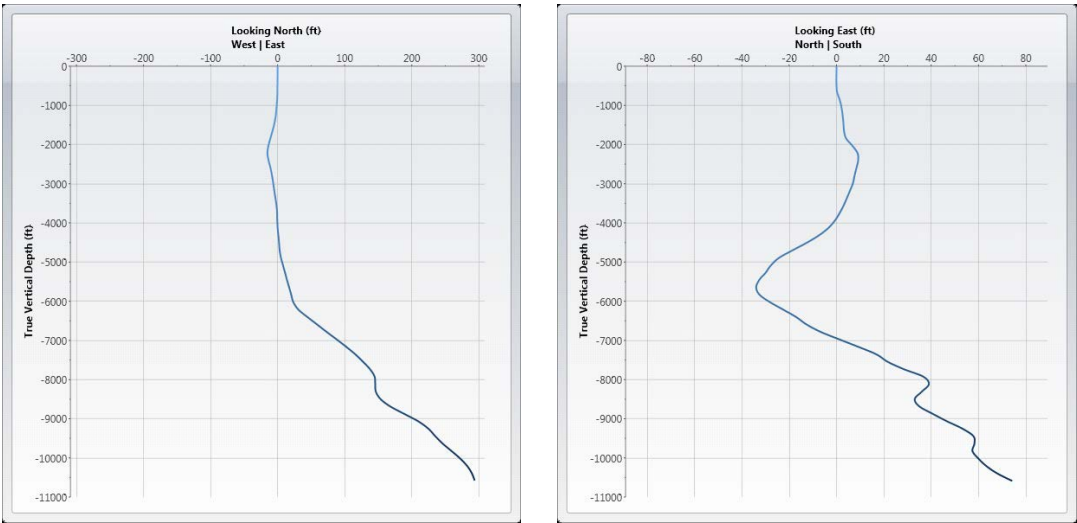
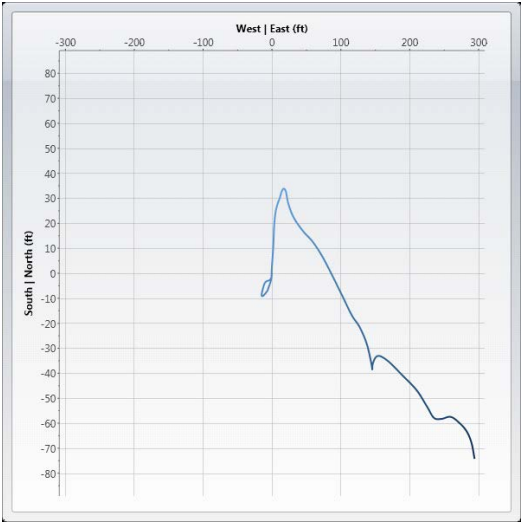
Example Wellbore #1

Top View

Start with wellbore deviations looking at inclination angles, dog leg severity in degrees and azimuth of hole. In this first wellbore example the maximum side load is 257lb @ 8693ft, maximum dog leg severity 1.69° @ 8693ft and maximum angle at 7.2° @ 8884ft these parameters are very important to formulate the proper recommendation to solve excessive calculates to receive the greatest amount of rod guides eight (8) per rod. Also very important is the guide's locations and spacing to maximize the rod support and tubing protection.

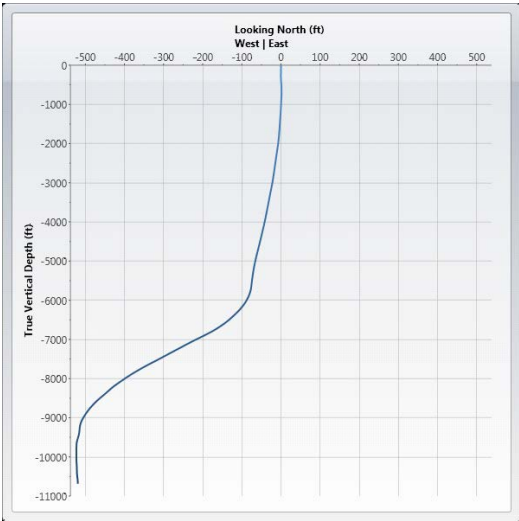
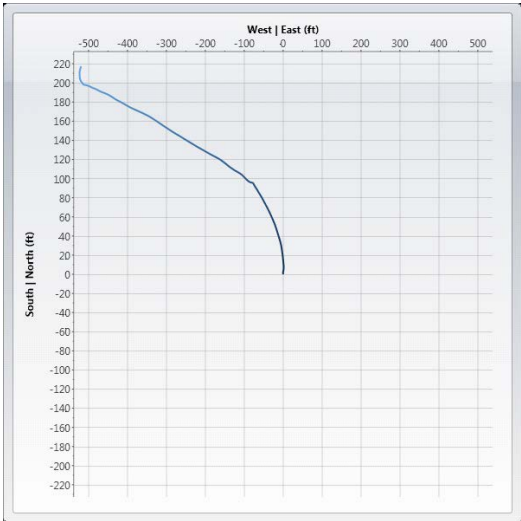
Example Wellbore #2

Top View

RGAP recommendation guided the entire well from the extreme variables of wellbore deviations looking at inclination angles, dog leg severity in degrees and azimuth of hole. In this second wellbore example the maximum side load is 533lb @ 9,200ft, maximum dog leg severity 3.24° @ 9200ft and maximum angle at 11.88° @ 7000ft these parameters are very important to formulate the proper recommendation to solve excessive tubing wear and premature work-overs. Specific number of guides were recommended with some zones to receive four (4) guides per rod and other zones used eight (8) guides per rod. This well shows how proper guide material, design, location and spacing are so very important to maximize the rod support and tubing protection, 88% of the string was reused with 12% lightly worn.

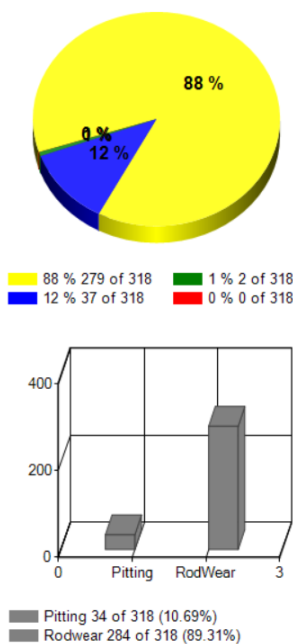
Tubing Scan Results – December2015 (Follow-up)

follow-up scan showing 88% of the string was saved and only 12% of tubing string was loss. These are just two wellbore examples used for this paper with 1000s of wells that have been helped with protecting rods and tubing extending run times, reducing loss production and saving millions of dollars in good quality well maintenance programs. This is how your tubular string profile compares to surveys and solutions.
