# FROM FAILURE TO SUCCESS: A METALLURGICAL STORY ON SUCKER ROD PUMP BARRELS

Pinar Karpuz-Pickell and Ricky Roderick  
Don-Nan Pump&Supply

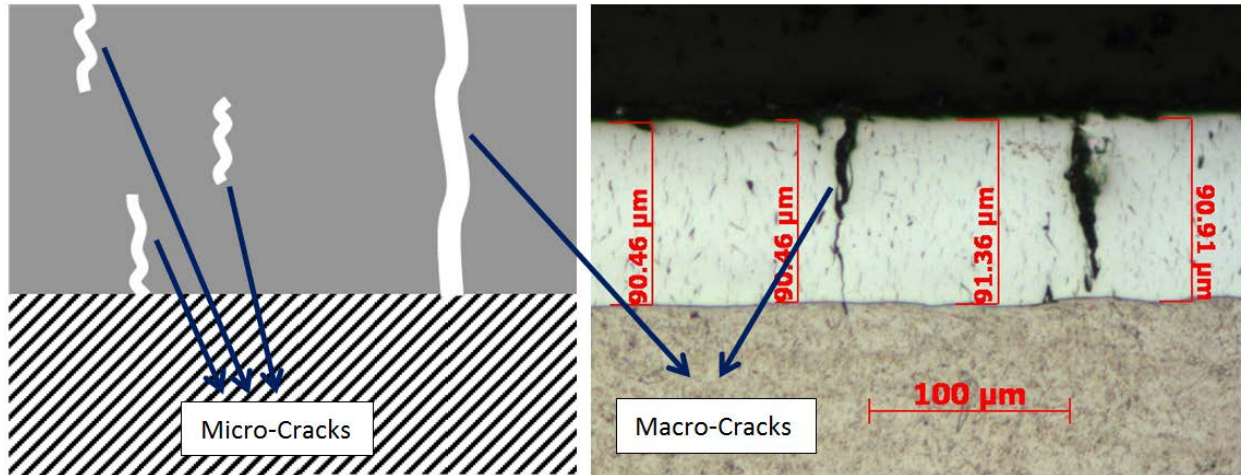
Figure 1 - Micro and macro-cracks in Chrome plating.

3. **Nature of the cracks:** Improved corrosion resistance means reducing the chance of corrosive media from reaching the base material. The cracks form during the plating operation on the chrome layer, and then are plated over to become micro-cracks. Micro-cracks are rather harmless since they are blunted, contained in a layer, and do not form an open path for the corrosive media to reach the base material. However, once the plating operation is over, the structure may have cracks that go through the whole plated layer. These cracks are called macro-cracks, and are detrimental in corrosion protection since they form a direct path for the corrosive media to reach the base material (Figure 1). As a rule of thumb, more and finer micro-cracks are preferred for better corrosion resistance. Since cracks form during the plating operation, their nature can be altered by changing the plating process parameters. However, as stated above, post-plating operations can also improve the crack characteristics.

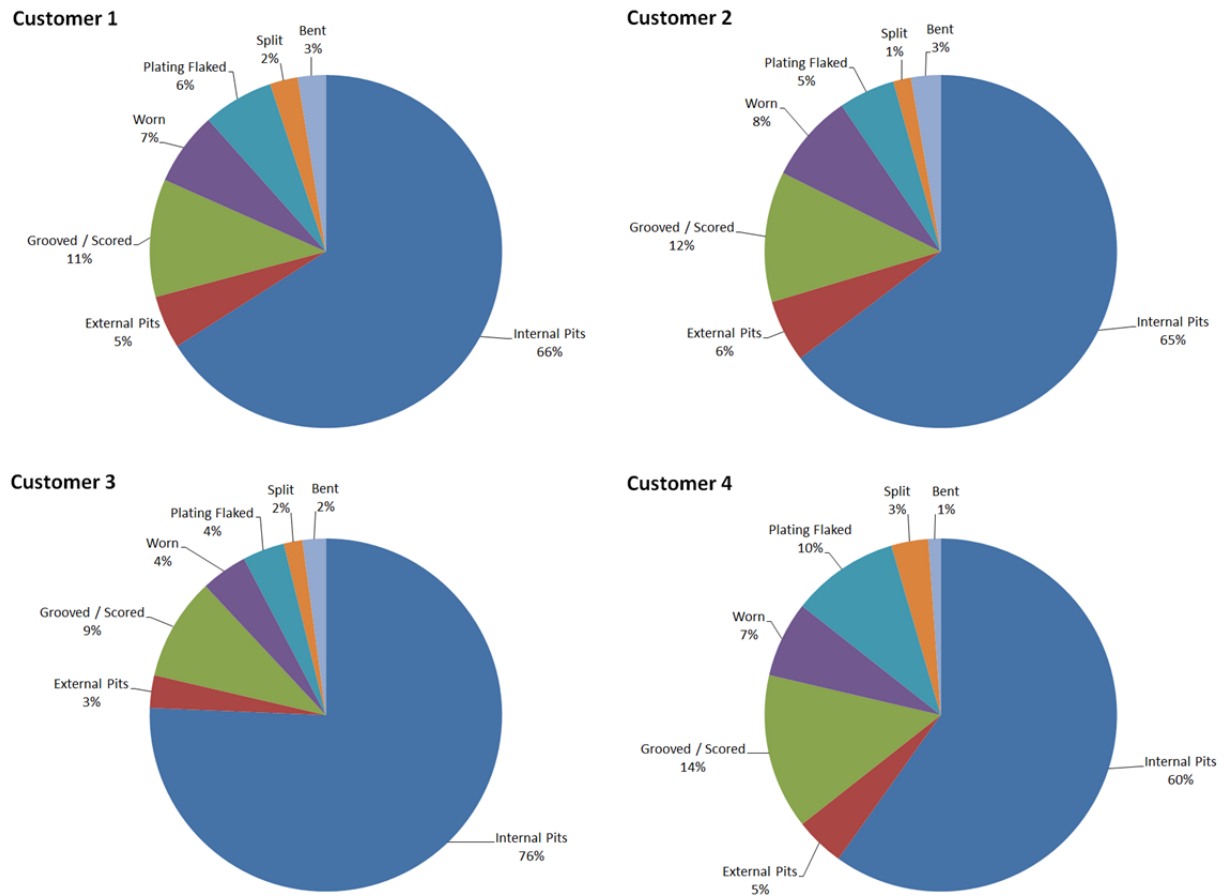
Figure 2 - Failures modes in sucker rod barrels for 4 major companies at Permian Basin

The results of these analyses, combined with pump service records are analyzed for 4 major companies operating in the Permian Basin in order to determine the failures in sucker rod pump barrels. This failure data is summarized in Figure 2. Examining the figure, the most common failures can be grouped as follows:

1. Internal pits
2. Grooved/scored
3. External pits
4. Worn
5. Plating Flaked
6. Plunger Stuck in Barrel

## 7. Split

As expected, the most widely experienced failures are due to corrosion and wear. It should be noted that more than one of these symptoms can occur in a single case.

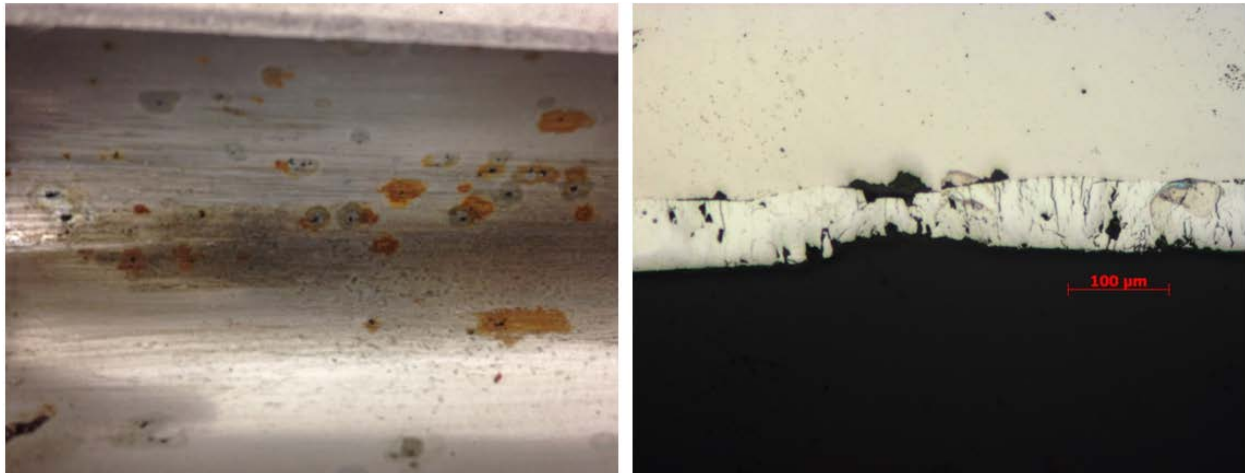
Randomly distributed shallow pits are the most commonly observed pitting type on internal surfaces (Figure 3). The degradation of the protective coating is the main reason for the formation of these pits. This degradation may be due to harsh well conditions or poor coating performance. For chrome plated barrels, poorly executed acid jobs yield to severe corrosion damage through pit formation and flaking of the coating. Galvanic corrosion between the steel base metal and the coating can yield localized corrosion pits. Poor coating adhesion due to the bad base material surface conditions prior to plating yields to a rapid degradation of the coating and detrimental corrosion damage in the part. As stated in the previous chapter, presence of macro-cracks can also be the source of the corrosion, by forming a free path for the corrosive media to reach the base material for Chrome plated barrels (Figure 1). If the chrome plating is not finished properly, helical honing marks may remain on the inner surface of the barrel. These honing marks and especially their intersections results in a decreased coating thickness and degrade the overall coating quality, and thus act as origins of corrosion pits (Figure 4).

Figure 3 - Random, shallow corrosion pits on the barrel surface.

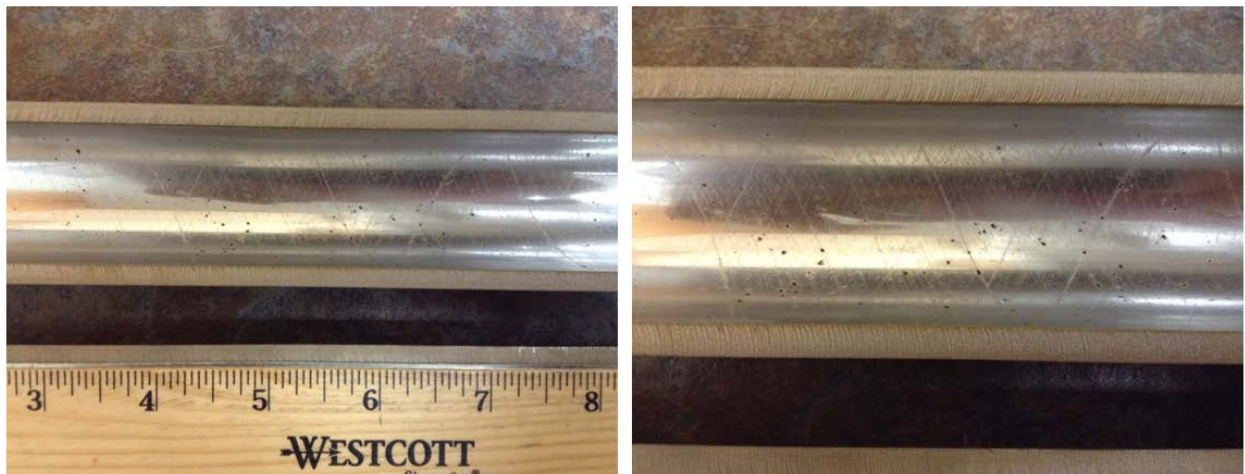
Figure 4 - Helical honing marks on the barrel surface.

2. **Post-Treatment Parameters:** Post-plating honing is not only important to ensure that the final plated part has the desired size, fit and finish, but also is very important for the final corrosion properties. It relieves the residual stresses introduced during the plating operation and increases the number of cracks in the coating structure, and these cracks, filled with oil during pumping, also improve the wear resistance of the part. Reducing the surface roughness of the coating by post -treatment operations including honing positively affects the salt spray test results and increases overall corrosion resistance significantly. It is also important to make sure that the finished surface should be free of honing marks and residues, since these can be corrosion initiation sites during service.

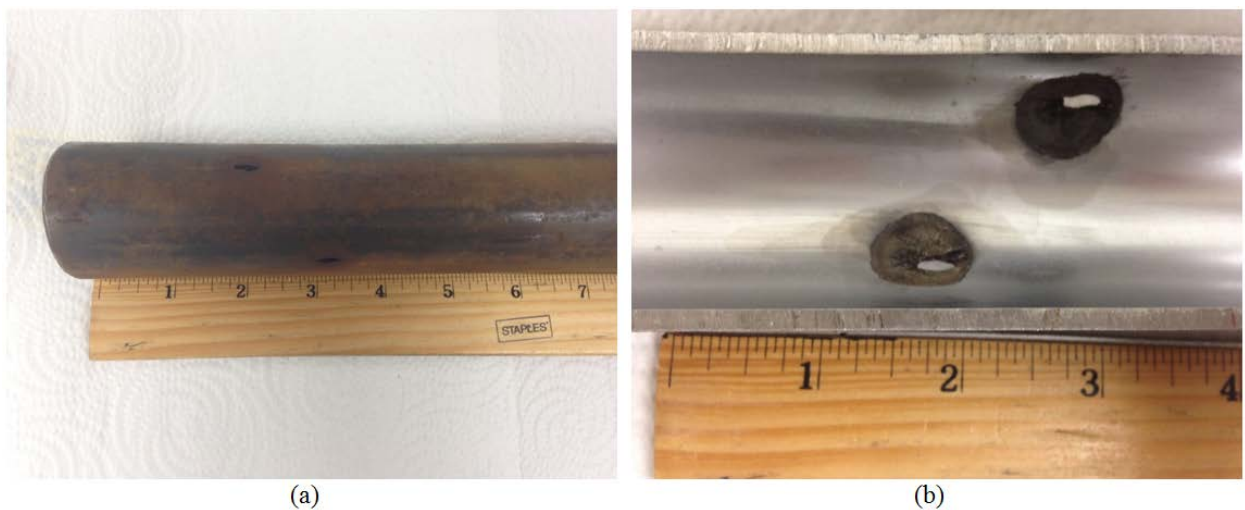
Another type of pitting observed has a very distinct characteristic of clean, well defined holes on the outer surface of the barrel. In most of the cases, these holes are not accompanied with outer surface corrosion evidence. Once the part is vertically sectioned, however, evidence of significant corrosion is observed around these pits while the remaining areas of the inner surface remains corrosion free (Figure 5). This pitting characteristic coincides with the effects of microbiologically influenced corrosion (MIC). MIC on the equipment and parts is primarily realized as localized attacks, usually in the form of pitting, occurring on the metal surface.

(a) (b)  
Figure 5 - MIC evidence on the (a) outer and (b) inner barrel surface.

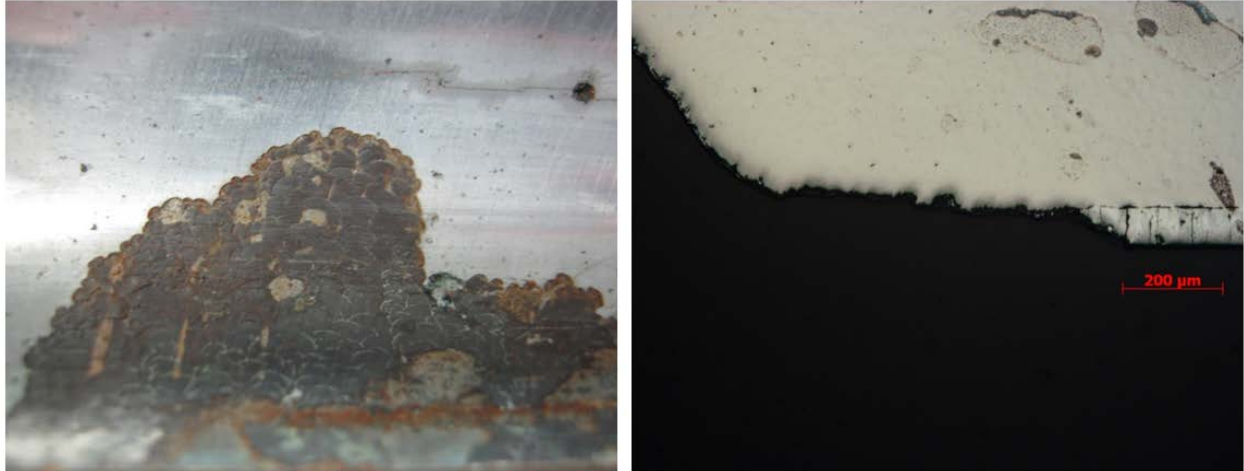
As mentioned above, for the chrome plated barrels, poorly executed acid jobs where the pump is sent back in the well too soon after the swabbing, are known to cause the dissolving and flaking of the coating (Figure 6). One of the key characteristics of chrome plating is that it is easily dissolved in hydrochloric acid. Hydrochloric acid, mixed with other chemicals is used to acidize the wells. The remnant acid from such acid jobs damages the Chrome coating rapidly and results in local degradation of the barrel's inner surface.

Figure 6 - Flaked Chrome coating on the barrel surface.

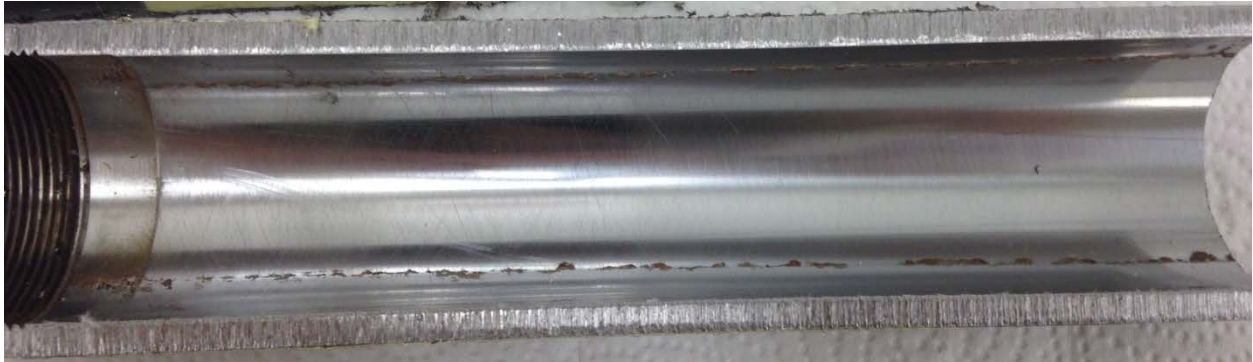
In some cases, the pits are observed to be aligned on a straight line (Figure 7). When studied in detail, it is observed that this kind of pitting is generally accompanied by grooves and other abrasion marks aligned in the same direction. Such grooves that are formed on the surface due to abrasion and wear result in local deterioration and even removal of the protective coating. Once the protective coating is removed, the base metal becomes exposed to corrosive media and the corrosion pits form.

Figure 7 - Pits aligned on a straight line on the barrel surface.
