# **YOUR TUBULAR STRING - KNOW ITS FIT FOR SERVICE WITH NDT TECHNIQUES**

Hilton Prejean  
NOV Tuboscope

## **ABSTRACT**

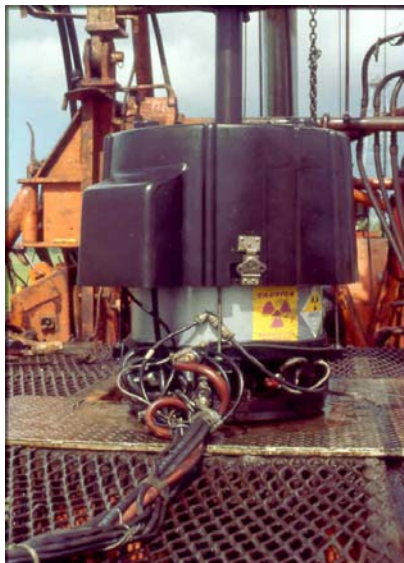
Used Pipe - EMI inspection head on workover rig floor

Field inspection at wellsite is focused on wall variations cause from in-service induced rod wear, erosion wear, and other general wall reductions from "like new" thickness. In conjunction to wall the EMI section detects cracks, corrosion pitting, holes and 3-Dimensional transverse type defects while the pipe is pulled from well displaying real time data on a CRT monitor in color coded graph (yellow blue green red). When pipe is identified as being suspect it is laid down from the rig by the crew for further investigation to determine actual classification. It's important to know this service does not check connections or drifting.

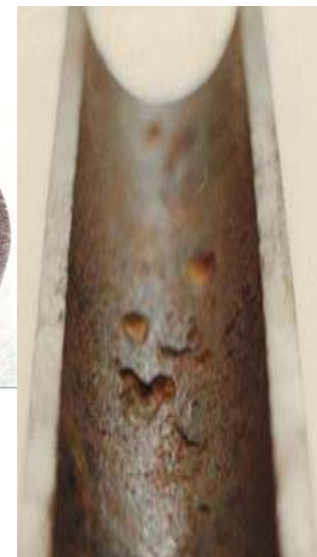
In Service  
Tubing Defects  
Pitting  
Rod Wear  
Tubing Split  
Mashed Coupling  
Damaged Pins

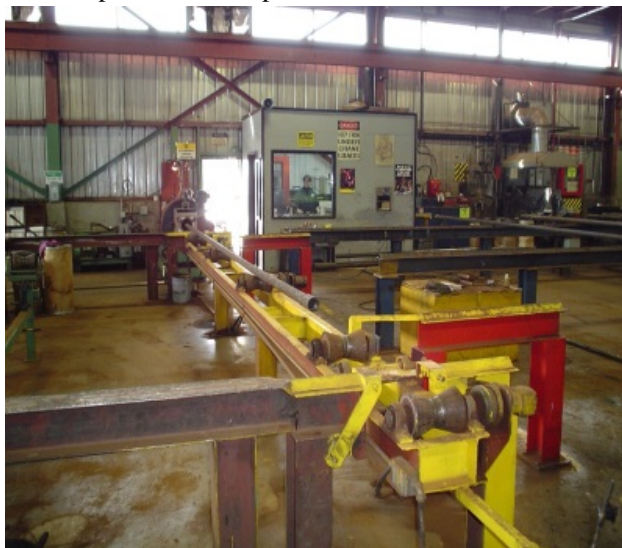
Used Pipe - InPlant Inspection Services

Used Tubular reclamation services are the most comprehensive economic choice when possible. Starts with Cleaning, for scale and paraffin, internally and externally, using our highly efficient, high-speed ID/OD cleaning system; Visual inspection, to inspect tubing to determine the extent of corrosion or physical damage and to reject those tubulars that are obviously unserviceable; Drifting, pulling cylinder full length of the tubing to identify

restrictions due to mashes, mechanical damage and to ensure it meets API or your own specifications; Electromagnetic inspection, performed on the tube body to detect service-induced flaws, such as corrosion pitting, cuts, gouges, cracks and rod wear; Connection inspection, performed on threads to catch defects in the end areas that an electromagnetic inspection cannot detect. This step also includes a critical examination of the upset area; Thread Compound, application of thread lube with either API-approved or customer specified, to protect the threads in storage and transit; Protectors, re-installing plastic pin-end thread protectors to connections protecting these vulnerable areas from damage during transit and storage; Marking, placing a stencil pertinent work order information onto each length of tubing; Tally, to measure tubulars verifying the number of good lengths ready for service or thread repair (when required); Segregate, to separate damaged tubulars by classification code (API5C1) or customer specifications, determining tubing inspected with reject footage; GOLD (global on line data), to track by computerized storage the inventory of your processed tubing using anytime access from internet showing recent activities.
