# EXTENDING RUN TIMES IN DEVIATED WELLS

## CASE STUDIES

Gary Abdo  
R&M Energy Systems

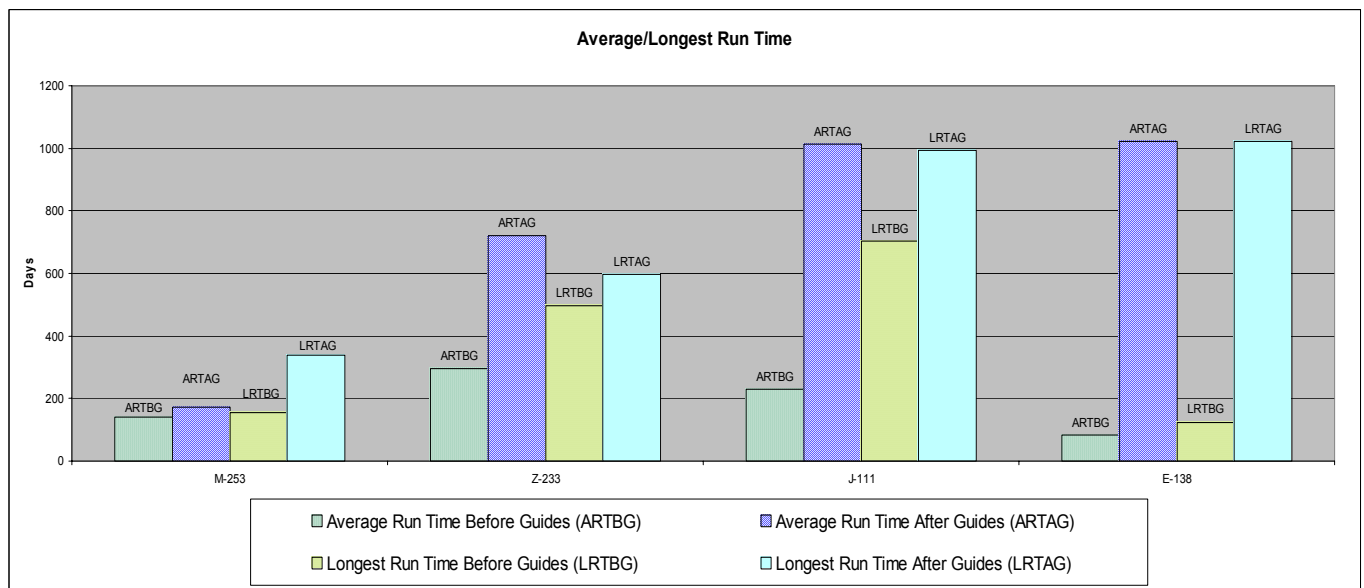
A rudimentary cost analysis is provided in **Figure 12**. This cost analysis does not take into account replacement tubing, rods or lost production. This cost analysis shows a cost savings for three of the four wells in this study. Well Z-233 had one pump failure which dropped the cost savings below investment costs. One of the most important items to consider is the virtual elimination of wear related failures for all four wells. **Figure 13** shows the average and maximum run days for all four wells in this case study. **Figures 14 and 15** are pie charts showing the number of failures by type before rod guides and after rod guides. Only one well logged a wear related failure. This occurred in the well that did not have a deviation survey and the failure occurred in an unguided section of the well. Wells without deviation surveys require accurate failure records for an optimum guide recommendation.

Figure 12 - Chart Showing Cost Savings Versus Money Spent

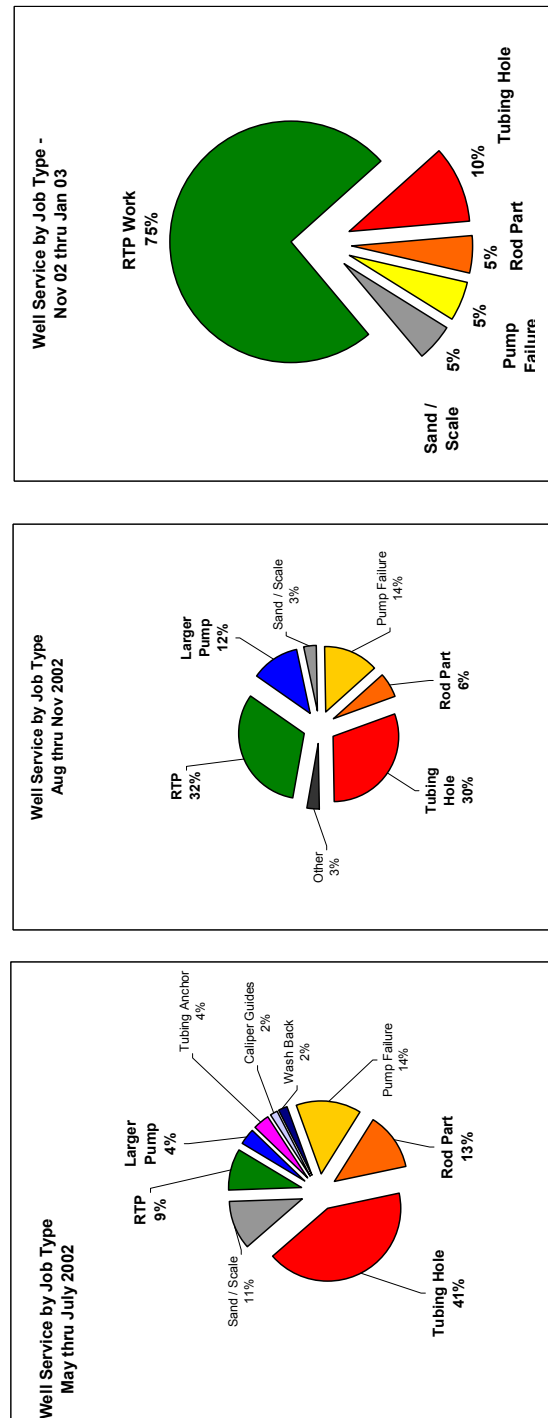
**Figure 12** shows the well service history by job type for the Buena Vista Hills Operations. By the end of 2002, the chart indicates:

- 33% fewer well pulls for tubing and rod failures
- 75% fewer tubing holes

Figure 16 - Buena Vista Hills Well Service History by Job Type
