Effect of Abuse and Missapplication On Pumping Unit Gears

By F. BEN ELLIOTT
Lufkin Foundry & Machine Co.

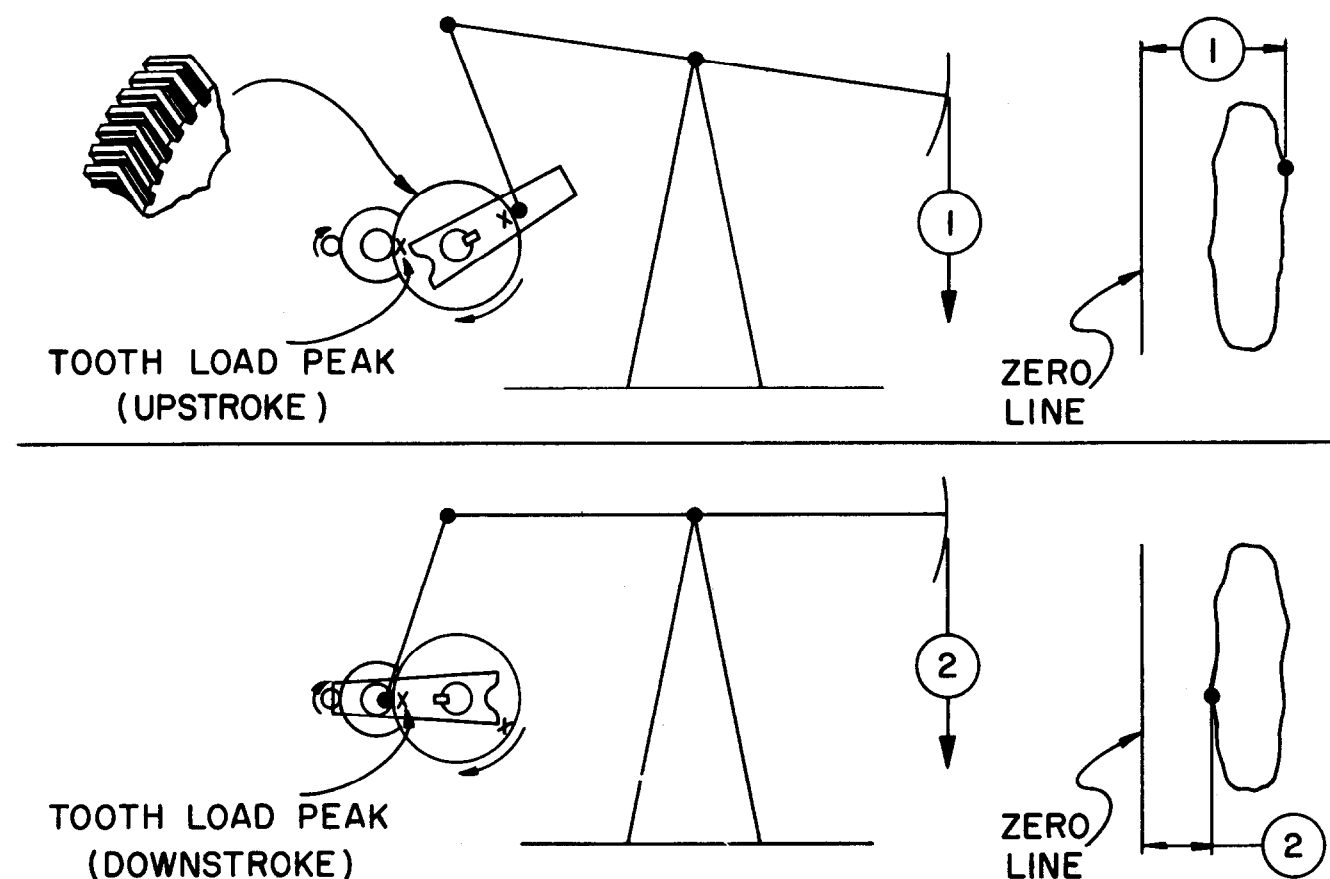
Fig. 7 Slow speed gear torque peaks.

In analyzing any kind of failure or difficulty with pumping unit reducers the basis for establishing loading is very important. The exact amount of torque loading on the reducer is the basis for determining the amount of load or overload, and it is essential that an accurate method of making these calculations be used. To determine accurate loadings the torque factor method must be used with a dynamometer card; Sine curve torque calculations are often inaccurate.
