Drill String Fatigue in Short Radius Horizontal Applications

W.G. Storbeck, P.E.,

Storbeck Consulting, Inc. for Mobil E&P U.S.

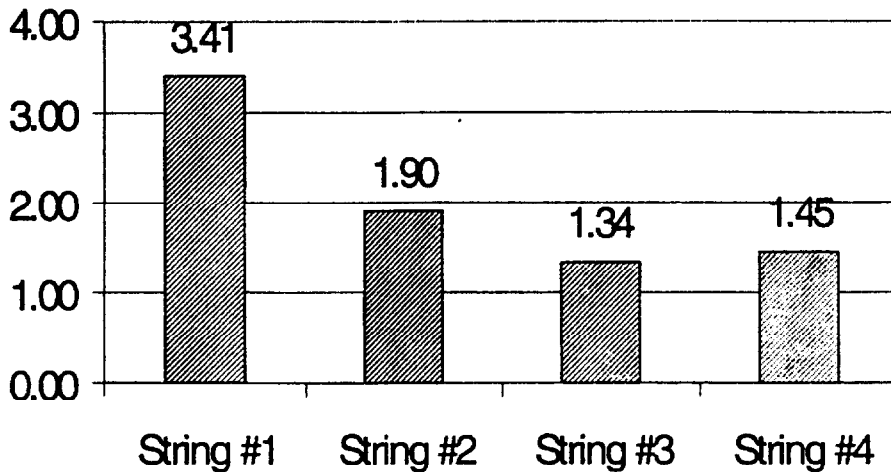
Figure 4 - String #2 at Rutherford
% Consumed Life of Tubing

Thus far the analysis includes the first seven runs for this tubing. This includes one medium radius lateral that was 3500 ft horizontal displacement. It can be seen in the attached graphs that the lower build rate curves drastically improve the percentage of tubing life spent. Although there were no failures, approximately 15 jts have been set aside mostly due to connection damage during make-up. (Figure 4)
