# COILED TUBING ROD STRINGS MAY EXTEND THE LIFE OF SPRABERRY WELLS (AND OTHERS) IN THE PERMIAN BASIN

Elton Smith, Pioneer Natural Resources USA, Inc.  
Jeff Harris, BJ Services Company, U.S.A.

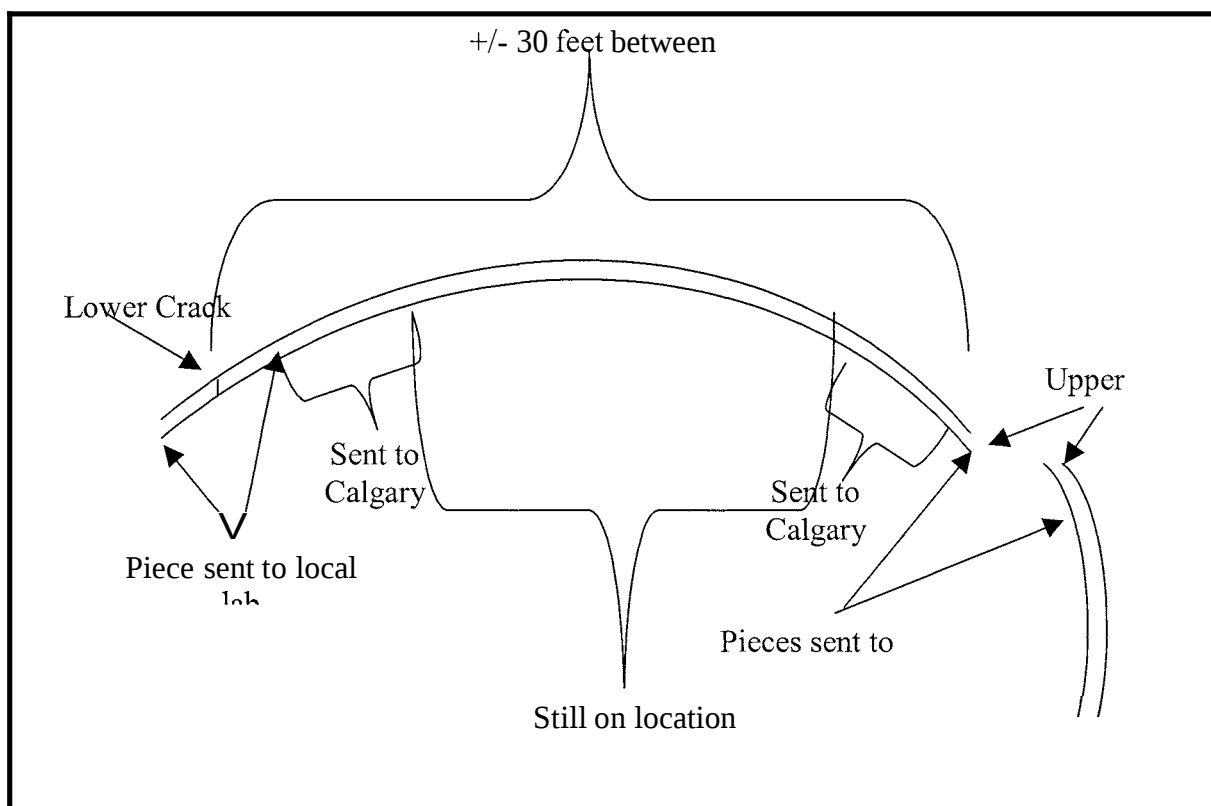
To find the root cause of the pipe failure, both failures and pieces of the pipe between the failures were sent to three different labs to be analyzed (figure 5). Also an independent ultrasonic inspection was conducted on the rest of the pipe that was pulled from the well to determine the amount of wall loss due to any wear while the CTRS system was in operation.

Figure 5 - Sample Collection For Testing
