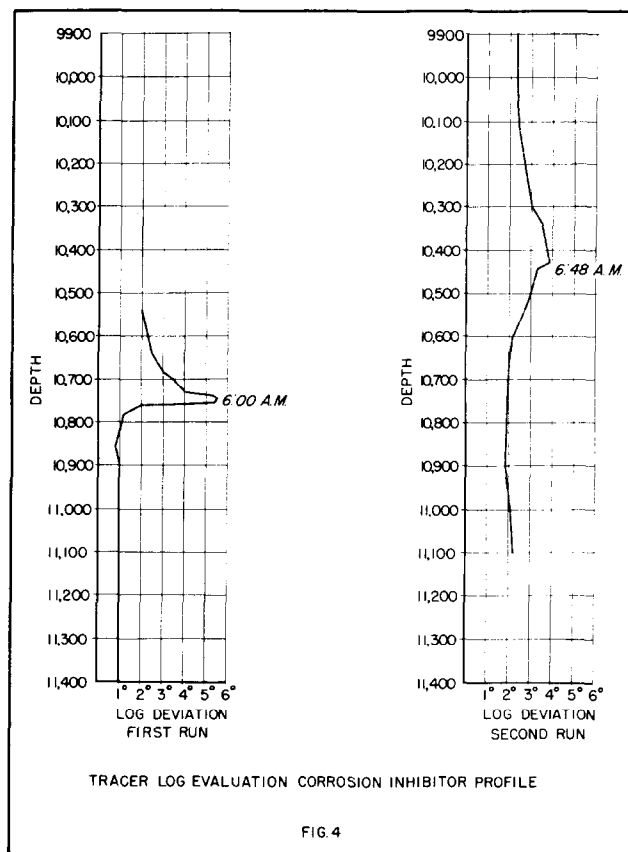
Since no history was available of anyone using this method, some experimental work was done to establish proper procedure. A radioactive tracer tool was lowered to the bottom of a well and a tagged inhibitor in a drum of solvent, followed by six drums of solvent, was pumped into the tubing. This was the proper amount to give a 1/16 in. coating on 13,500 ft. of 3-1/2 in. OD tubing. After waiting eight hr. with no response, the tool was moved up the hole until it encountered radioactivity at 10,700 ft. after 10 hr. total elapsed time. Only a short column of chemical was indicated at that point. Fig. 4 is a profile of the log locating the bottom of the inhibitor.

The log further indicated that there was no feathered lead edge of inhibitor. After the inhibitor was located, the tool was again lowered to 11,100 ft. and the same area was logged again. It appears that the tool became coated with inhibitor and that it carried

most of the inhibitor down with it. It was noted that an increase in radioactivity was not recorded until the tool was raised above the highest point of its first run. This probably indicates that high temperature had driven off some solvent and thickened the inhibitor at this depth so that it did not flow freely. One, or both, of two things probably prevented the inhibitor from reaching bottom: (1) Eight hours was insufficient time, or (2) seven drums of solvent was insufficient to reach the bottom of the well.
