CONTINUOUS ROD SCANNING USING LV-EMI™ PROPRIETARY TECHNOLOGY

Enio Oliveros, L.J. Guillotte Jr., and Anne Marie Weaver, LPS Jared Jensen, Chevron

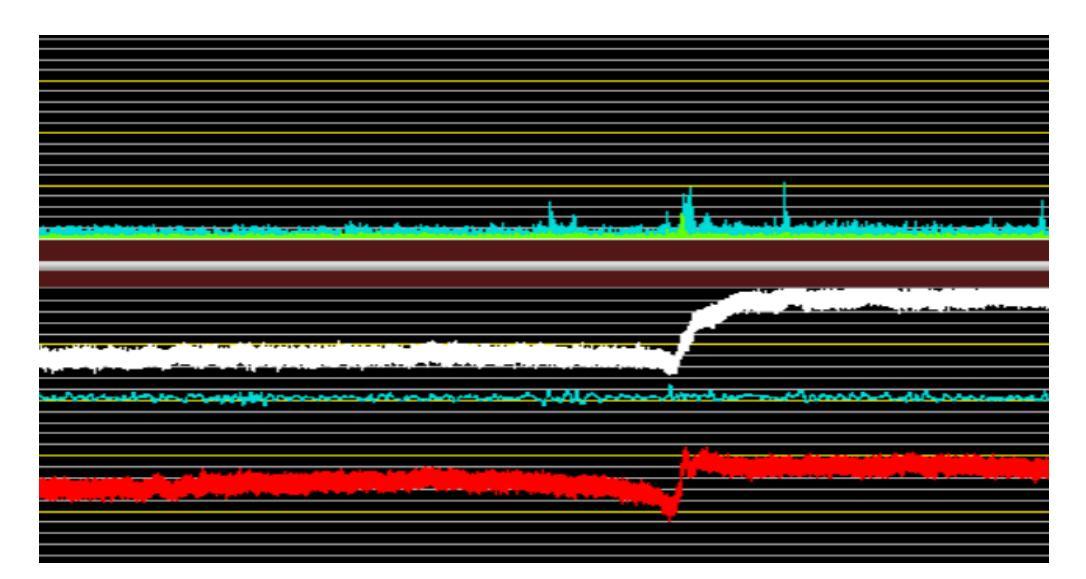
Figure 1 displays a screenshot of what the EMI operator observes as the rod string is traveling through the unit. The top portion of the graph represents the magnetic flux leakage (MFL) readings, and the bottom portion represents the magnetic flux density (MFD) readings.

Figure 1: EMI Indications for Rod String Scan
