METALLURGIC AND COATING SOLUTIONS FOR CORROSION MITIGATION IN ANNULAR FLOW WELLS

Joe Koessler and Joe Alapati, Devon Energy Page Laird, NOV Tuboscope

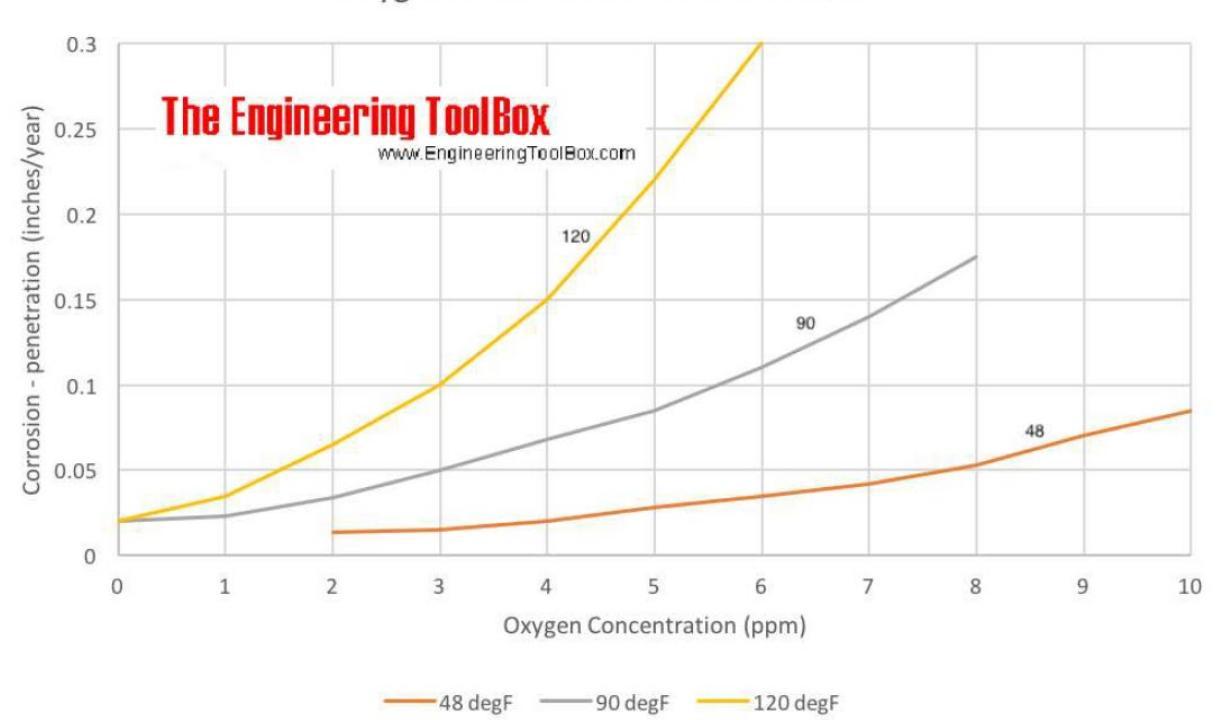
Figure 2 – Oxygen corrosion rate at varying temperatures.

Figure 2 describes the relationship between oxygen-based corrosion of low carbon steels (like L80 grade tubing). Oxygen corrosion rate increases with both temperature and corrosion, though the relative impact of elevated temperature is more pronounced. General trends observed from field-based scans of tubing removed from annular flow wells shows that the pitting and overall corrosion environment is most prevalent in the deeper sections of the tubing string where the flow is hotter, often well in excess of 120°F by downhole gauge observation.

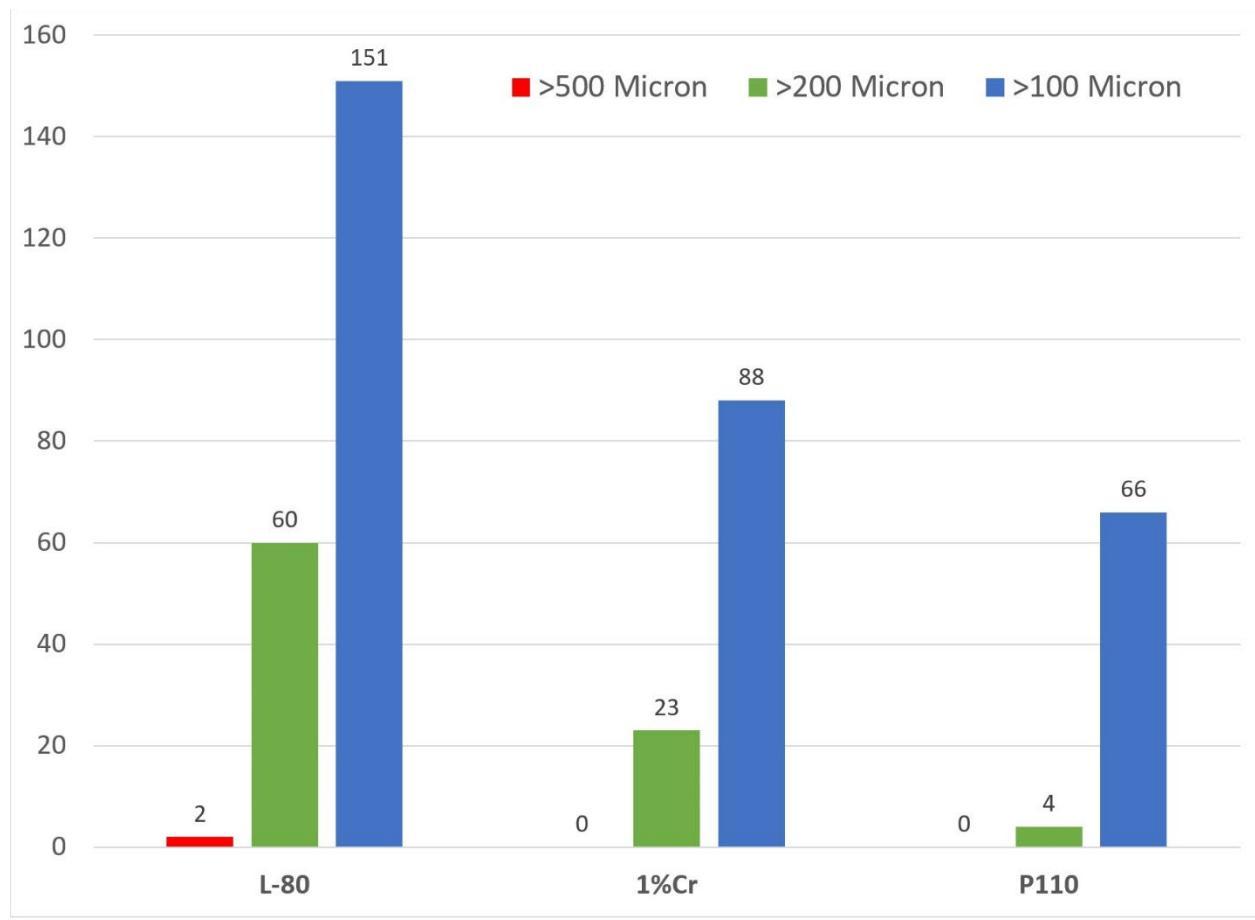
Using a similar testing method, 3 different corrosive resistant tubing strings were tested in the same flow cell described previously. L80 with 1% Chromium, P110, and standard L80 coated with a spray metal coating containing chromium were all tested against an L80 control sample in a high shear, high temperature flow cell with oxygen dissolved in the water. Overall, a direct comparison of the L80 control to 1% chromium and P110 samples showed significant improvement in resistance to pitting corrosion. P110 offered the greatest resistance to the identified corrosion mode under conditions like high rate, annular flow wells. 1% chromium L80 showed improvement compared to L80 in the laboratory setting.
