HIDDEN COMPLEXITIES OF ROD ROTATION: UNDERSTANDING TORQUE BUILDUP IN SUCKER ROD SYSTEMS

Walter Phillips, WANSCO Nick Hooper, Continental Resources Justin Bates, Echometer Company

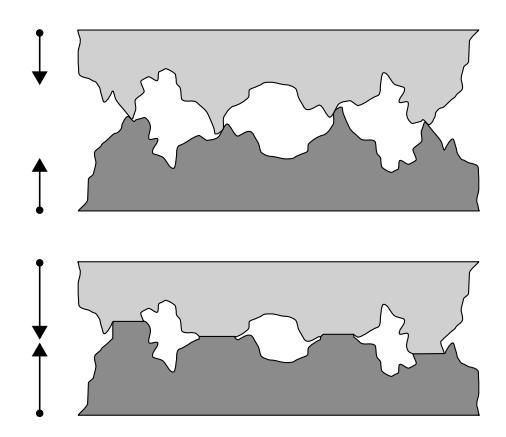
Figure 3 – Friction is a complicated phenomenon. Contact surfaces are not perfectly smooth and microscopic ridges may be present. The shearing of these ridges is the mechanism which creates wear (similar to the working theory of sand paper). We should see the result of the changing contact interface as a change in tensile load, but this is very tricky to determine apart from normal well load fluctuations. The reason tensile load may change is because the coefficient of friction is not perfectly fixed; it may change as the surface of the contact interface changes. Whether the resulting load is measurable or not is dependent on many factors.

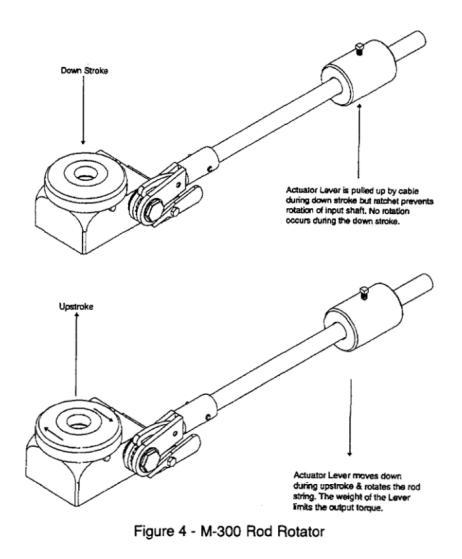
Figure 4 – Smith introduced a radically different rotator design that inherently limited torque. In particular, it was described as applicable for fiberglass rods that may be more susceptible to torque on the rods themselves. The amount of rotational energy fiberglass rods may store when free rotation is resisted should also be considered. Figure reference: (Smith, 1988). Alternative rotator designs or application of existing rotator technology may be of interest.
