BORIDED TUBING SCANNING UTILIZING LASER TECHNOLOGY

Bryan Weaver, ConocoPhillips

Brandon McGinn, Stress Engineering Services

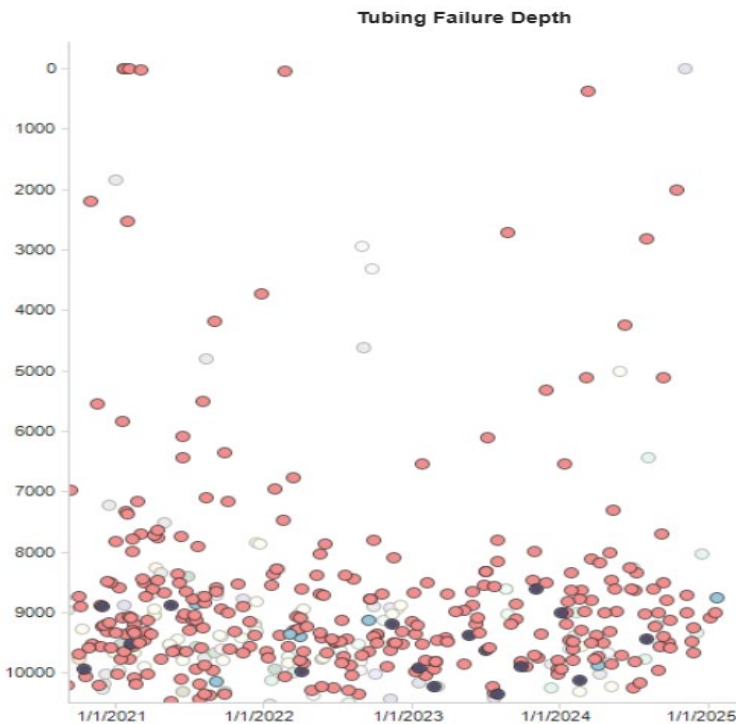
Figure 1. Historical plot of tubing failure depths in ConocoPhillips Bakken rod pumped wells- pump set depth ~10,000. Pink/orange dots represent standard L80 tubing failure depths. Dark purple and light blue correspond to bored tubing failures.

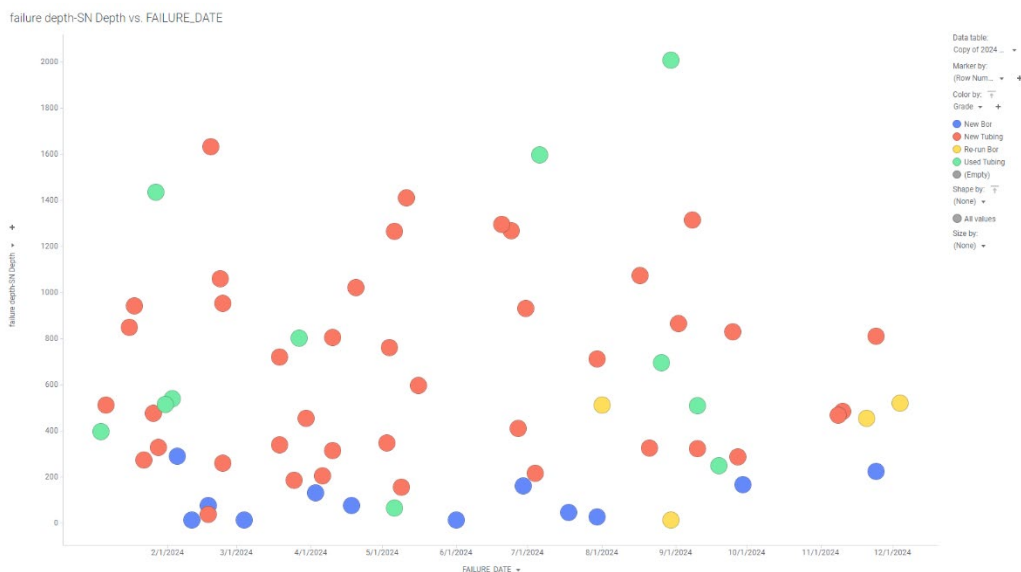
Figure 2. Normalized failure depths relative to pump seat nipple in ConocoPhillips rod pumped - indicating that true problem area is not only TVD is a measure of higher risk areas for corrosion but wear but a 400' relative distance from SN proves to be most challenging section for tubing survival. Important to note that most common failed material is new and used L80 tubing.

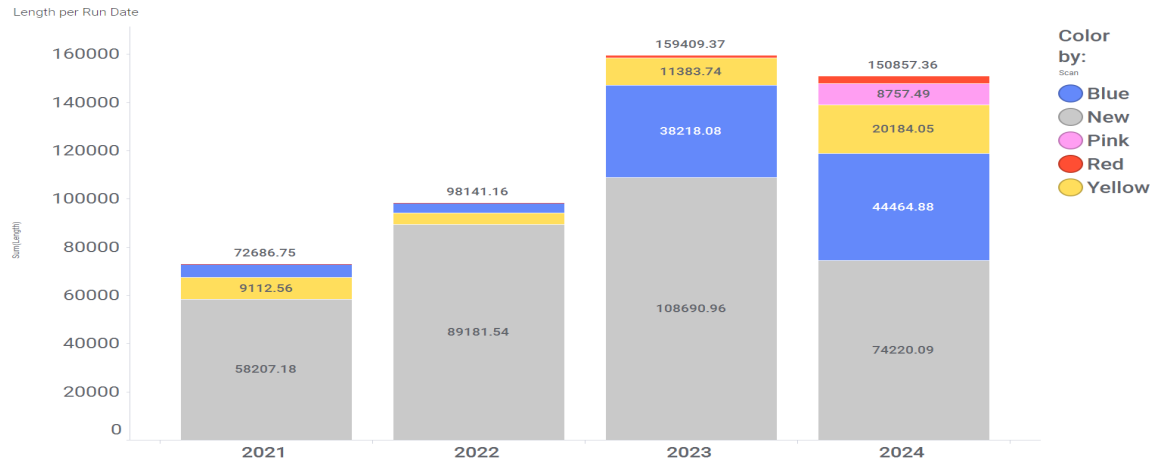
Figure 8. Tubing tally data of total lengths of borided tubing installed in Bakken wells from 2021-2024 - showing significant growth in quantity of re-run tubing and reductions in quantity of new borided tubing run- note red/blue joints are typically used interchangeably in wellview configurations.

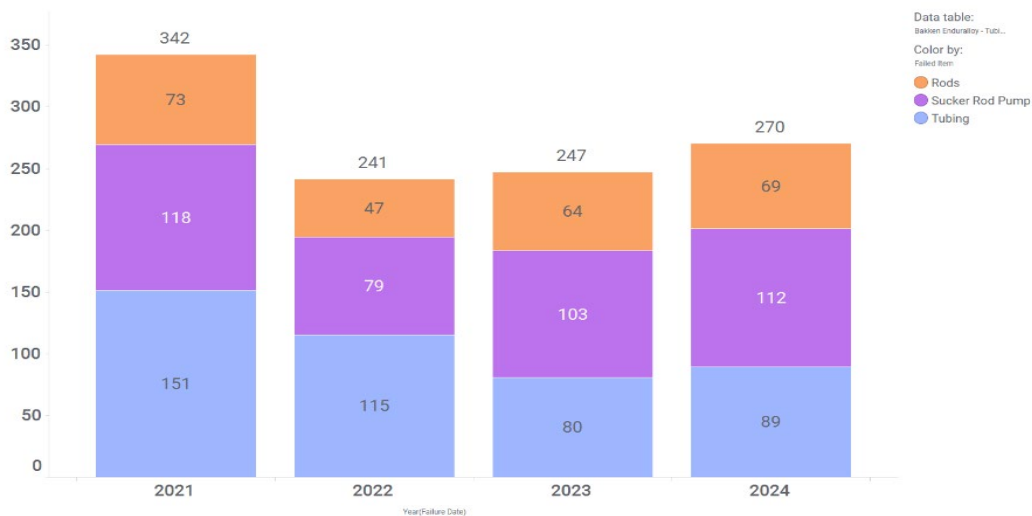
Figure 9. Component failure trend from 2021-2024- note that tubing failure counts are on downward trend correlating with lengths of borided tubing run in wells- giving some lagging indication that tubing failure frequencies are decreasing.
