# THE DOWNHOLE VIDEO CAMERA -- OPEN AND CASED HOLE APPLICATIONS IN THE PERMIAN BASIN

# By Lee Sanders and Cary Joe Burkhart Halliburton Energy Services Midland, Texas

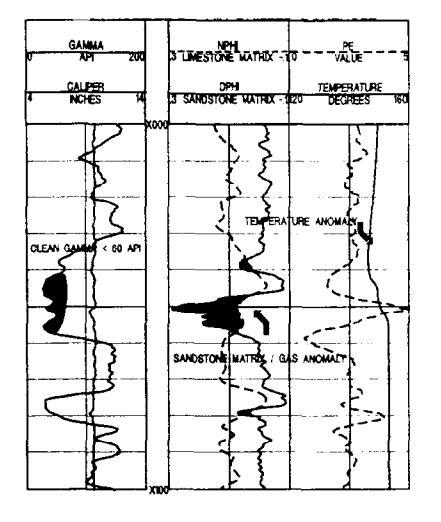
Wolfcamp Sandstone Terrell County downhole video comparison open hole log - air drilled borehole

This example is from an open hole wellbore in Terrell County, Texas. The well was air-drilled and logged without loading the wellbore with fluid. This procedure is followed to avoid swelling clays that may arise with conventional drilling fluids. The open hole logs indicated a possible productive interval based upon the presence of a temperature anomaly and a neutron -- density "crossover". Both of these measurements are considered to be a signature of a reservoir containing natural gas (Fig. 10). In this area the better gas production, from an economic consideration, corresponds to those reservoirs that are naturally fractured. The problem in this example well is that the conventional logging fracture- finder devices require fluid in the wellbore to operate. Because of the absence of fluid in the wellbore, a downhole video camera was run to determine the presence of natural fractures. Figure 11 shows the zone of interest as imaged by the video camera. There are two factors to consider. First, the presence of gas entering the wellbore is indicated by the swirling vortex of sediment that is being eroded from the entry passage. Secondly, the gas entry appears to be associated with the matrix porosity. There is no evidence of fracturing on the video display. Although there existed two independent sources (logs and the video camera) that confirmed the presence of gas, natural fracturing was not present in the zone of interest. In spite of this absence of fracturing, the well was cased and perforated. One month later the well was plugged because of insufficient production.

Figure 10 - This is the open hole gamma/neutron/density/temperature log which shows the presence of gas as reflected by logging criteria.
