THE DOWNHOLE VIDEO SERVICE
CURRENT APPLICATIONS IN THE PERMIAN BASIN

Lee Sanders and Rick Tate
Halliburton Energy Services

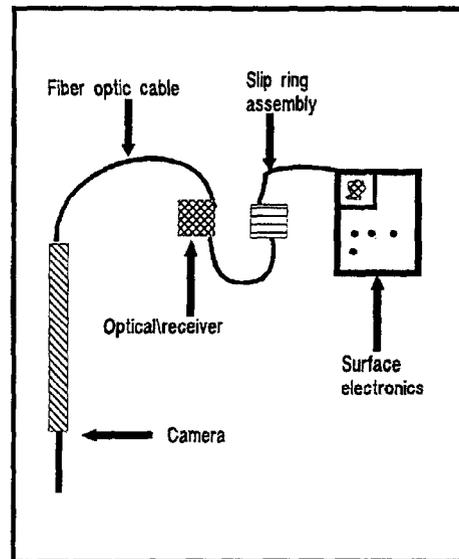
Figure 1 - The main components of the Downhole Video Service

The main components of the Downhole Video Service (Fig. 1) are the video camera, fiber optic cable, and the surface electronics system. The camera assembly (Fig. 2) has an outside diameter of 1 11/16 in., length of 72 in., and weighs 31 lb. (Table 1). The visual integrity of the image is maintained because of the camera recording of 30 frames per second. The fiber optic cable assembly (Fig. 3) has an outside diameter of 7/32 in. and a tensile strength rating of 1200 psi. The fiber optic element consists of a 50 micron core with a 125 micron cladding. The surface electronics system consists of three viewing monitors and a digital recording system. The video images are recorded on 8mm data tapes. The digital video image can then be transferred to a VHS tape, thermal print, or transmitted through the electronic-mail systems.

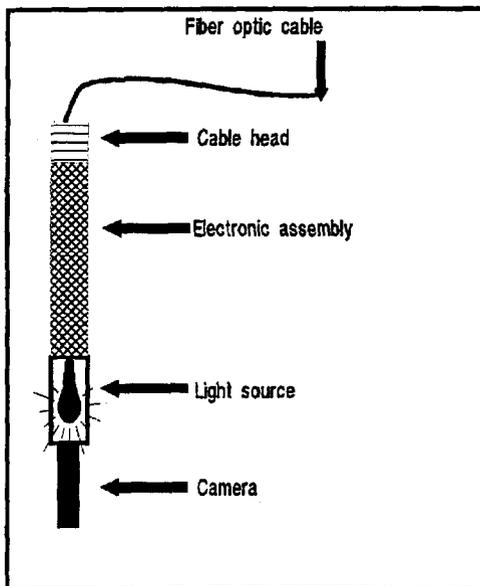
Figure 2 - The Downhole Video Camera assembly

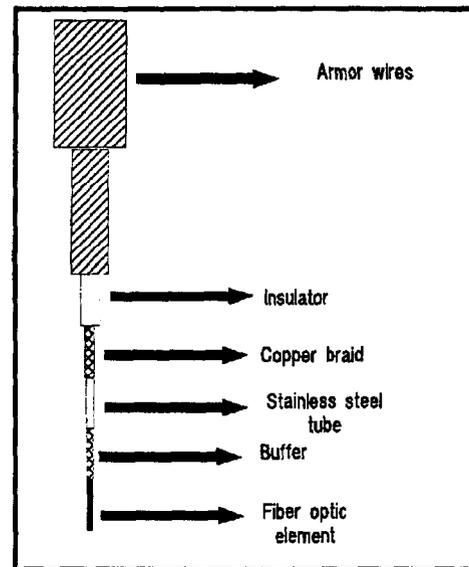
Figure 3 - Main parts of fiber optic cable

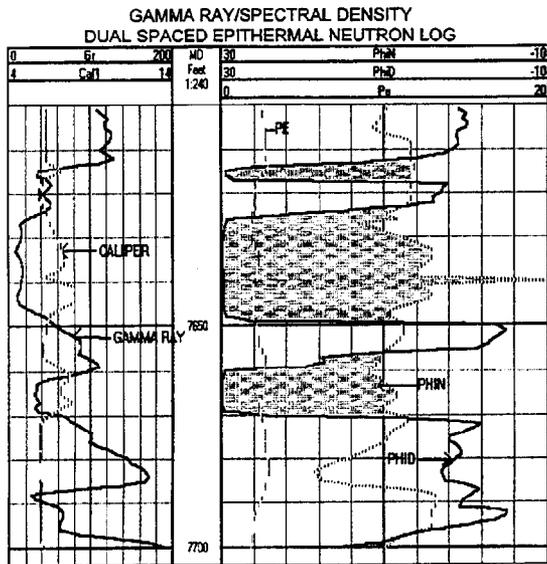
Figure 4 - Example of Pennsylvanian aged sandstone "pay zone".

Fig. 4 shows the standard logging presentation for a Pennsylvanian aged sandstone interval. Track 1 and Track 2 show a highly variable range in the caliper and density porosity measurements through the Pennsylvanian aged sandstone. This variation in the measurements may be caused by borehole rugosity. The borehole rugosity which may be caused by

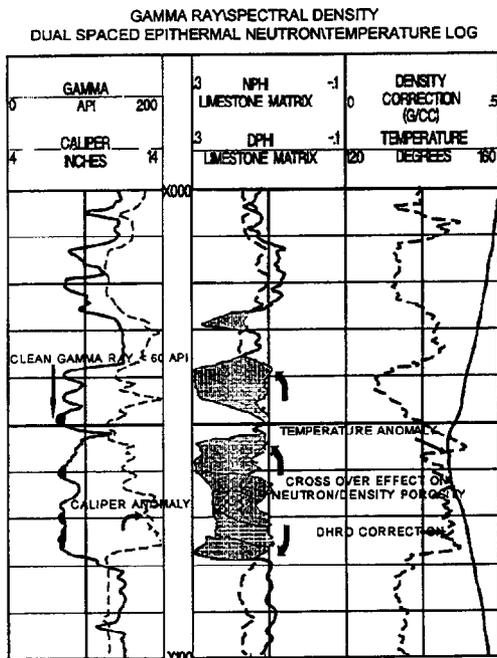
Figure 6 - Wolfcamp sandstone exhibiting "gas effect" on the Density Neutron porosity.

Fig. 6 shows the standard log suite from a well drilled into a Wolfcamp sand reservoir. The log exhibits properties similar to the previous example. That is, an erratic caliper and spiking density porosity would suggest the possibility of the presence of a natural fracture system, borehole breakout, or a laminated sequence of sands and shales. Fig. 7 shows the video image of the zone. The gas entry is very sluggish when compared to past observations. There are no visible fractures and there appears to be no borehole breakout. The caliper and density anomalies appear to be associated with laminated shales within the main sand zone. Although the Downhole Video Service showed none of the criteria for setting pipe, a well completion was initiated. The well produced gas in the amount of less than 50 mcfpd and was plugged after six months of declining production.

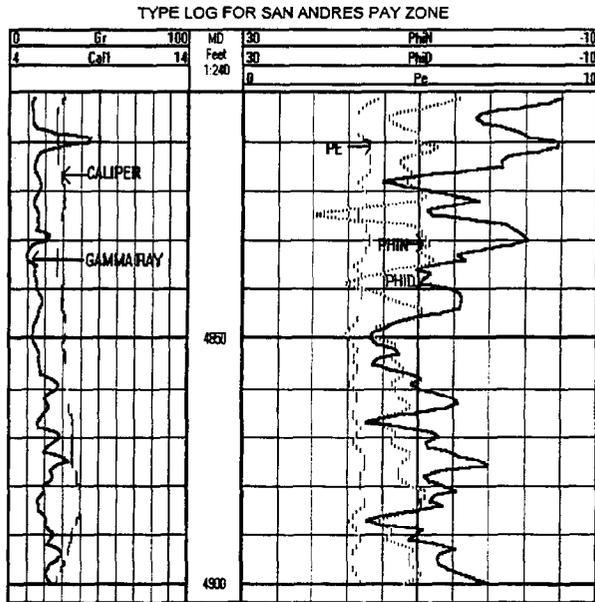
Figure 8 - Gamma ray/Spectral Density/Dual Spaced Neutron log of San Andres "pay zone"

A second Downhole Video Service application in the open hole is to compare two different types of stimulation treatments for the San Andres formation. Fig. 8 is a type log showing the main zone of interest. The San Andres formation in the study area is a dolomitic facies with anhydrite inclusions dispersed throughout the zone. The basic purpose for stimulating these wells is to increase production in a low permeability formation by achieving maximum vertical exposure but minimizing growth into the water zone at the bottom of the interval. Fig. 9 is a video image from an open hole wellbore in which a slow rate acid job (1-3 bpm) was applied to the formation. A total of three 5000 gallon acid jobs were applied. The video image shows that the entire acid volume from the three jobs went into a very small area of the open hole resulting in minimum fracture height growth and poor production results (7 bopd and 37 bwpd). The well was later sand-fractured with a Delta Frac treatment. The well is currently producing 78 bopd. Fig. 10 is a video image in which a Closed Fracture Acidizing technique was performed after a CO₂ foam fracture job. Closed fracture acidizing is the stimulation technique in which acid is applied at low pump pressures and in low volumes. In this wellbore a 10,000 gallon 65 quality foamed CO₂ and 2000 gallons acid were applied. The result was to increase the observed fracture height with a small volume/rate job compared to the previous well example.

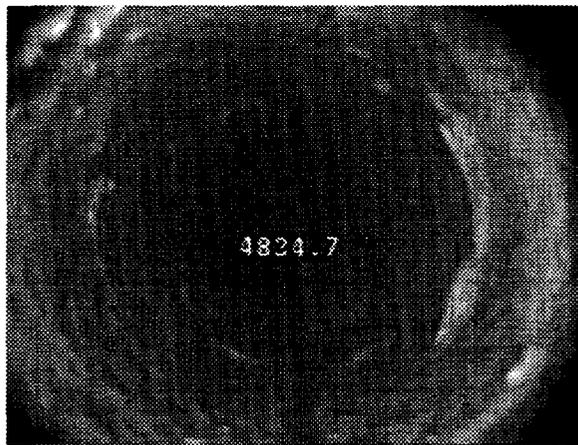
Figure 10 - The video image shows the result of a closed fractured acid job. The treatment covers the zone of interest.
