DYNAPUMP FIELD EVALUATION

Arturo R. Pena, Yates Petroleum Corporation
O. Lynn Rowlan, Echometer Company

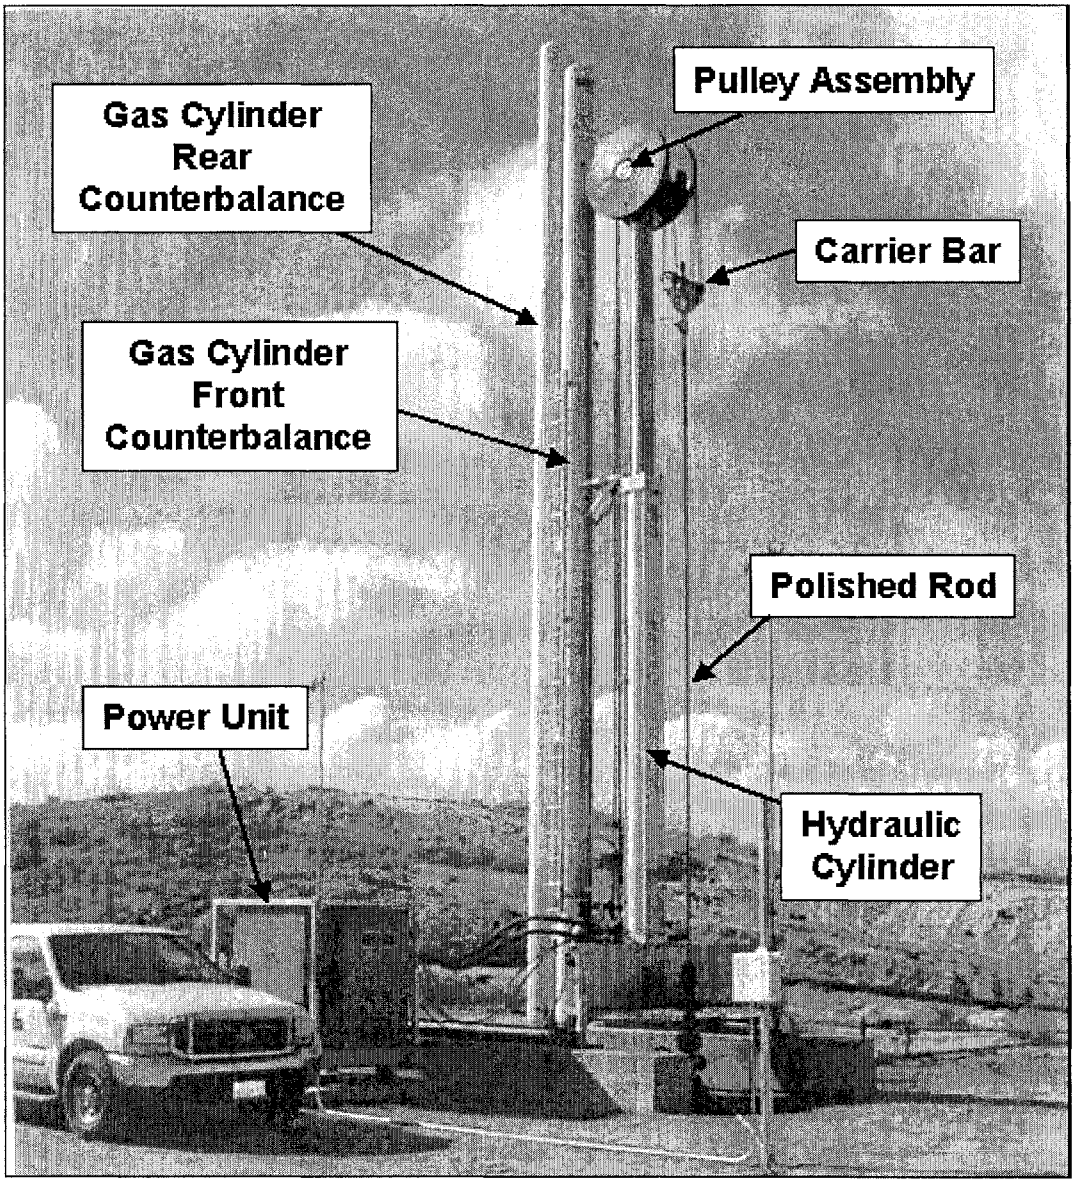
Figure 1 - DynaPump System

The DynaPump System' is a computer controlled sucker rod hydraulic lift pumping system. The system has two main components the Pumping Unit and the Power Unit, **Fig. 1.** The Pumping Unit uses closed loop hydraulics to move a three-chamber cylinder up or down. The polish rod is connected to the hydraulic cylinder by a 2:1 cable and pulley system using high strength nylon pulleys and steel bearings to carry the load. A nitrogen counterbalance system helps support the weight of the rods in fluid, plus a portion of the fluid load. The pressure in the two nitrogen cylinders establishes the counterbalance load and it is connected to the load only during the normal operating conditions. Injecting or bleeding off nitrogen gas pressure stored in the two back cylinders is done to balance loading on the Pumping Unit on the up and down stroke.

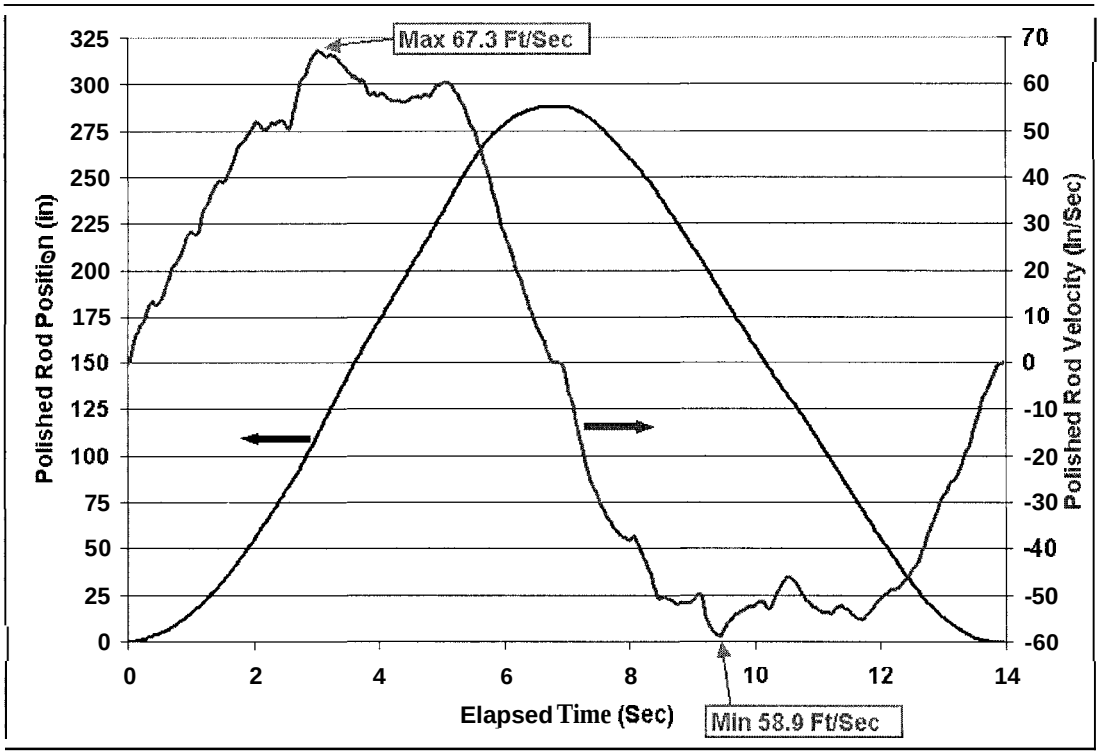
Figure 2 – DynaPump Control of Speed During One Stroke

The DynaPump allows variable speed control and allows independent up versus down vertical speed control. The pump cycle consist of two directions with 4 accelerations and decelerations. The accelerations can be independently controlled, which can reduce rod stresses. **Fig. 2** displays the acquired polished rod position and the control of the vertical polished rod velocity during one stroke. The average constant up velocity during the up stroke is approximate 60 inches per second, with a maximum velocity of 67.3 inches per second. The average constant down velocity during the down stroke is approximately 52 inches per second, with a maximum downward velocity of 58.9 inches per second. The faster up velocity results in less fluid slippage through the pump clearances, while the slower downward velocity will result in less friction and less rod buckling on the down stroke.

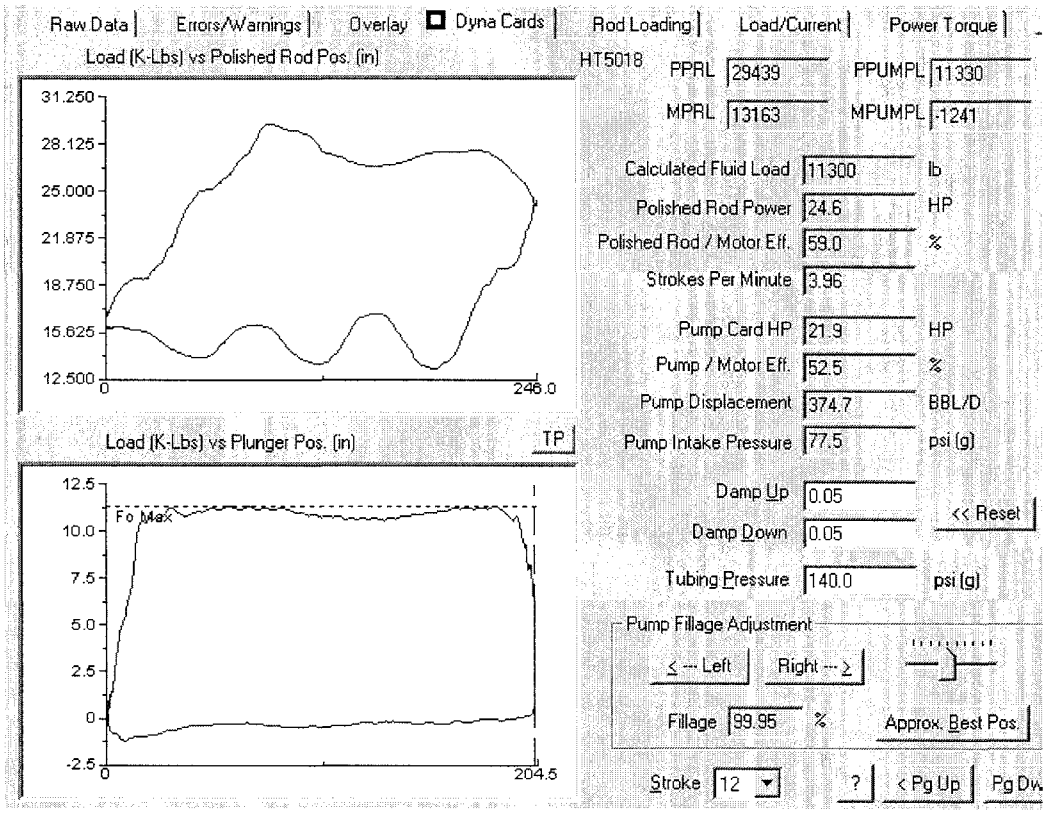
09/10/02 – **Fig. 3, Fig. 4,** and **Fig. 5** are the display of the data acquired with the leaky pump and with the polished rod stroke shortened from 288 to 246 inches. The acoustic liquid level tests showed the highest fluid level above the pump, along with a corresponding slight increase in the production rate over 03107102 time period when the well was conventionally pumped. The casing annulus gas flow rate is approximately 22 MCF per day.

The dynamometer surface cards and pump card are shown in **Fig. 3,** the SPM is 3.96 and polished rod horsepower is 24.6. The pump card shows that the pump is being filled with liquid and no gas interference is present. The calculated pump displacement is 375 BPD compared to the 318 BPD tested production rate. The valve check load test in **Fig. 4** indicates that the pump leakage past traveling valve appears to be approximately 67 BPD. The standing valve did not leak and held a constant load during the test. The downhole pump should be replaced, because the leakage rate is significant and is affecting the performance of the equipment.

Figure 3 - Down-Hole Analysis, Leaky Pump with Shortened Stroke, Date 09/12/2002

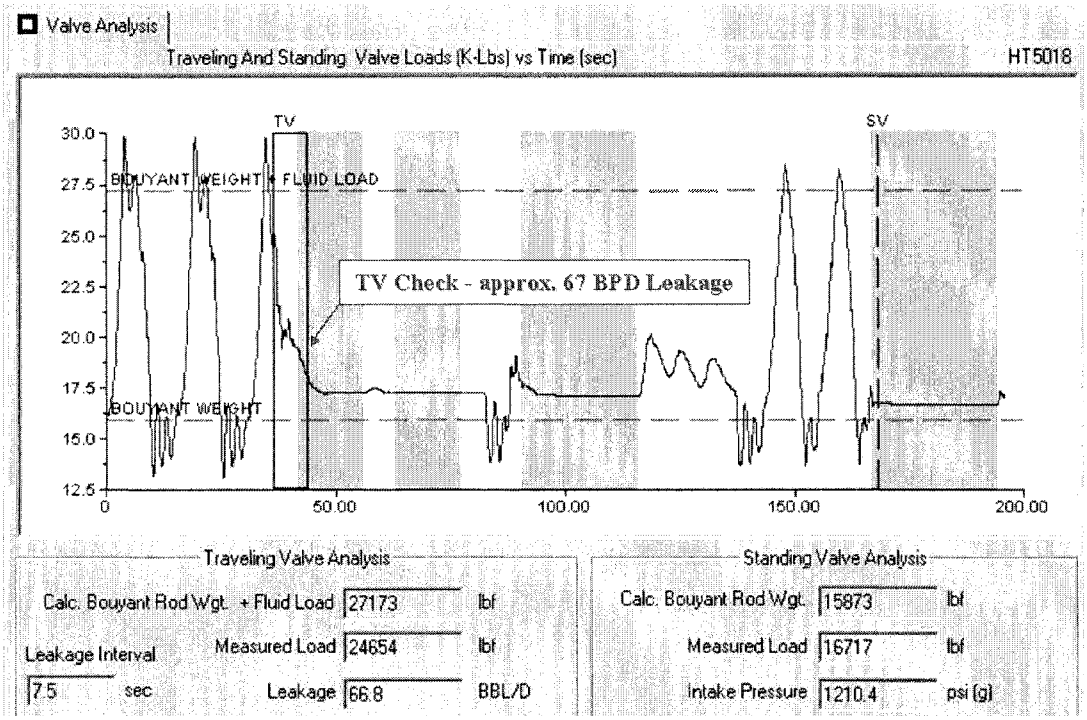
Figure 4 – Dynamometer Analysis, Valve Checks, Date 0911212002

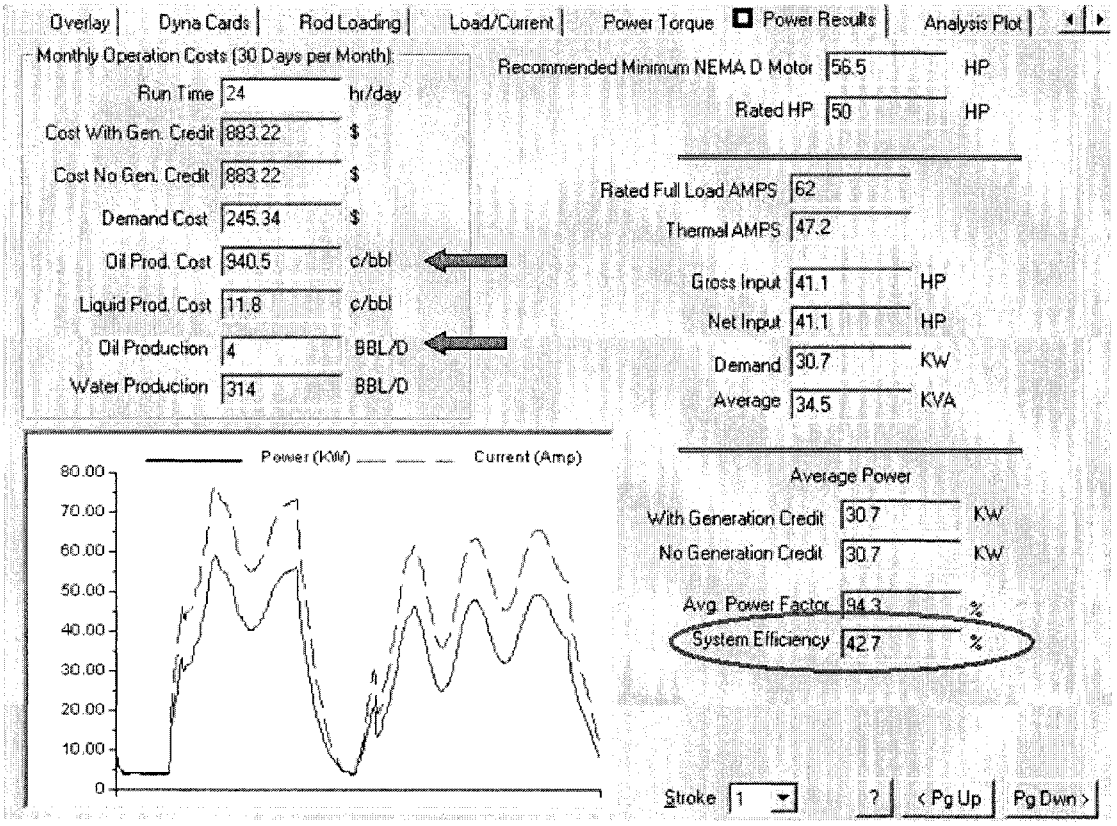
The power measurements shown in **Fig. 5** were obtained at the same time the dynamometer data was acquired. The overall system efficiency is 42.6%. That is, the amount of power required to raise the liquid produced by the well from the net liquid level depth is 42.6% of the power supplied to the motor. The electrical cost to produce the 4 BOPD is $9.41 per barrel of oil, based on the electric rate paid for power.

Figure 5 - System Efficiency Analysis, 43% System Efficiency w/ 67 BPD Leakage, 09/12/2002

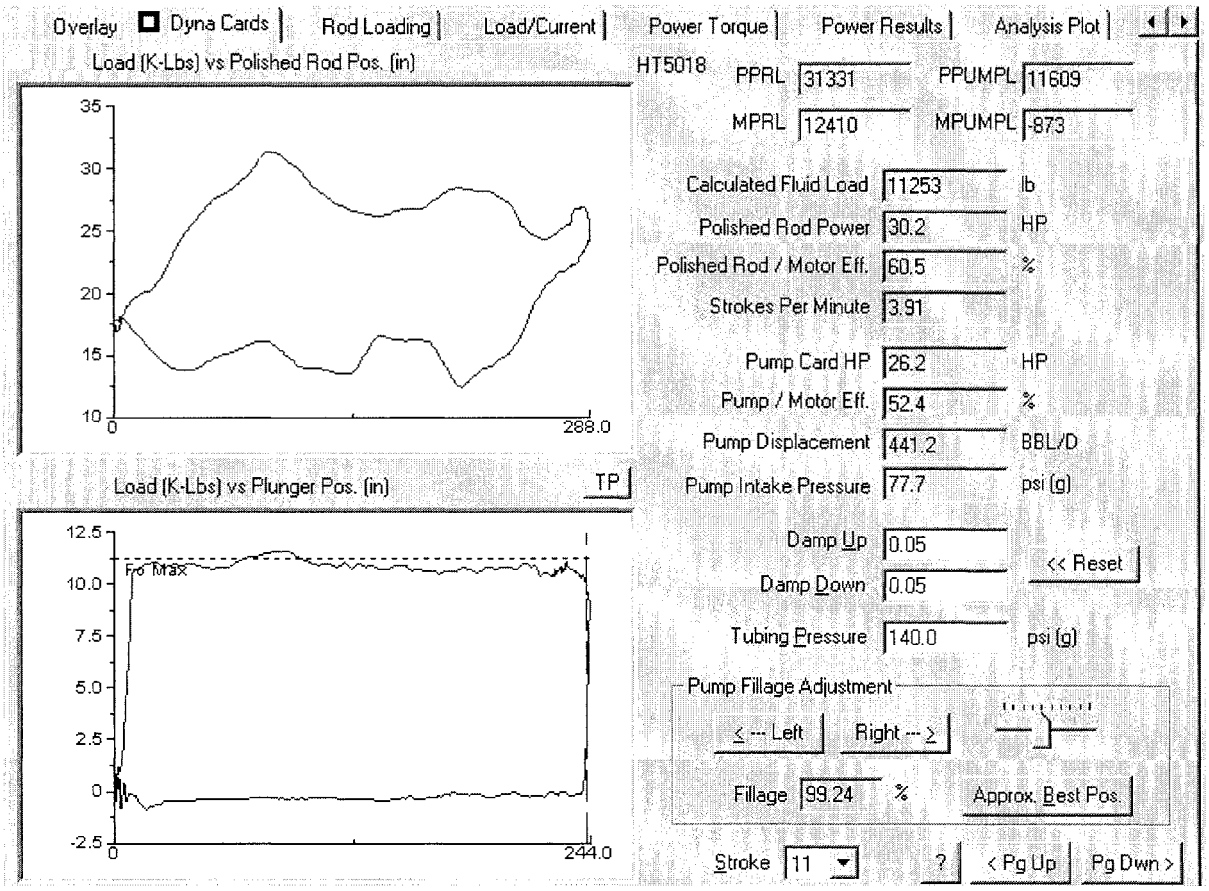
09/26/02 – **Fig. 6, Fig. 7,** and **Fig. 8** are the display of the data acquired with the new pump and with a polished rod stroke of 288 inches. The acoustic liquid level tests showed a decrease in the fluid level above the pump, along with a 105 BPD corresponding increase in the production rate. The casing annulus gas flow rate is approximately 33 MCF per day.

The dynamometer surface cards and pump card are shown in **Fig. 6,** the SPM is 3.91 and polished rod horsepower is 30.2. The pump card shows that the pump is being filled with liquid and no gas interference is present. The calculated pump displacement is 441 BPD compared to the 405 BPD tested production rate. The valve check load test in **Fig. 7** indicates that the pump leakage between the plunger and barrel's 0.006 inch clearance appears to be approximately 22 BPD. The standing valve did not leak and held a constant load during the test. The down hole pump is operating as expected, but additional production from the well is possible if the production rate can be increased.

Figure 6 - Down-Hole Analysis, New Pump with 2 8 8 Stroke, Date 09/26/2002

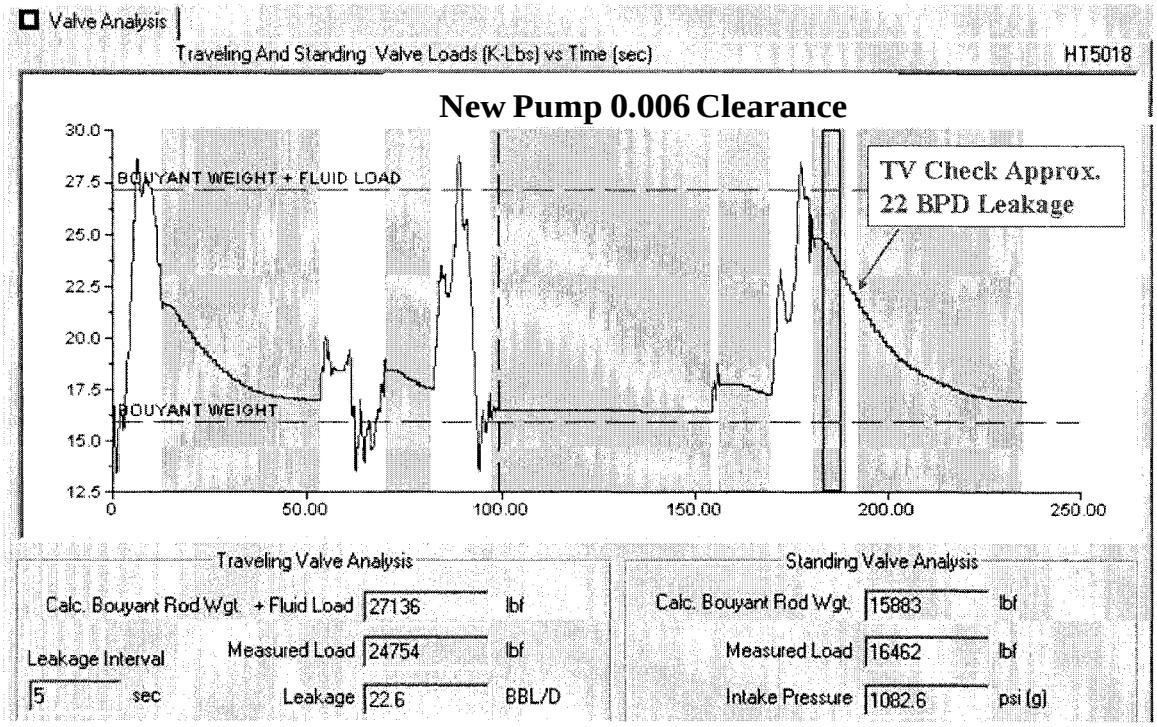
Figure 7 - Dynamometer Analysis, Valve Checks with New Pump, Date 09/26/2002

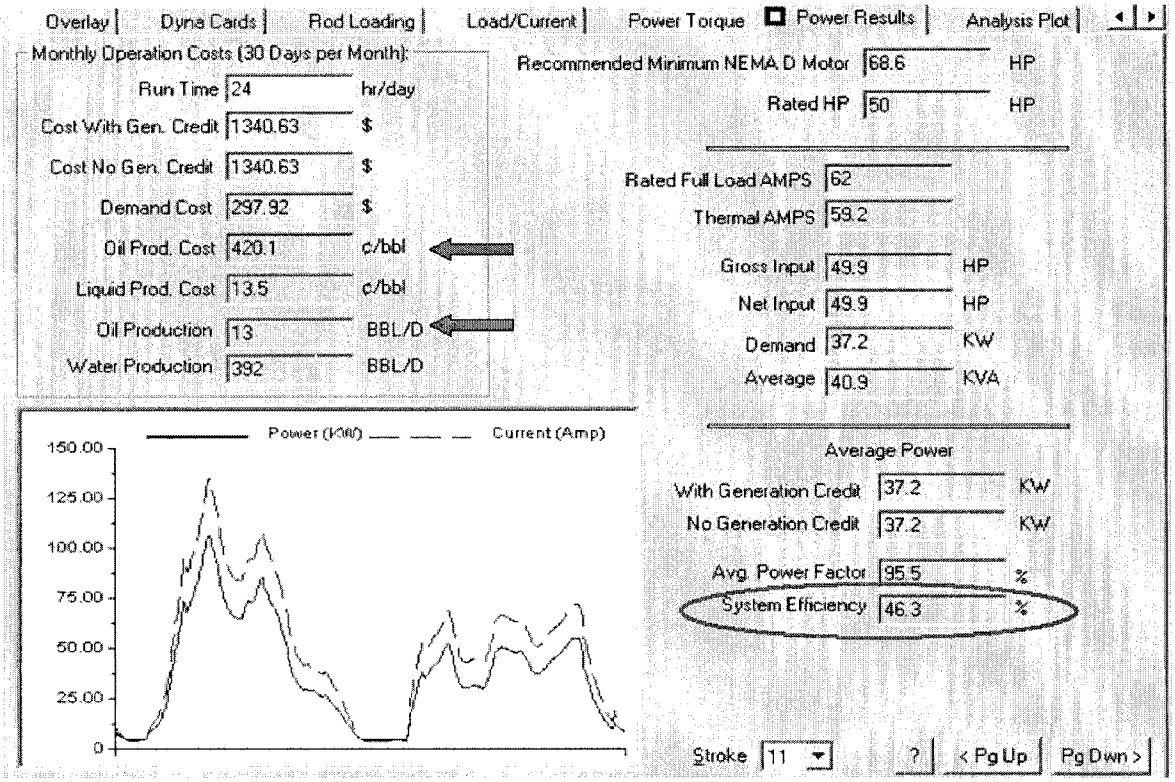
The power measurements shown in **Fig. 8** were obtained at the same time the dynamometer data was acquired. The overall system efficiency is 46.3%. The electrical cost to produce the 13 BOPD is $4.20 per barrel of oil, based on the electric rate paid for power. Replacing the pump and increasing the stroke length resulted in an increase in the system efficiency, plus the increase in the oil production rate resulted in a greater than 50% drop in the electric cost to produce a barrel of oil.

Figure 8 - System Efficiency Analysis, 46% System Efficiency with New Pump, 09/26/2002

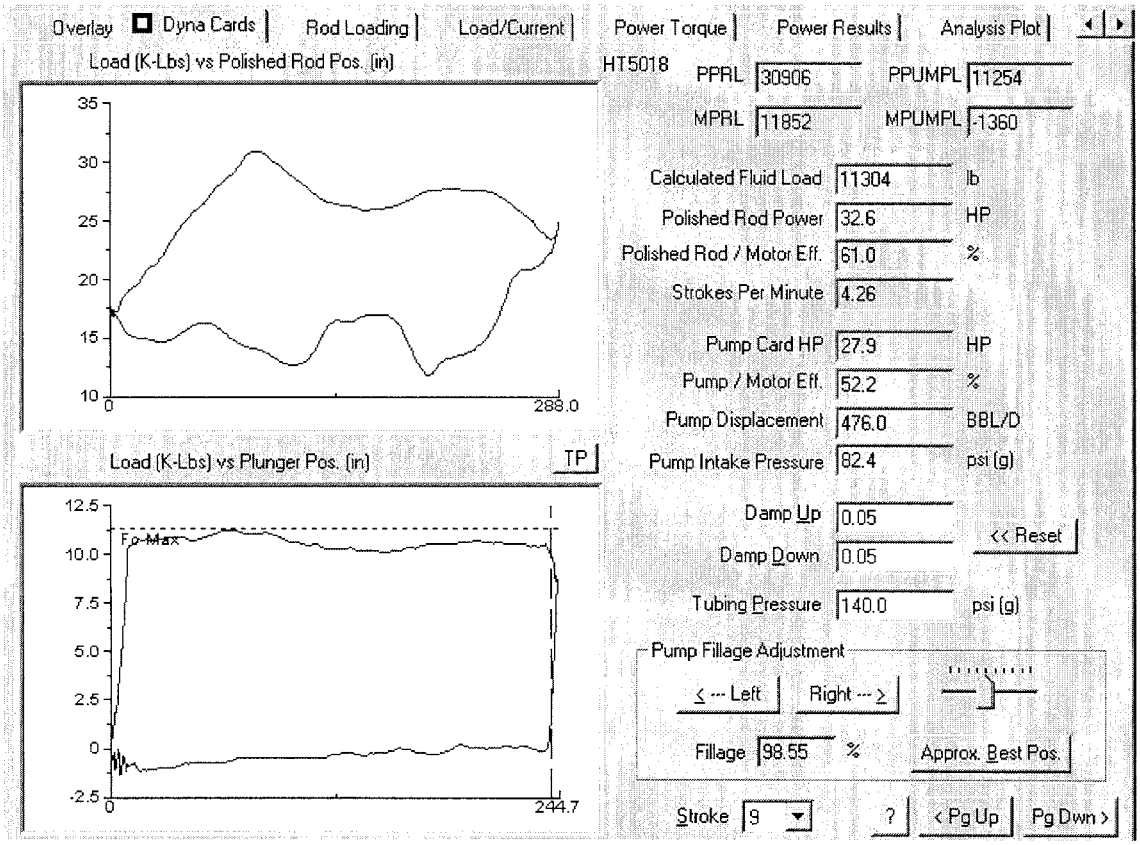
10/22/02 – Fig. 9, Fig. 10, and **Fig. 11** are the display of the data acquired after the SPM was increased from 3.91 to 4.26 with the new pump and the polished rod stroke of 288 inches. The acoustic liquid level tests showed a 311 foot decrease in the fluid level above the pump, along with a 138 BPD corresponding increase in the production rate, from when the well was conventionally pumped. The casing annulus gas flow rate is approximately 36 MCF per day.

The dynamometer surface cards and pump card are shown in **Fig. 9,** the SPM is 4.26 and polished rod horsepower is 32.6. The pump card shows that the pump is being filled with liquid and no gas interference is present. The calculated pump displacement is 476 BPD compared to the 465 BPD tested production rate. The valve check load test in **Fig. 10** indicates that the pump leakage between the plunger and barrel's 0.006 inch clearance appears to be approximately 22 BPD. The standing valve did not leak and held a constant load during the test.

Figure 9 - Down-Hole Analysis, New Pump at Faster Strokes/Min, 10/22/2002

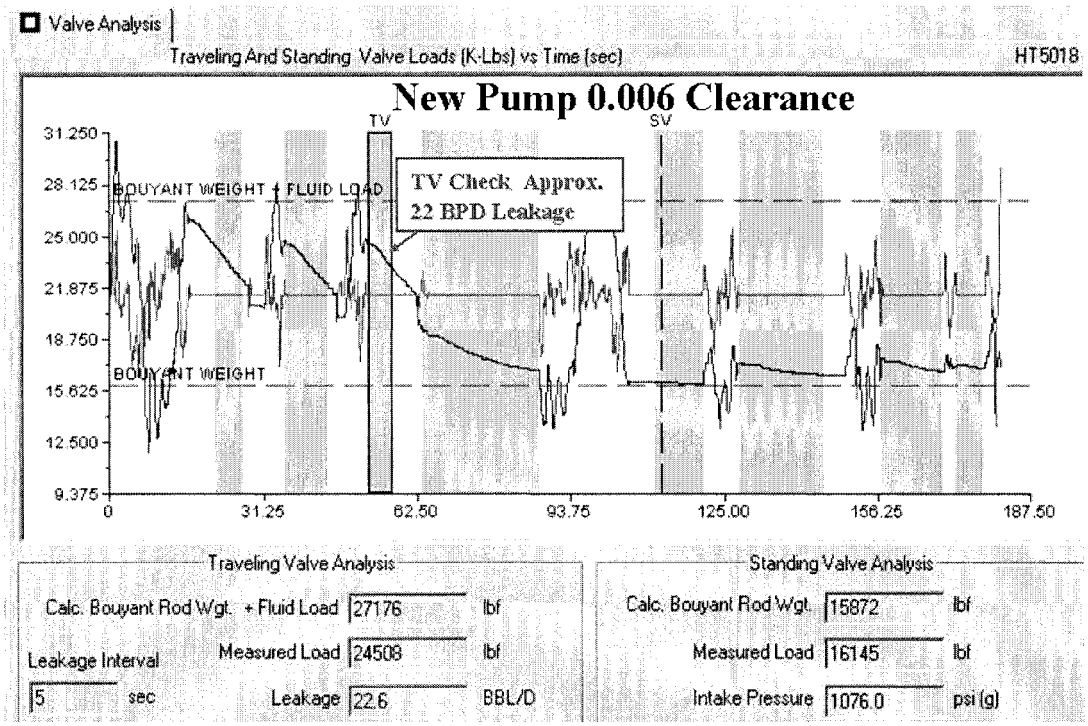
Figure 10 - Dynamometer Analysis, Valve Checks Fastest Strokes/Min, 10/22/2002

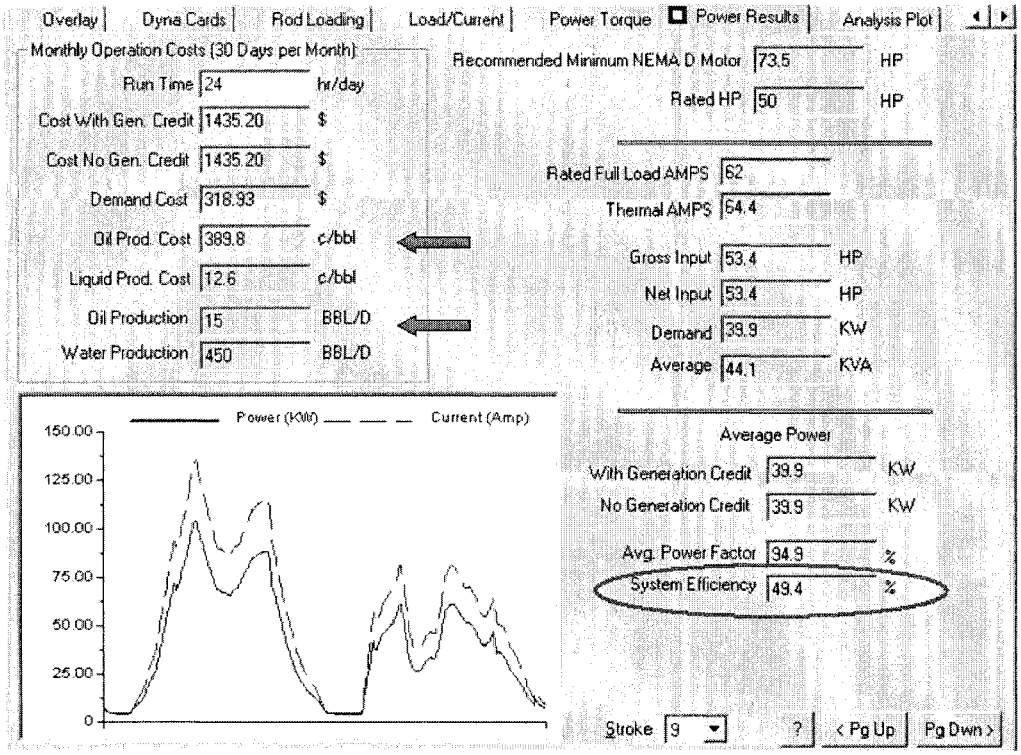
The power measurements shown in **Fig. 11** were obtained at the same time the dynamometer data was acquired. The overall system efficiency is 49.4%. The electrical cost to produce the 15 BOPD is $3.90 per barrel of oil, based on the electric rate paid for power. Replacing the pump, increasing the stroke length, plus increasing the speed to 4.26 SPM resulted in the highest efficiency with the lowest electric cost to produce a barrel of oil.

Figure 11 - Highest System Efficiency Analysis, Fastest Rate, 10/22/2002
