EXTENDING RUN LIFE IN SAND-PRODUCING WELLS: THE BENEFITS OF ROD PUMP SAND MANAGEMENT TOOLS

Presenters: Blake Bredemeyer, Oxy; Wade Erwin, PetroQuip

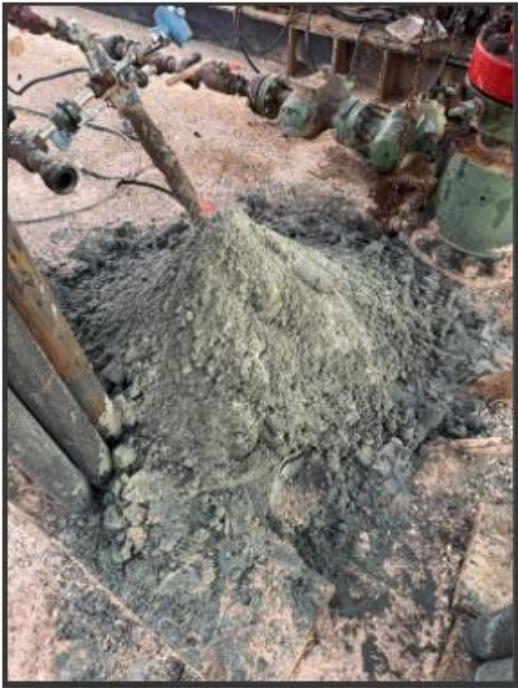
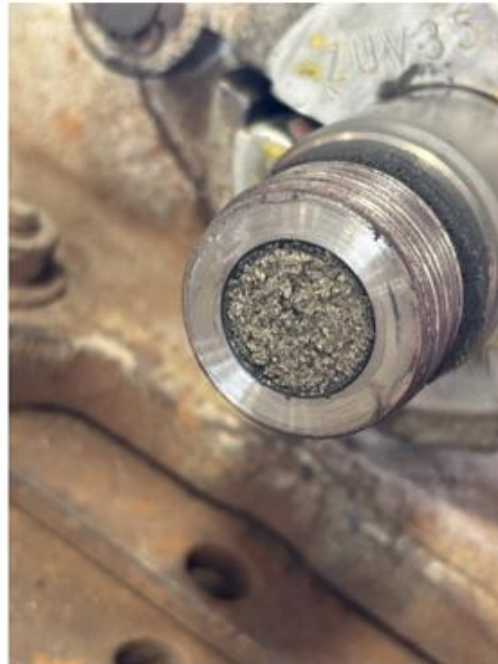
Figure 2: Examples of solids found during the pulls and pump teardowns.

plunger packed off with sand

Large amounts of sand are often encountered in unconventional wells produced on sucker rod pumps. The heavy sand movement is caused by the initial fracture or fracture hits by nearby completions. In many cases, sand accumulates on top of the pump, resulting in stuck pumps which require extra steps in the pulling process. This problem results in elevated workover costs and short runtimes between failures. Figures 2 and 3 provide photos of the severity of sand problems that are being

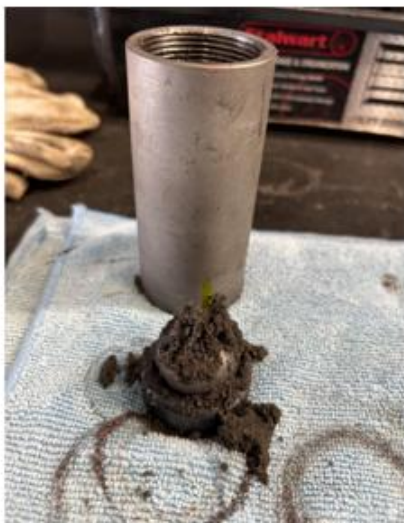
primary traveling valve ball and seat

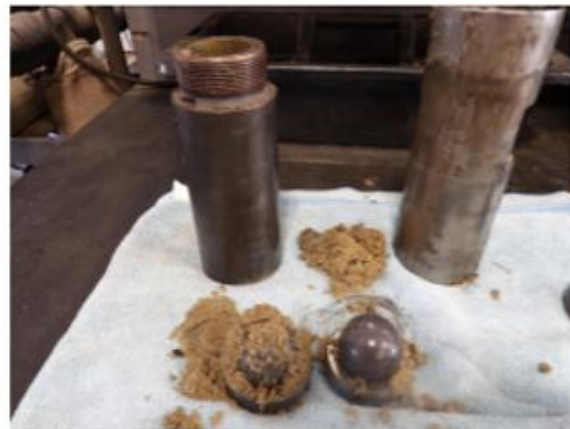
Standing valves prior to cleaning

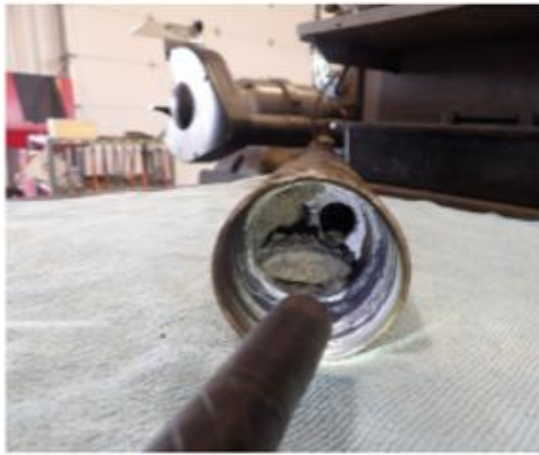
Figure 3: More examples of solids found during pump teardowns.

Sand in primary standing valve

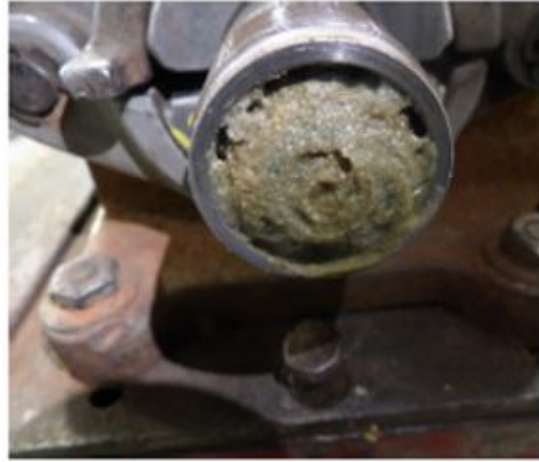
Barrel packed off sand

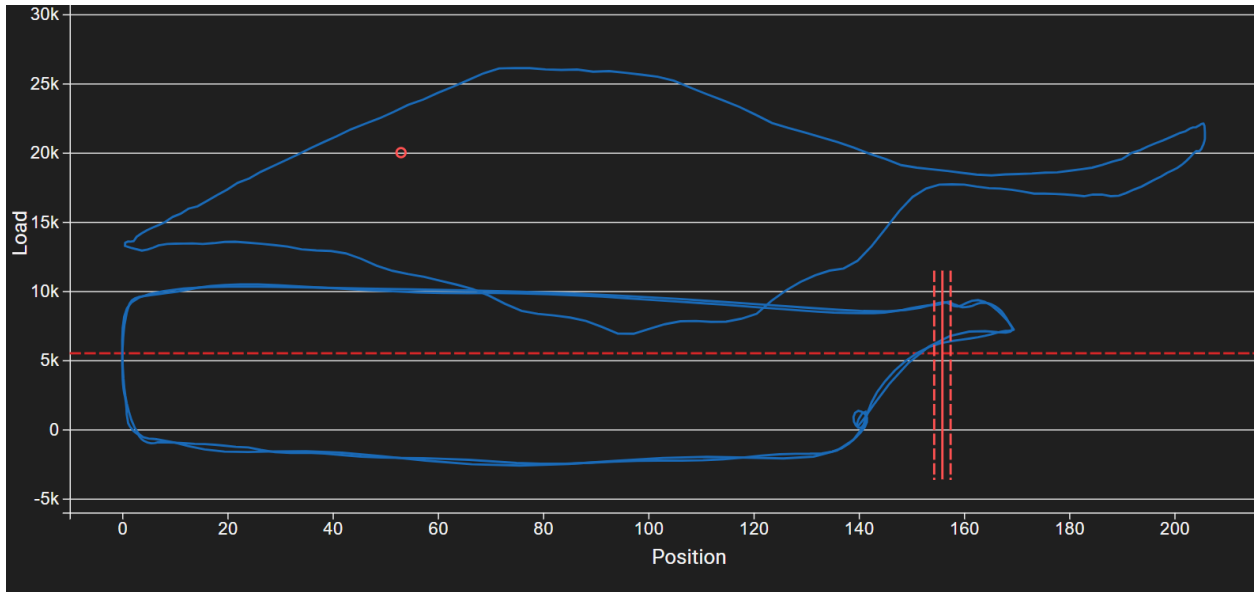
Figure 5: Added pump friction from solids in a dynamometer card.

encountered. Figures 4 through 6 are examples of dynamometer cards from these sand-producing wells. (a dynamometer card is a graph that plots the polished rod load in relation to its vertical displacement during a pump stroke.)

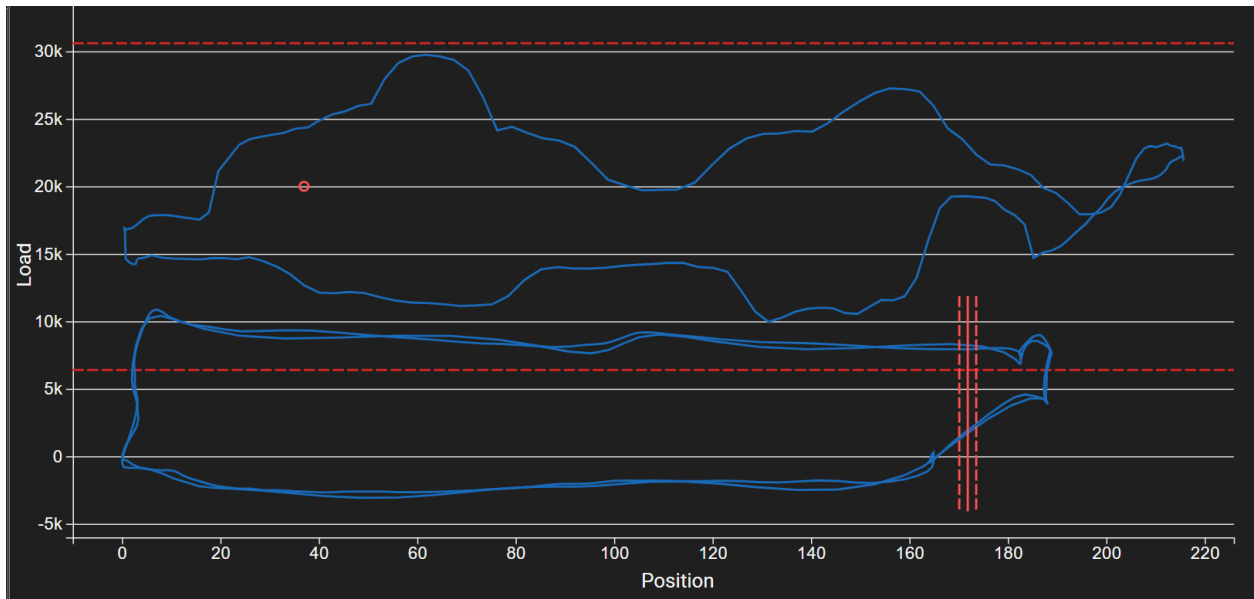
Figure 6: Dynamometer card showing added pump friction from solids.

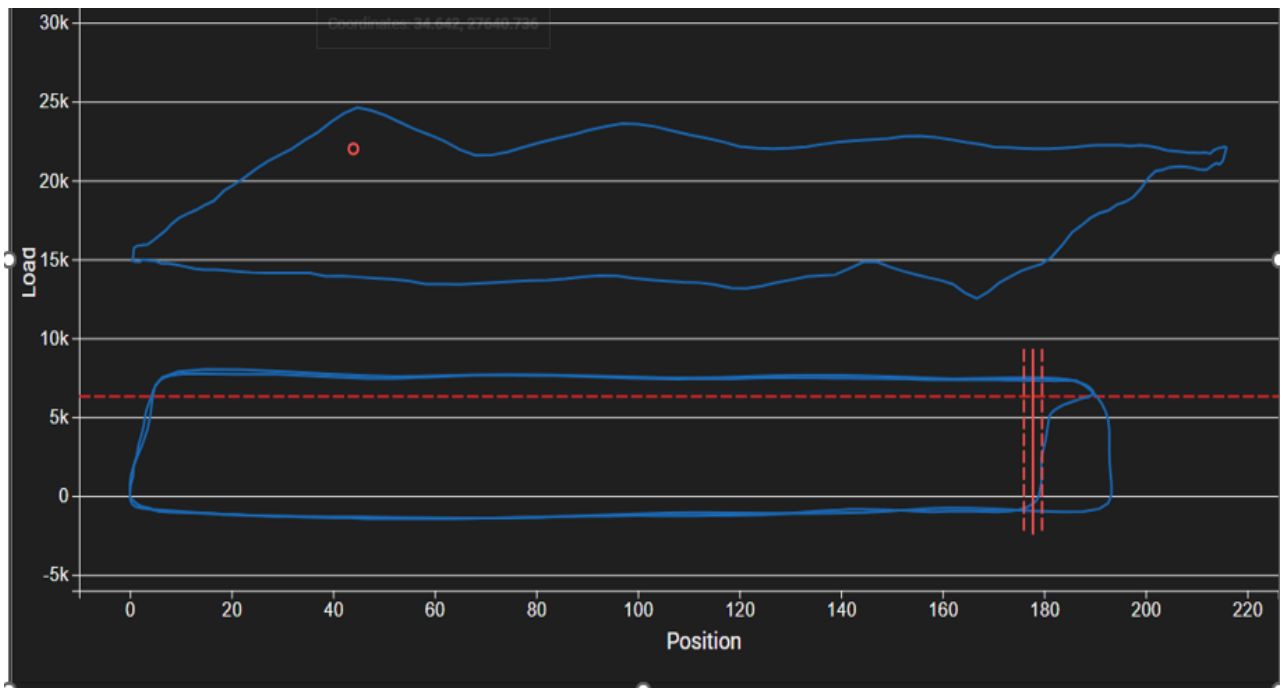
Figure 8: Case Study 2 dynamometer card.

Case Study 2 well has a long history of sand-related pump failures since being converted to SRP July 5, 2023. The SRP lift mean time to failure is approximately 70 days since the conversion. Many different bottomhole assemblies and pump configurations have been tested with similar results. On March 17, 2025, an SRP sand management tool was installed and ran 119 days before a rod part event on July 14, 2025. The tool resulted in an easy pump hold down release. The operator tried several other sand separation/management tools that resulted in short runs. On November 11, 2025 an SRP sand management tool was reinstalled and has been running for 110 days. The dynamometer cards show worn travelling valve (Figure 8).

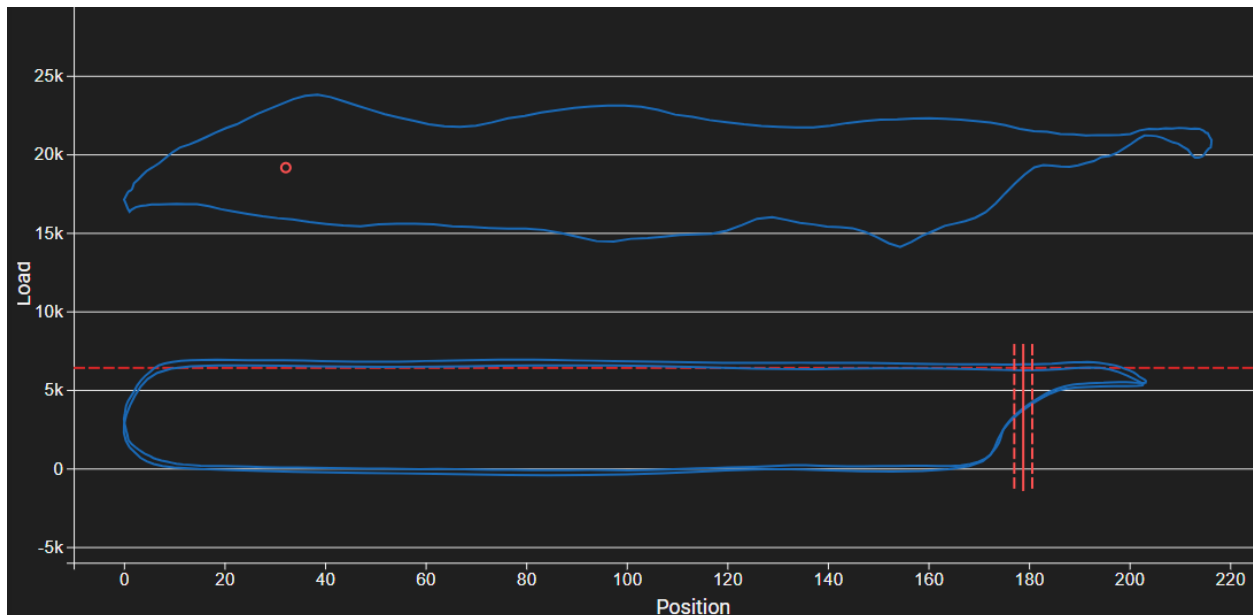
Figure 13: Case Study 7 dynamometer card.

This well was converted to SRP April 8, 2023. The mean time between failures is approximately 124 days. All 6 of the failures have been caused by sand. On December 8, 2025, SRP sand management tool was installed. On December 12, the dynamometer cards indicate a worn traveling valve. The pump was unable to recover and was classified as failure on December 16, 2025. The total run days were 8. The pump was unseated easily, and the report shows that there was heavy sand found throughout the pump. On December 31, 2025, a SRP sand management tool was reinstalled and has been running for 59 days. The dynamometer cards (Figure 13) are normal and have no signs of solids. There have been no downtime events.
